## **APPENDIX J HISTORIC RESOURCES**

This appendix provides documentation of consultation with the Ohio State Historic Preservation Office. Attachments 1 - 7 are surveys and consultation in support of the impact assessment for Historic, Architectural, Archaeological, and Cultural Resources.

***Federal Aviation Administration***  
**ENVIRONMENTAL IMPACT STATEMENT**  
**FOR**  
**REPLACEMENT RUNWAY AND TERMINAL PROJECT**  
**AT**  
**PORT COLUMBUS INTERNATIONAL AIRPORT**  
**AGENCY MEETING – OHIO HISTORIC PRESERVATION OFFICE**  
**MEETING MINUTES**  
**NOVEMBER 21, 2006**

**Cultural Resources Existing Conditions and Survey  
Methodology Report for the  
Port Columbus International Airport  
Environmental Impact Statement,  
Cities of Columbus and Gahanna, Franklin County, Ohio**

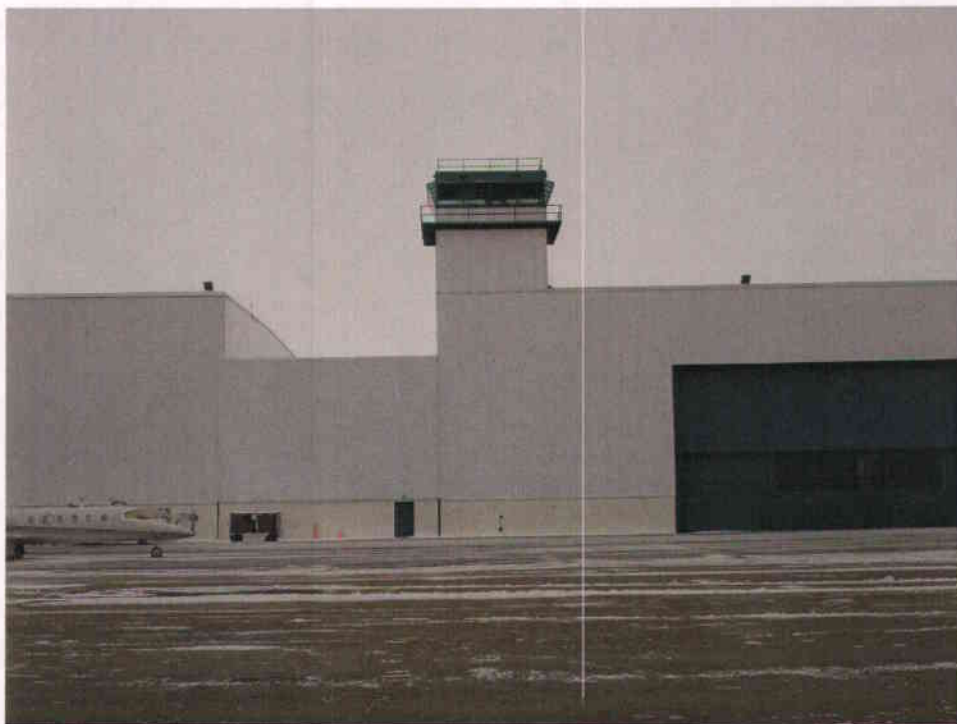
Plate 8. International Air Center ramp tower, part of AFP 85 Building 7 (Service Building) [FRA-8368-12].

The OHI form FRA-8368-12 for Building 7 (constructed 1943) mentions that the tower was added to the northeast corner of the structure in 1953 (Figure 3, Sheets 2 and 3)). There is no further discussion of the Air Control Tower either in the Historic Inventory and Evaluation report for Plant 85 (Earth Tech and CCRG 1996) or the OHI form completed for that report. The tower is about 100 ft from ground level, and is square in plan (Plate 17). As is typical of Air Control Towers, all sides of the control room are glazed and the glass walls slope inwards towards the floor. Outside the control room is a contiguous gallery with a railing. A railing on the roof of the control tower indicates that this area is perhaps also accessible. The control tower appears to be in a good condition, though in the absence of existing information, there is no indication as to whether it has been modified. The tower was not originally a part of Air Force Plant 85, and was constructed during the Cold War when North American Aircraft was using Building 7 to manufacture combat aircraft (Earth Tech and CCRG 1996:3-27). The Air Control Tower was thus used in conjunction with the aircraft and missile manufacturing activity during the Cold War from the 1950s through to the 1980s.

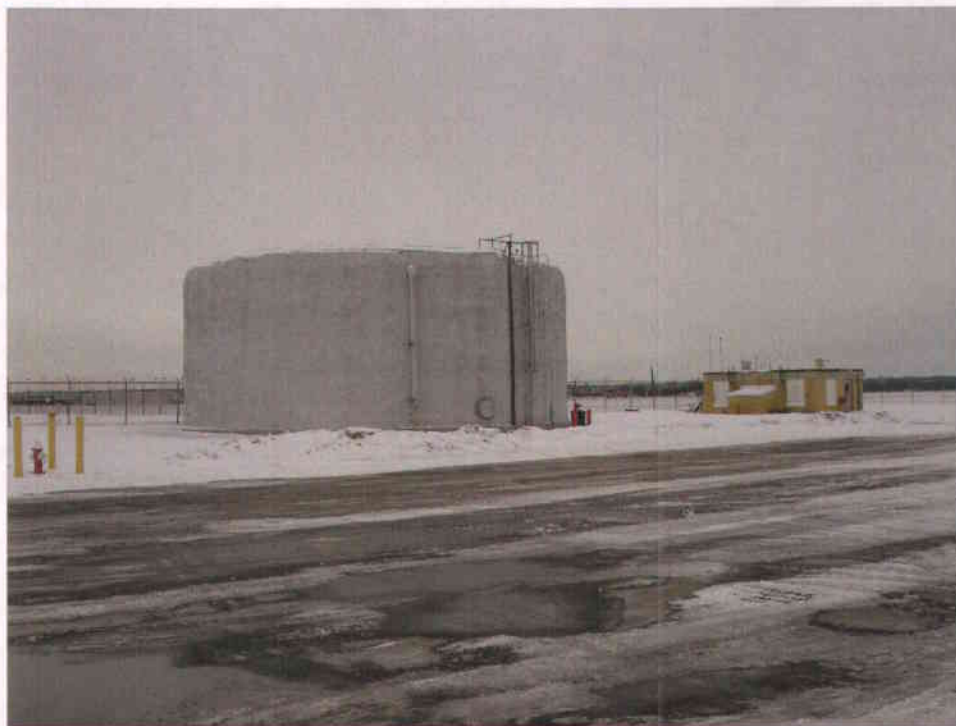
Plate 9. AFP 85: Building 26 (pump house) [FRA-8380-12] and storage tank.

The Building 26 Storage Tank and Pump House Complex comprises three structures: two single storied, flat-roofed brick buildings of similar construction (numbers 26 and 144) and a cylindrical concrete storage tank (Figure 3, Sheet 2; Plate 19). It is located north of the main Air Force Plant 85 buildings. Building 26 was constructed in 1943, and is associated with the Air Force Plant 85 activities during the war. Building 144 was a fueling station constructed, according to the 1996 survey report, in 1953. However, its form, style, construction materials, and craftsmanship are identical to Building 26. Both the buildings are of concrete slab construction with brick walls and steel sash windows. Both are in poor condition, with wear showing on the visible portions of the roof, and some of the windows damaged and boarded up. The storage tank, whose construction date is unknown, is in a fairly good condition.

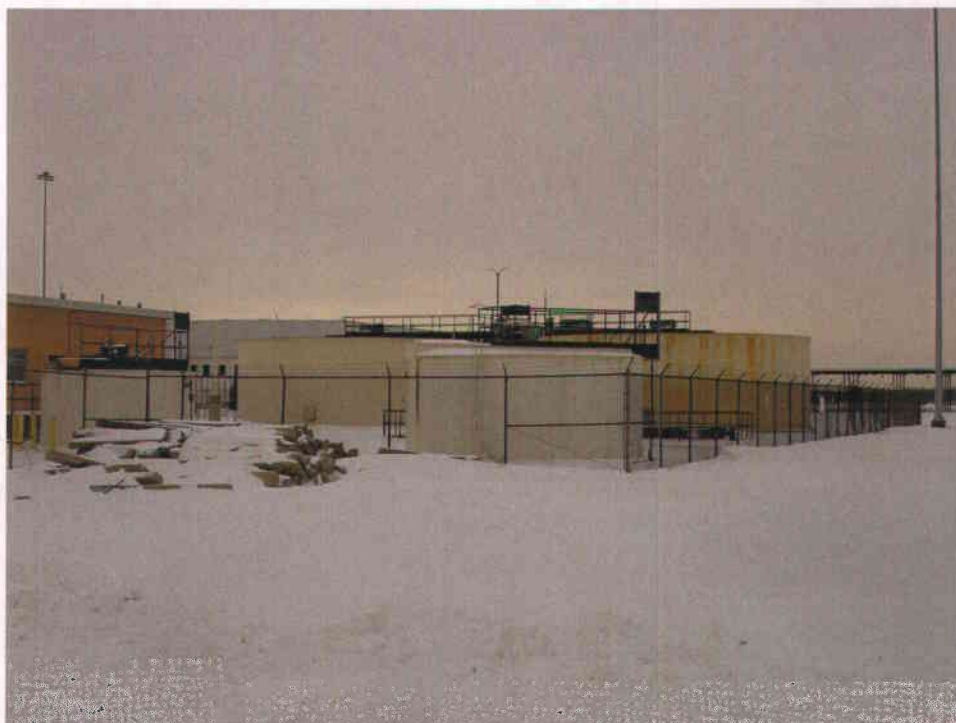
Plate 10. AFP 85: Building 282 (waste treatment facility) and storage tanks.

Building 282 and the Waste Treatment Facility associated with it are located immediately northwest of Building 3 of Air Force Plant 85 (Figure 3, Sheet 2). It includes several tanks and other structures constructed out of concrete, brick, and metal that are associated with the treatment of waste and fenced off from its surroundings (Plate 20). The facility was constructed in 1965, and was likely an ancillary part of the aircraft and missile construction at the plant during the time.

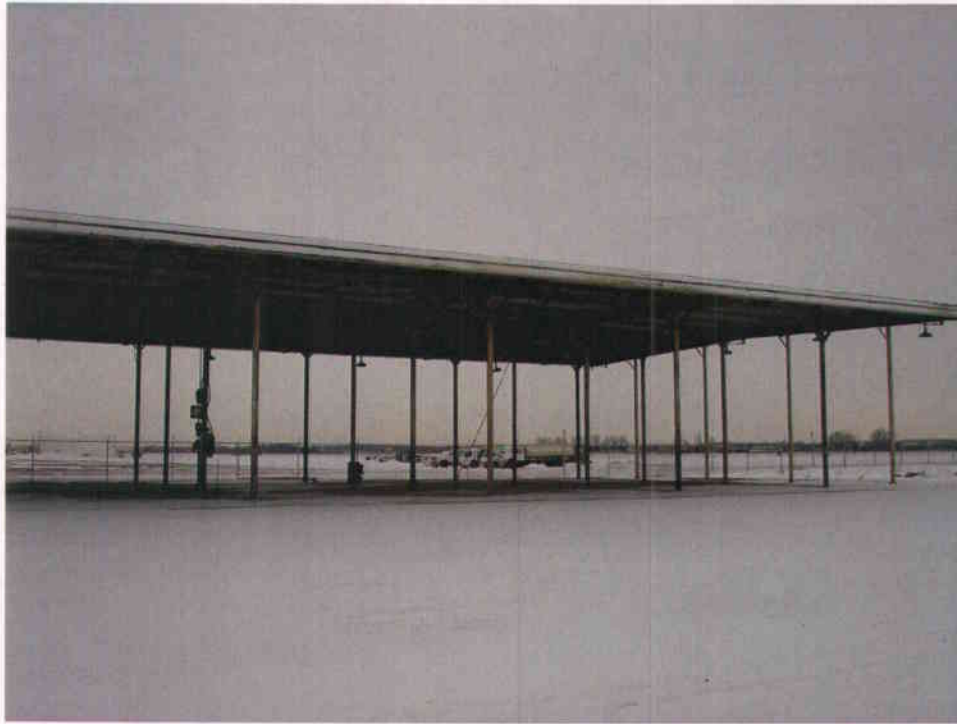
Plate 11. AFP 85: Building 30 (steel frame shed) [FRA-8378-12].

Building 30 is a open, steel-frame shed (65 ft by 115 ft) with a gently pitched, near flat steel-truss roof resting on metal posts (Figure 3, Sheet 2; Plate 21). The decking is constructed out of concrete. As the Historic Inventory and Evaluation (Earth Tech and CCRG 1996) and the corresponding OHI form indicate, the structure was constructed in 1943 during World War II.

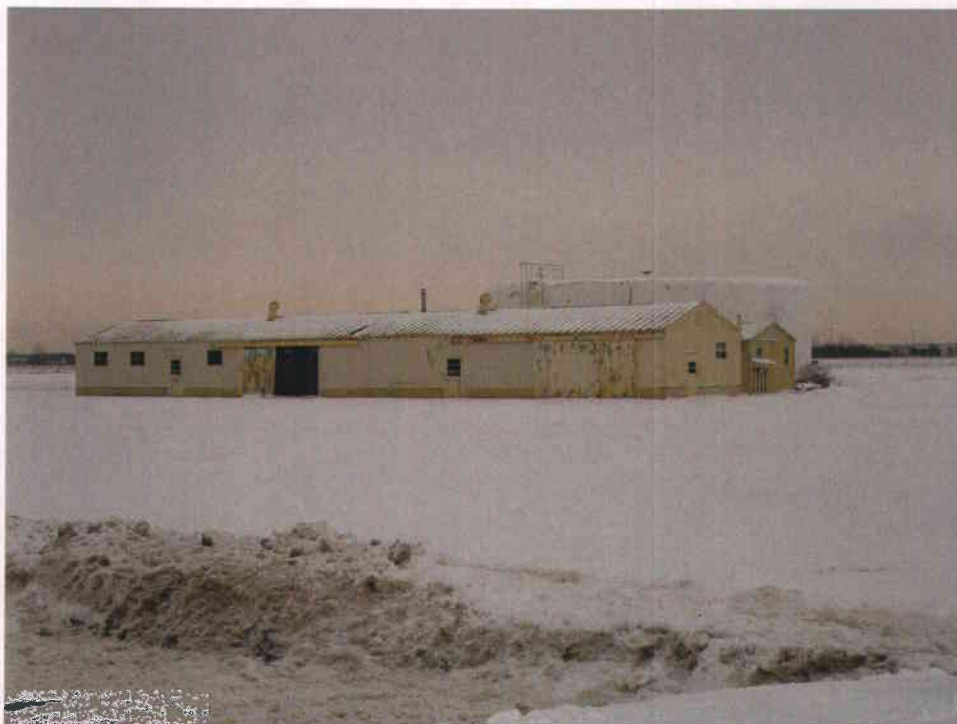
Plate 12. AFP 85: Building 49 and storage tank associated with Building 25 (FRA-8381-12).

The Building 25 cluster comprises four structures, namely the Pump House (Building 25), two single-storied, gabled-roof structures (the southernmost of which is Building 49), and a cylindrical storage tank of the same type as the one associated with AL005 (Figure 3, Sheet 3; Plate 22). The cluster is located immediately north of Building 7. Also erected in 1943, Building 25 (the Pump House), is identical in its dimensions, concrete slab construction, brick walls, and metallic windows as Building 26, also a pump house. Building 49, constructed in 1952 is an elongated equipment storage structure with a concrete block foundation, clapboard walls with metal frame windows and a large gate to allow for movement of equipment, and a metal roof with vents. The other building is a second, smaller gable roofed metal shed of unknown use.

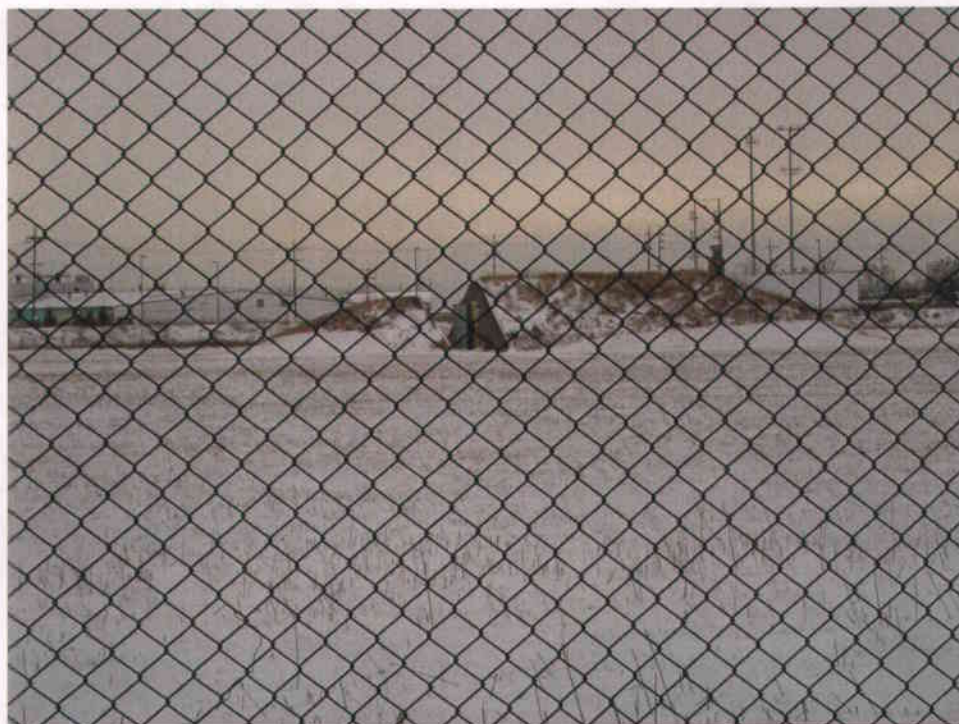
Plate 16. AFP 85: Building 229 (ammunition storage building).

13. AFP 85 Building 229 (ammunition storage building, 1959) [Plate 16];
14. Structural remnant of uncertain origin, located within AFP 85 boundary;
15. Possible farm silo, located outside AFP 85 boundary (Plate 17); and
16. Concrete structure of uncertain function, located outside AFP 85 boundary (Plate 18).

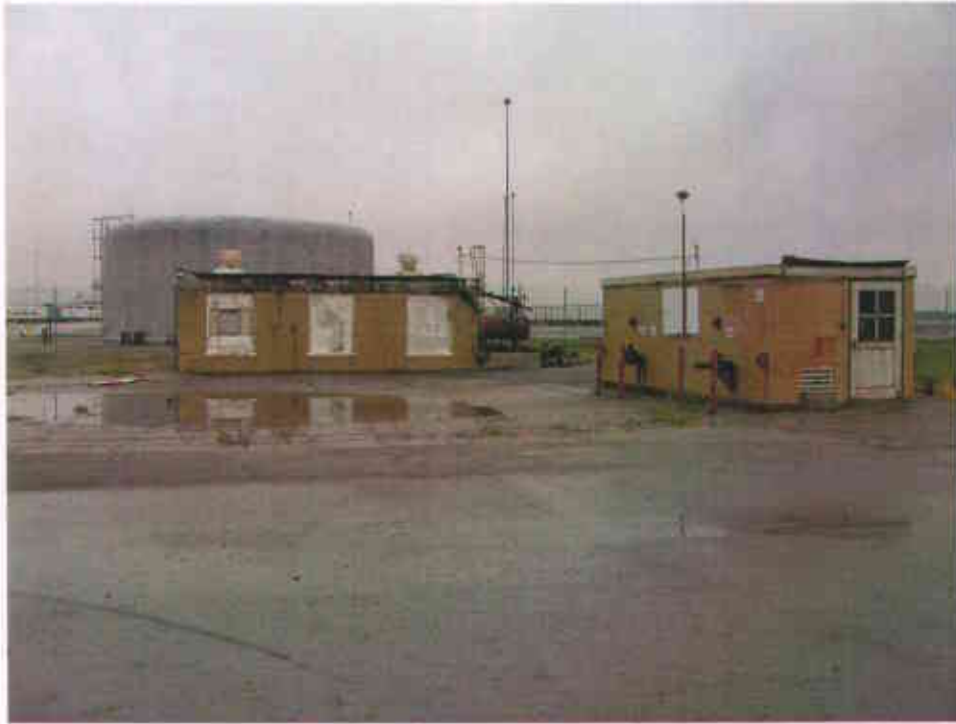
Plate 19. AL005/ FRA-8380-12, Building 26 (Pump House and Storage Tank), looking west.

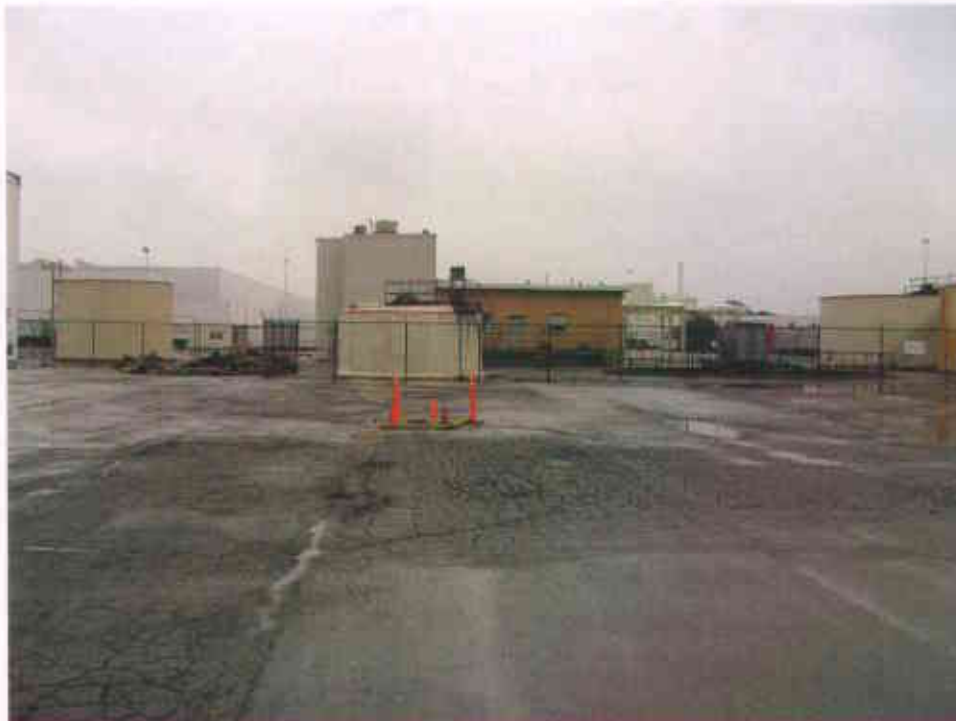
Plate 20. AL006, Building 282 (Waste Treatment Facility), looking south.

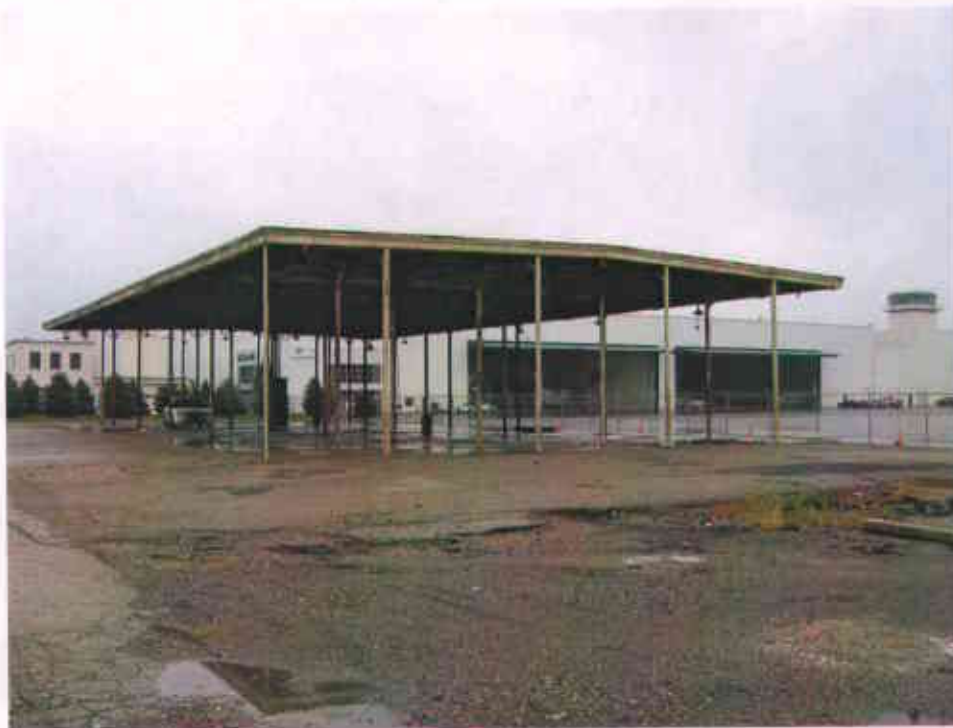
Plate 21. AL007/FRA-8378-12, Building 30, looking southwest.

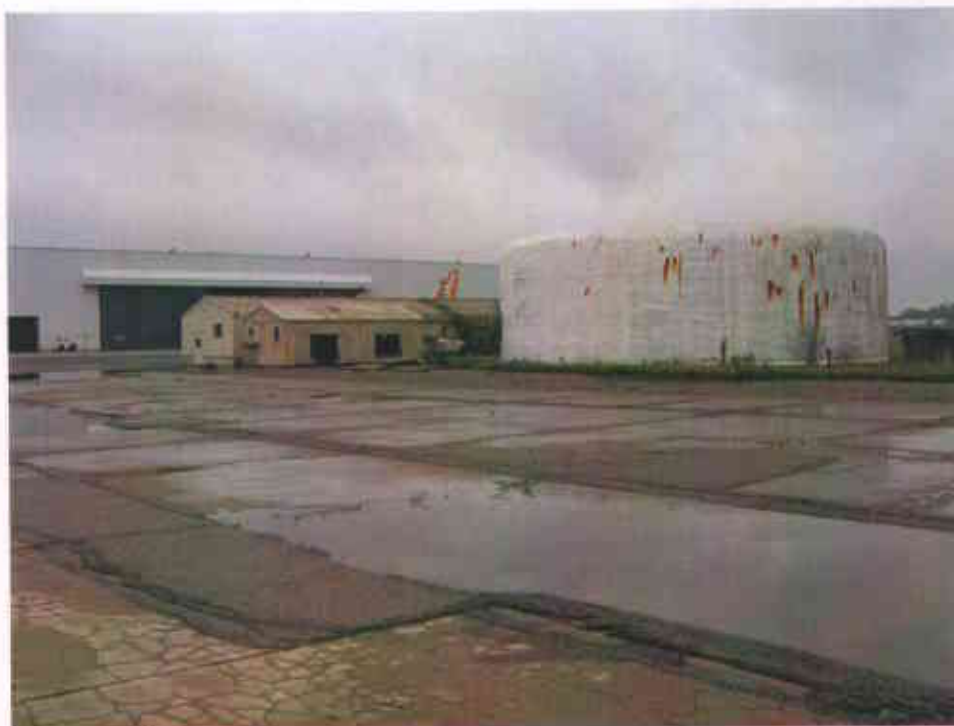
Plate 22. AL008/FRA-8381-12, Building 25 (Pump House), looking southwest.

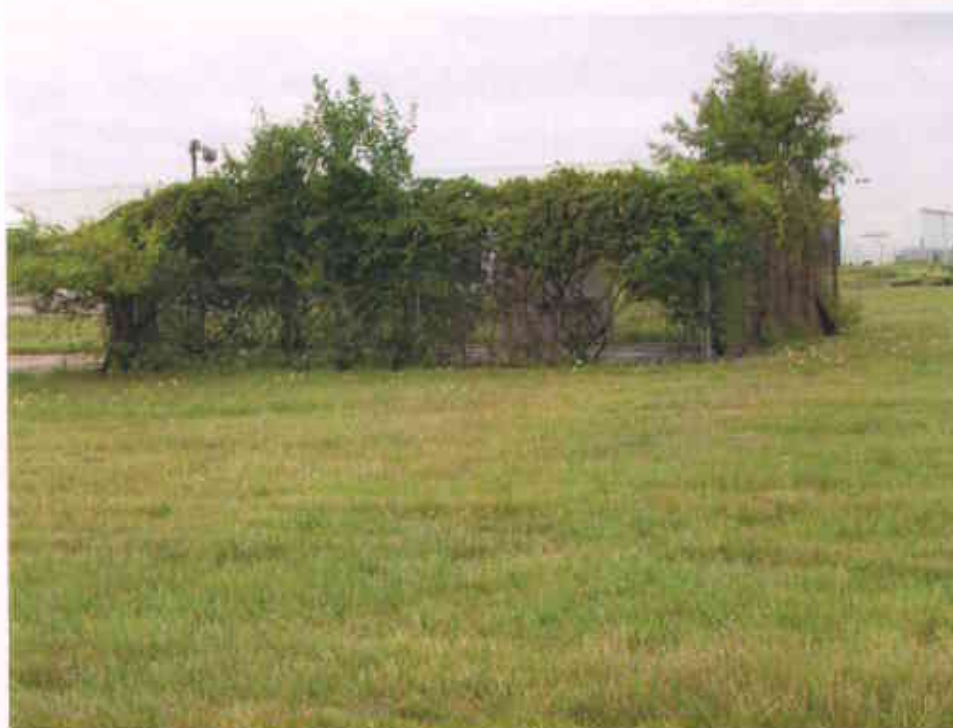
AL009 is a windowless, flat-roofed, cast-concrete structure located immediately north of Building 7 (Figure 3, Sheet 3; Plate 23). There are two entrance doors closely spaced at right-angles to each other located in a recess on the west corner of its south-facing façade. The entrances are partly hidden from view by the western concrete wall, which projects out and tapers towards the roof. A vent is visible on the roof. A plaque designates the structure as Building No. 120, an ammunition magazine constructed in 1952.

Plate 23. AL009 FRA-9677-12, Building 120 (ammunition magazine), looking northeast.

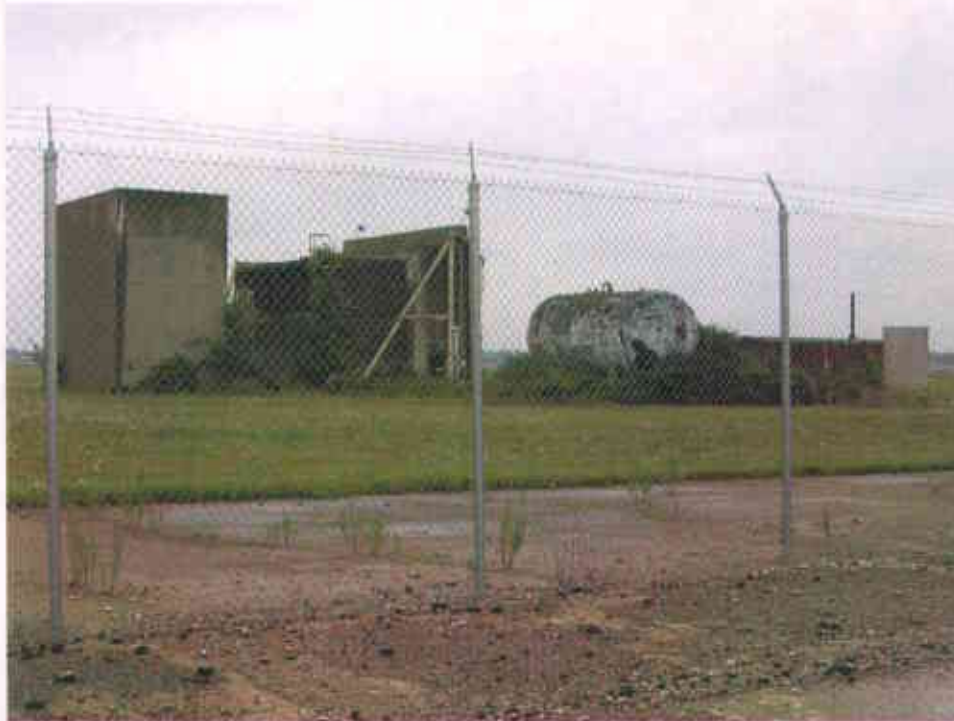
Structure 10 is a single-storied concrete building within a secured, fenced area south of the airport runway and northwest of Building 7 and the Air Force Plant 85 complex (Figure 3, Sheet 3; Plate 24). The structure is only partly visible because it is surrounded on all sides by a metal fence and heavy vegetation. The building is not associated with Air Force Plant 85 and was not indicated on the original plan of the facility included in the 1996 Earth Tech and CCRG

Plate 24. AL010 FRA-9678-12, Structure 10, looking southeast.

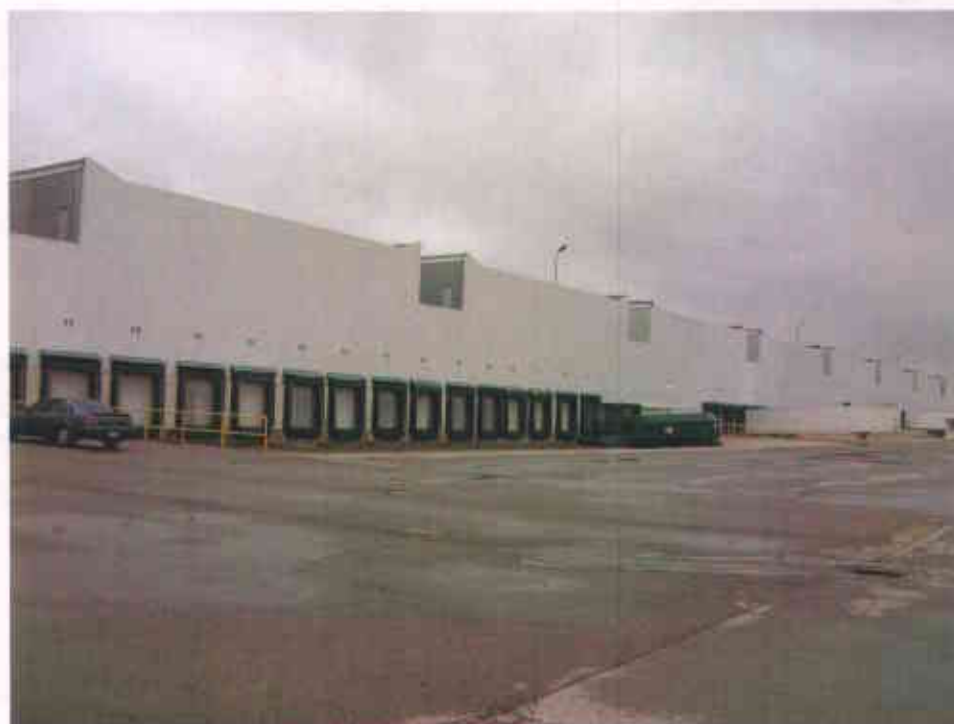
Building 3 was the main manufacturing building of Air Force Plant 85 and was constructed in 1941 (Figure 3, Sheet 2; Plates 29 and 30). The east end of the building was the

Plate 29. AL015/FRA-8366-12, Building 3 (Manufacturing Building), looking northwest.

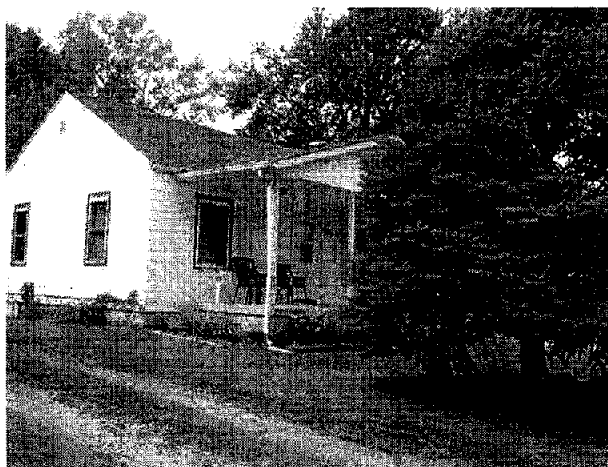
1. No. **FRA-09667-12**

17. Date(s) or Period <b>1946</b>		28. No. of Stories <b>One story</b>		
18. Style Class and Design <b>Dominant No academic style - Vernacular</b>		29. Basement? <b>Yes</b>		38. Building Dimensions <b>24 ft x 28 ft</b>
18a. Style of Addition or Elements(s)		30. Foundation Material <b>Concrete block</b>

41. Distance from & Frontage on Road <b>30 ft</b>
				51. Condition of Property: <b>Good/Fair</b>
				52. Historic Outbuildings & Dependencies Structure Type <b>Garage</b> Date <b>1977</b> Associated Activity

53. Affiliated Inventory Numbers Historic (OHI) Archaeological (OAI)
42. Further Description of Important Interior and Exterior Features (Continued on Reverse if Necessary) The single story minimal traditional house is located on the south side of E. 13th Avenue, and is fronted by a yard about 30 ft. deep. The basement of the house is discernible from the glass-block filled glazing that punctuates the concrete block foundation. The house has a wooden, open deck along the front facade and a side entrance with a door in the central bay of the west facade. Alterations to the house include newer siding and roofing materials. The rear yard of the house is fenced.

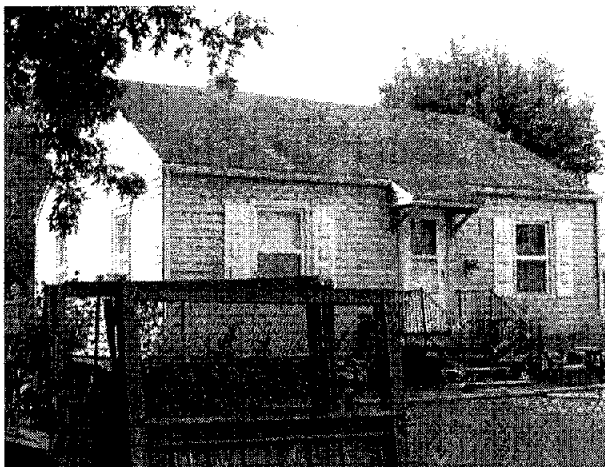
17. Date(s) or Period <b>1947</b>		28. No. of Stories <b>One story</b>		
18. Style Class and Design <b>Dominant</b> <b>No academic style - Vernacular</b>		29. Basement? <b>Concrete block</b>		38. Building Dimensions <b>24 ft x 28 ft</b>
18a. Style of Addition or Elements(s)		30. Foundation Material <b>Concrete block</b>

41. Distance from & Frontage on Road <b>30 ft</b>
				51. Condition of Property: <b>Good/Fair</b>
				52. Historic Outbuildings & Dependencies Structure Type <b>Garage</b> Date <b>1977</b> Associated Activity <b>Addition</b>

53. Affiliated Inventory Numbers Historic (OHI) Archaeological (OAI)
42. Further Description of Important Interior and Exterior Features (Continued on Reverse if Necessary)				
<p>The single story minimal traditional house is located on the south side of E. 13th Avenue, and is fronted by a yard about 30 ft. deep. A driveway to the west of the house leads to the large garage located to the rear of the property. The basement of the house is discernible from the glass-block filled glazing that punctuates the concrete block foundation. A porch covered with a gable roof extends out 10 ft from the front facade of the house. It is likely that the porch has been altered with the addition of a newer roof. Other alterations to the house include newer siding and roofing materials.</p>

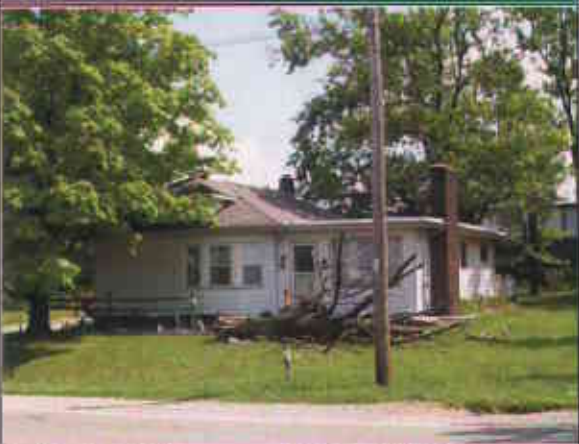
Photo No.	Direction	Description <sup>3</sup>	Photo
1	NE	<p>1024 Taylor Station Road formerly a front-gabled bungalow now with addition and façade alterations, built 1936 aluminum siding and asphalt shingle roof</p> <p>Lacks integrity due to loss of design, setting, materials</p>

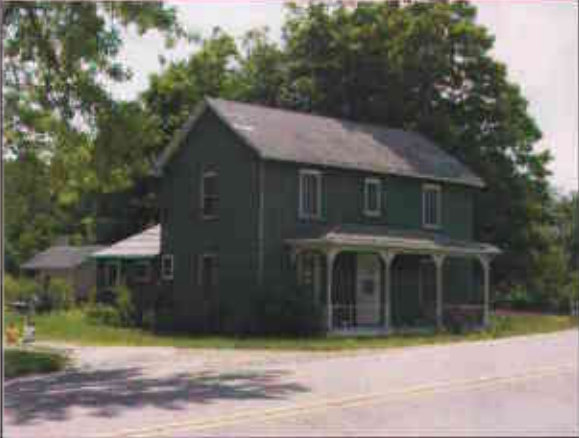
3	SE	<p>5873 North Alley 1.5-story side-gabled house, built ca. 1920 concrete foundation, asbestos cement shingle siding, and asphalt shingle roof</p> <p>Lacks significance and integrity of setting</p>

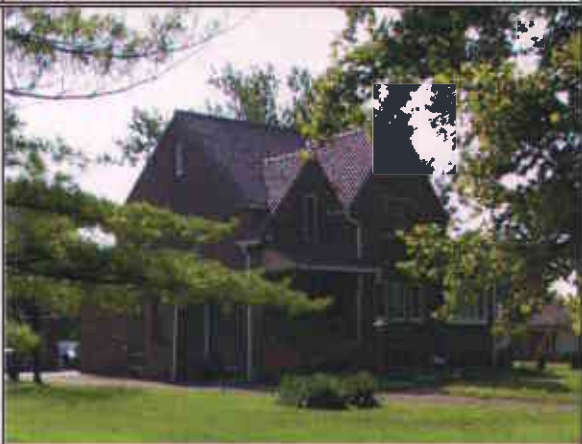
Photo No.	Direction	Description <sup>3</sup>	Photo
4	SE	<p>1116 Parkview Boulevard 2-story side-gabled house with front cross gabled wing, built 1929 brick walls and foundation and tile roof</p> <p>High level of integrity, but lacks significance</p>

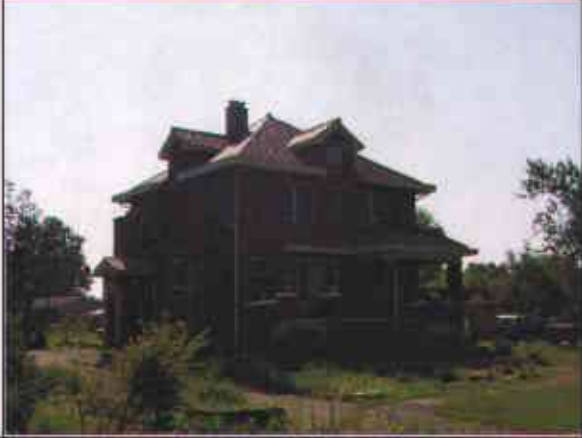
5	SE	<p>2541 Johnstown Road American Foursquare, built 1929 Brick walls and foundation and tile roof</p> <p>High level of integrity, but lacks significance</p>

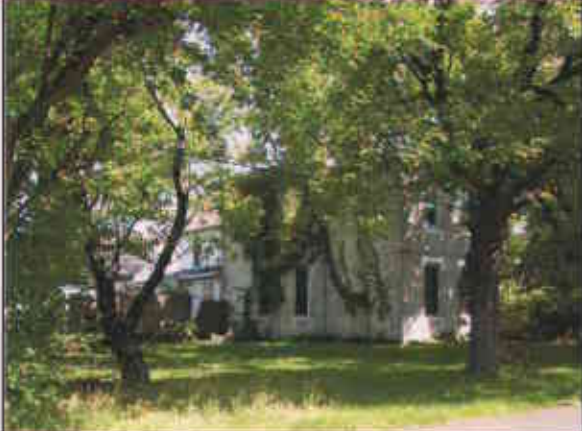
6	N	<p>2568 Johnstown Road 2-story Italianate house, built 1860 stone foundation, brick walls, and asphalt shingle roof</p> <p>Lacks integrity due to rear frame additions and loss of setting</p>

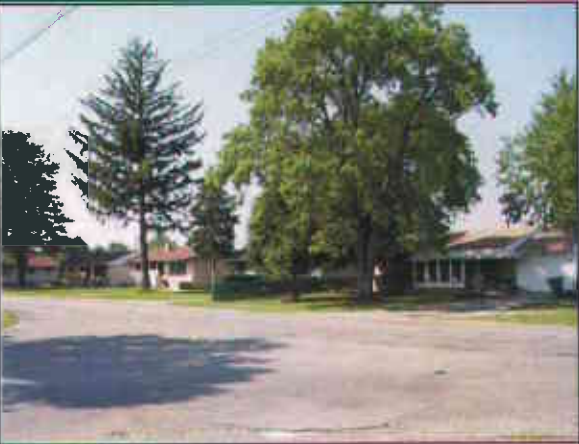
Photo No.	Direction	Description <sup>3</sup>	Photo
7	SW	<p>N. Cassady Avenue south of 14th Avenue Ranch houses, built 1957. All have stucco walls with Permastone on the lower half of their façade and asphalt shingles on their roof</p> <p>Lack significance</p>

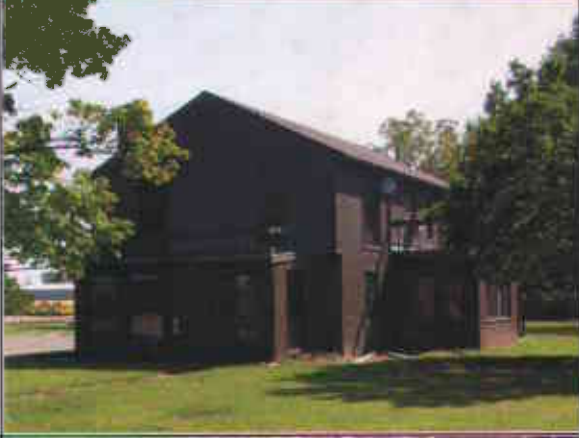
8	NE	<p>1110 N. Cassady Avenue 2-story front-gabled house-turned-business, built 1950 stucco walls and asphalt shingle roof</p> <p>Heavily altered and lacks significance and integrity</p>

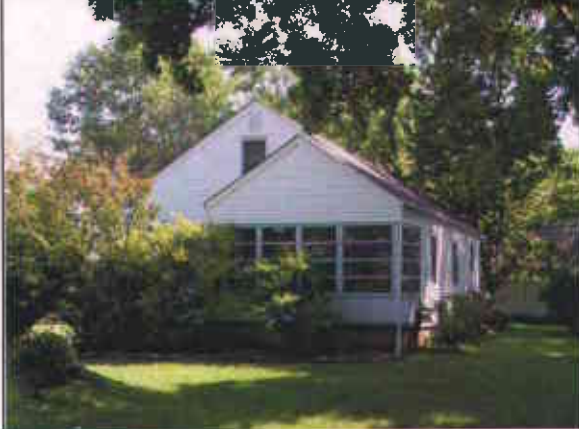
9	NE	<p>1096 N. Cassady Avenue 1.5-story front-gabled house, built 1952 concrete block foundation, vinyl siding, and asphalt shingle roof</p> <p>Lacks significance</p>

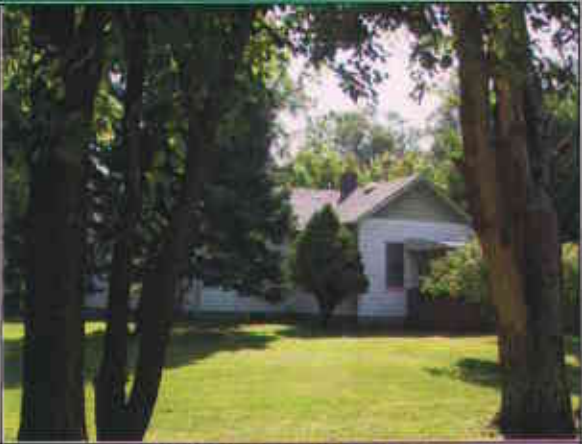
11	NW	<p>N. Cassady Avenue north of 13th Avenue (middle house is 1091 N. Cassady) 1-story front-gabled ranch houses, built 1955 vinyl siding and brick veneer with asphalt shingle roofs</p> <p>Lack significance</p>

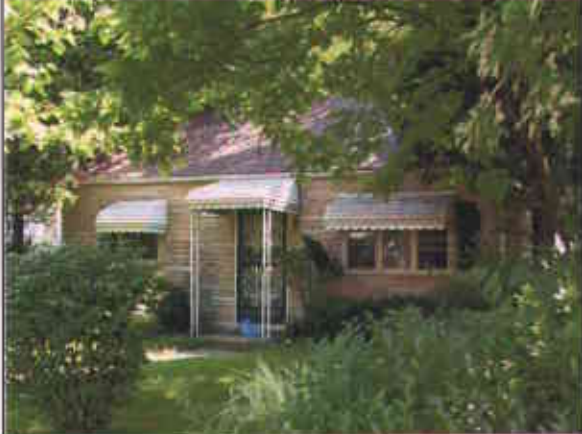
12	NE	<p>1080 N. Cassady Avenue 1-story side-gabled house, built 1952 PermaStone and aluminum siding with asphalt shingle roof</p> <p>Lacks significance</p>

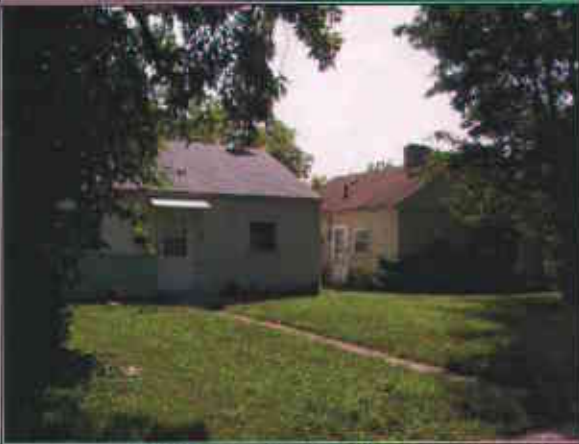
Photo No.	Direction	Description <sup>3</sup>	Photo
13	SE	<p>1076 N. Cassady Avenue 1-story side-gabled house, built 1950 vinyl siding and asphalt shingle roof</p> <p>1070 N. Cassady Avenue. 1-story front-gabled house, built 1950 vinyl siding and asphalt shingle roof</p> <p>Lack significance</p>

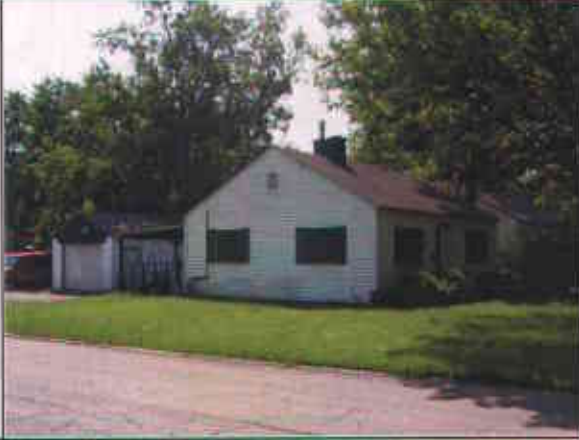
14	SE	<p>1060 N. Cassady Avenue 1-story side-gabled house, built 1950 vinyl siding and asphalt shingle roof</p> <p>Lacks significance</p>

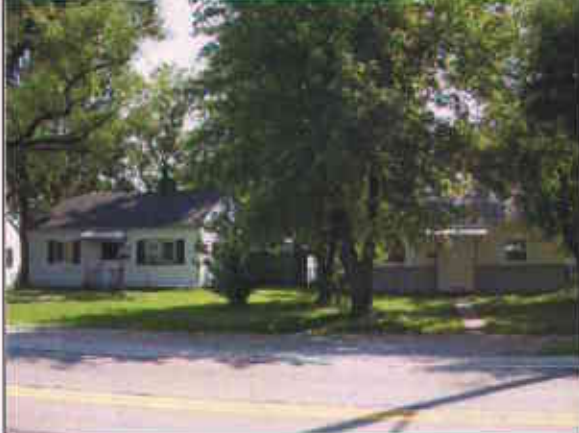
15	E	<p>1052 N. Cassady Avenue 1-story side-gabled house, built 1950 aluminum siding and asphalt shingle roof</p> <p>1048 N. Cassady Avenue 1-story side-gabled house, built 1950 brick and asbestos cement shingles with asphalt shingle roof</p> <p>Lack significance</p>

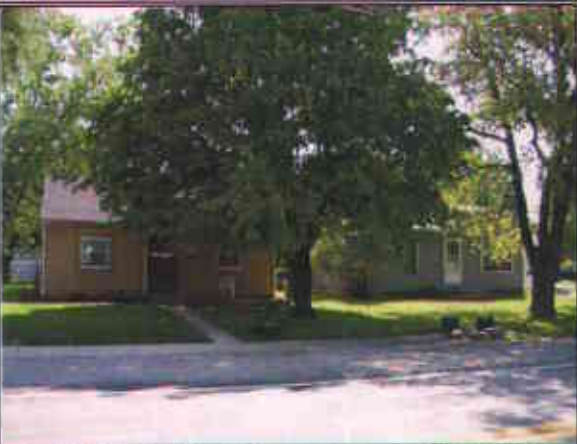
Photo No.	Direction	Description <sup>1</sup>	Photo
16	SE	<p>1038 N. Cassady Avenue 1-story side-gabled house, built 1950 asbestos cement shingles and asphalt shingle roof</p> <p>1034 N. Cassady Avenue 1-story side-gabled house, built 1950 vinyl siding and asphalt shingle roof</p> <p>Lack significance</p>

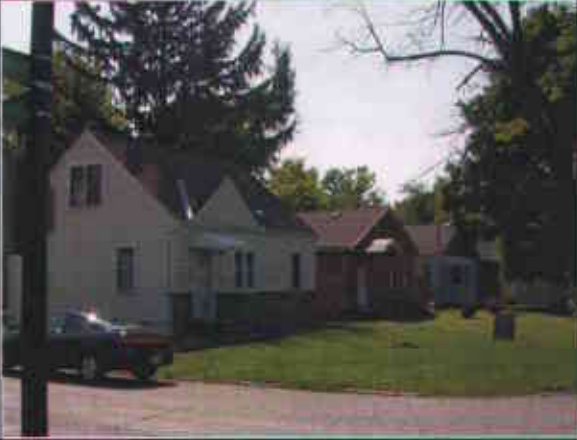
17	SE	<p>1022 N. Cassady Avenue 1.5-story side-gabled house, built 1950 aluminum siding and PermaStone and asphalt shingle roof</p> <p>1016 N. Cassady Avenue 1-story front-gabled house, built 1952 asbestos cement shingle siding and asphalt shingle roof</p> <p>1012 N. Cassady Avenue 1-story front-gabled house, built 1952 vinyl siding and asphalt shingle roof</p> <p>Lack significance</p>

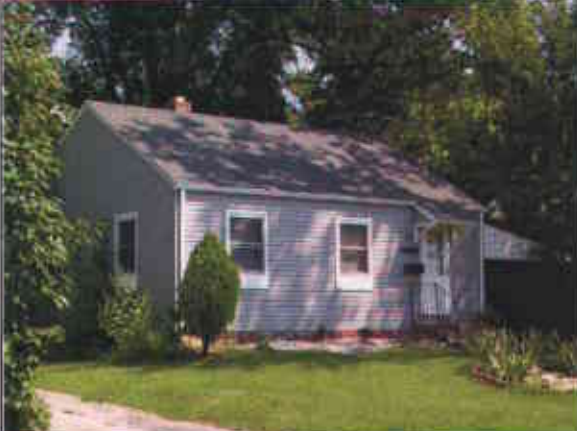
18	NE	<p>2830 E. 13th Avenue 1-story side-gabled house, built 1946 vinyl siding and asphalt shingle roof</p> <p>Lacks significance</p>

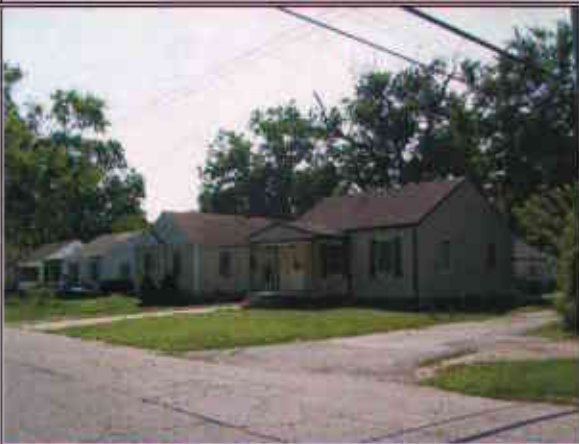
Photo No.	Direction	Description <sup>3</sup>	Photo
19	SE	<p>2829 E. 13th Avenue 1-story side-gabled house, built 1946 vinyl siding and asphalt shingle roof</p> <p>2835 E. 13th Avenue 1-story front-gabled house, built 1939 vinyl and aluminum siding and asphalt shingle roof</p> <p>2841 E. 13th Avenue 1-story side-gabled house, built 1947 aluminum siding and asphalt shingle roof, porch added</p> <p>Lack significance</p>

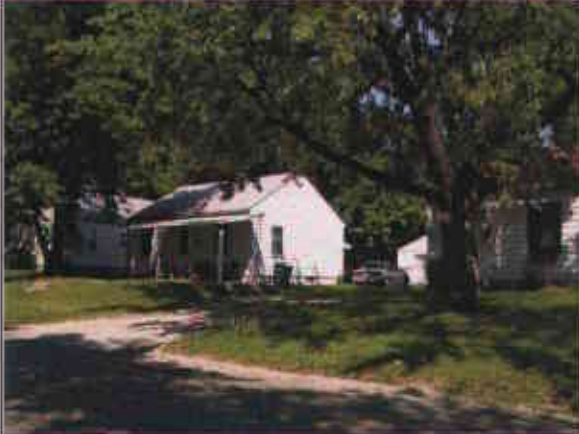
20	NW	<p>2836 E. 13th Avenue 1-story front-gabled house, built 1947 vinyl siding and asphalt shingle roof</p> <p>2842 E. 13th Avenue 1-story side-gabled house, built 1950 aluminum siding and asphalt shingle roof</p> <p>2848 E. 13th Avenue 1-story side-gabled house, built 1947 aluminum siding and asphalt shingle roof</p> <p>Lack significance</p>

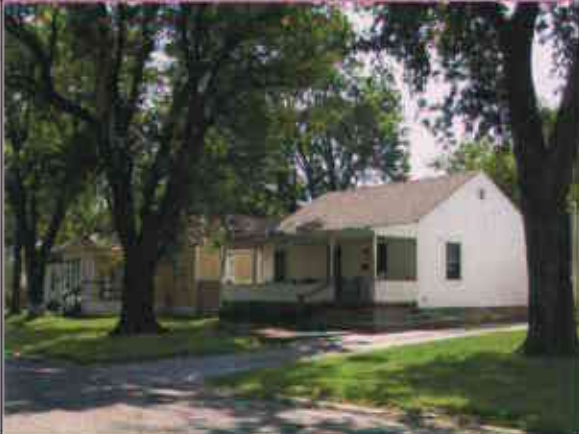
21	SE	<p>2847 E. 13th Avenue 1-story side-gabled house, built 1947 asbestos cement shingle siding and asphalt shingle roof, porch added</p> <p>2853 E. 13th Avenue 1-story front-gabled house, built 1948 aluminum siding and asphalt shingle roof, porch added</p> <p>Lack significance</p>

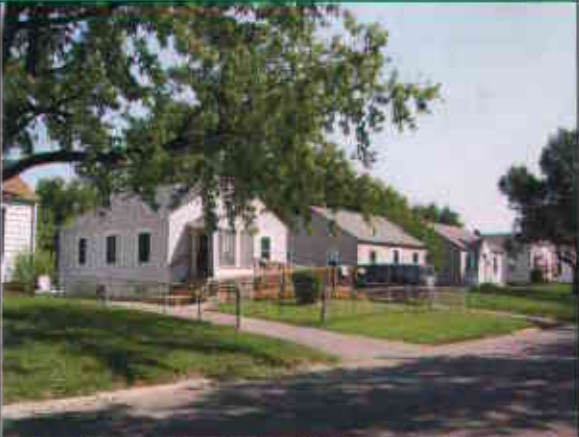
Photo No.	Direction	Description <sup>1</sup>	Photo
22	NE	<p>2854 E. 13th Avenue 1-story front-gabled house, built 1947 vinyl siding and asphalt shingle roof</p> <p>2860 E. 13th Avenue 1-story side-gabled house, built 1947 asbestos cement shingle siding and asphalt shingle roof</p> <p>2866 E. 13th Avenue 1-story side-gabled house, built 1946 vinyl siding and asphalt shingle roof</p> <p>Lack significance</p>

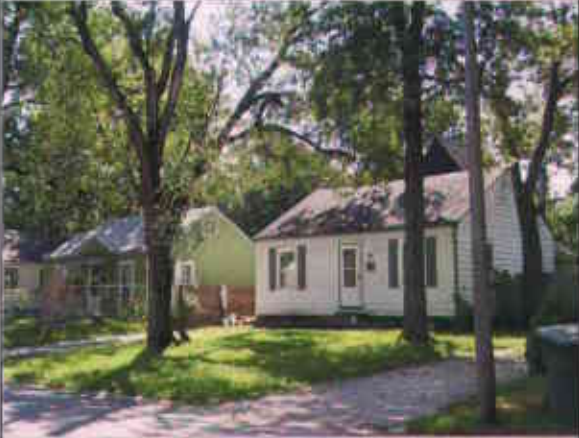
23	SE	<p>2859 E. 13th Avenue 1-story side-gabled house, built 1946 aluminum siding and asphalt shingle roof</p> <p>2865 E. 13th Avenue 1-story side-gabled house, built 1948 asbestos cement shingle siding and asphalt shingle roof</p> <p>Lack significance</p>

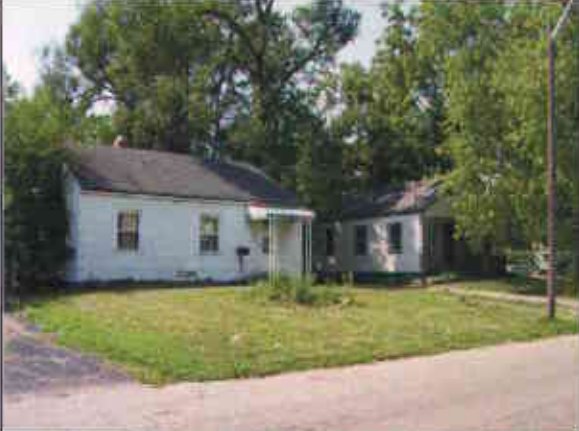
24	SW	<p>2871 E. 13th Avenue 1-story front-gabled house, built 1947 vinyl siding and Permastone and asphalt shingle roof</p> <p>2879 E. 13th Avenue 1-story side-gabled house, built 1950 asbestos cement shingle siding and asphalt shingle roof</p> <p>Lack significance</p>

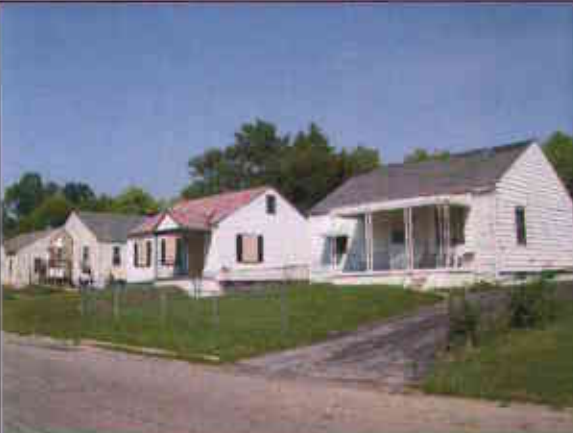
Photo No.	Direction	Description <sup>3</sup>	Photo
25	NW	<p>2872 E. 13th Avenue 1-story front-gabled house, built 1946 Permastone and vinyl siding and asphalt shingle roof</p> <p>2880 E. 13th Avenue 1.5-story side-gabled house, built 1946 asbestos cement shingle siding and asphalt shingle roof</p> <p>2886 E. 13th Avenue 1-story side-gabled house, built 1949 aluminum siding and Permastone and asphalt shingle roof</p> <p>Lack significance</p>

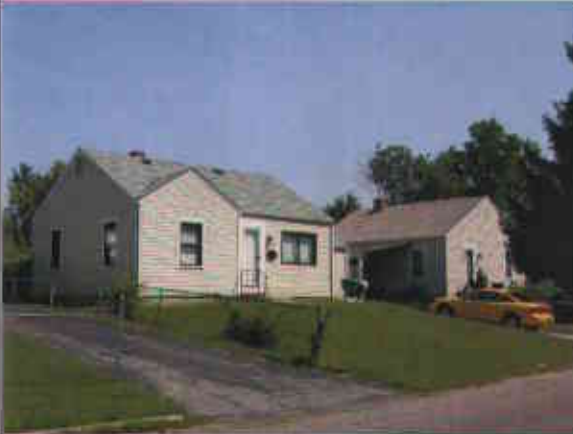
26	NE	<p>2892 E. 13th Avenue 1-story Minimal Traditional, built 1949 vinyl siding and asphalt shingle roof</p> <p>2898 E. 13th Avenue 1-story front-gabled house, built 1946 vinyl siding and asphalt shingle roof</p> <p>Lack significance</p>

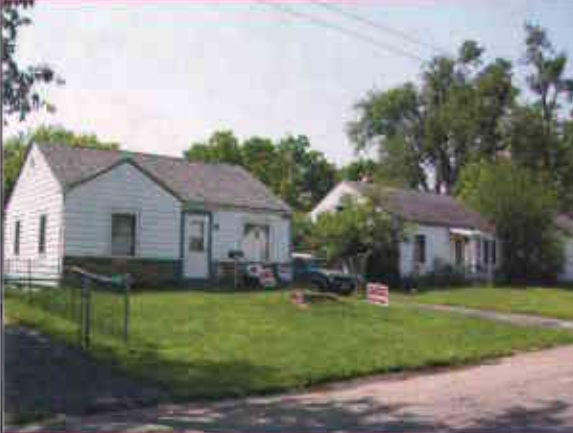
27	SW	<p>2885 E. 13th Avenue 1.5-story side-gabled house, built 1946 aluminum siding and asphalt shingle roof</p> <p>2891 E. 13th Avenue 1-story Minimal Traditional, built 1944 aluminum siding and Permastone and asphalt shingle roof</p> <p>Lack significance</p>

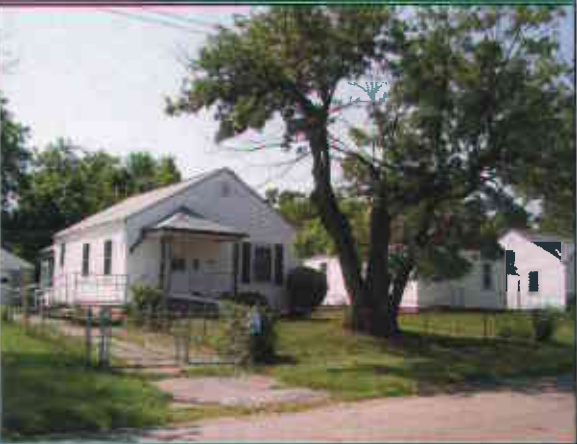
Photo No.	Direction	Description <sup>3</sup>	Photo
28	SW	<p>2897 E. 13th Avenue 1-story front-gabled house, built 1949 aluminum siding and asphalt shingle roof</p> <p>2903 E. 13th Avenue 1-story front-gabled house, built 1946 vinyl siding and asphalt shingle roof</p> <p>Lack significance</p>

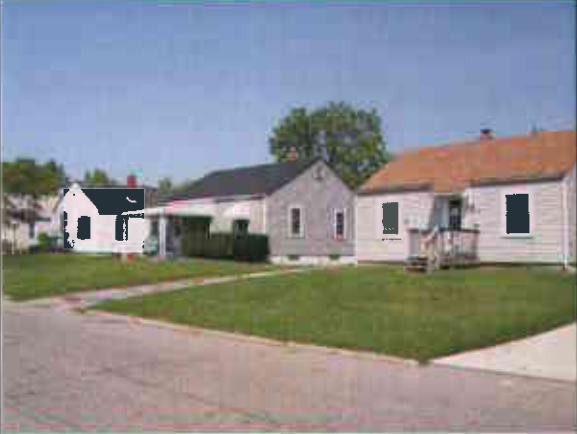
29	NW	<p>2904 E. 13th Avenue 1-story front-gabled house, built 1947 vinyl siding and asphalt shingle roof</p> <p>2912 E. 13th Avenue 1-story side-gabled house, built 1946 vinyl siding and asphalt shingle roof</p> <p>2918 E. 13th Avenue 1-story side-gabled house, built 1948 vinyl siding and asphalt shingle roof</p> <p>Lack significance</p>

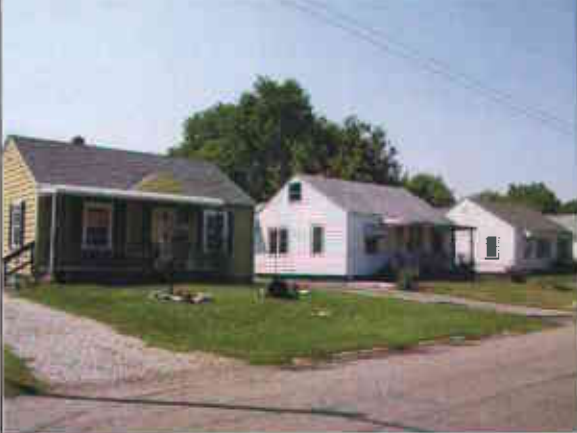
30	SW	<p>2911 E. 13th Avenue 1-story side-gabled house, built 1946 aluminum siding and asphalt shingle roof</p> <p>2917 E. 13th Avenue 1.5-story side-gabled house, built 1951 aluminum siding and asphalt shingle roof</p> <p>2923 E. 13th Avenue 1-story side-gabled house, built 1946 aluminum siding and asphalt shingle roof</p> <p>Lack significance</p>

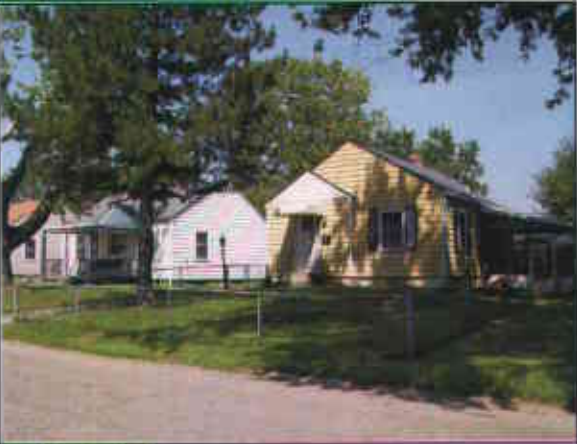
Photo No.	Direction	Description <sup>3</sup>	Photo
31	NW	<p>2924 E. 13th Avenue 1-story side-gabled house, built 1948 aluminum siding and asphalt shingle roof, porch added</p> <p>2930 E. 13th Avenue 1-story front-gabled house, built 1947 aluminum siding and asphalt shingle roof, porch added</p> <p>Lack significance</p>

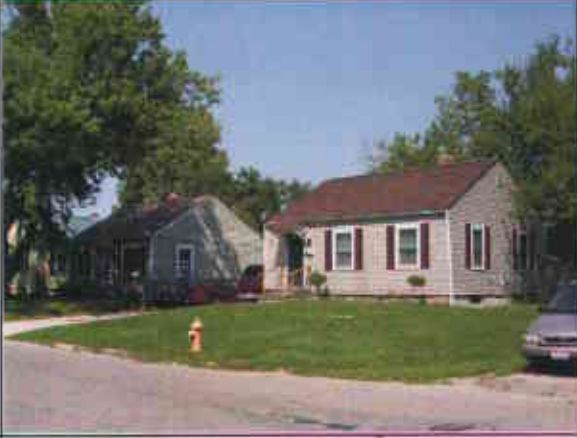
32	NW	<p>2936 E. 13th Avenue 1-story side-gabled house, built 1948 vinyl siding and asphalt shingle roof</p> <p>2942 E. 13th Avenue 1-story side-gabled house, built 1947 vinyl siding and asphalt shingle roof</p> <p>Lack significance</p>

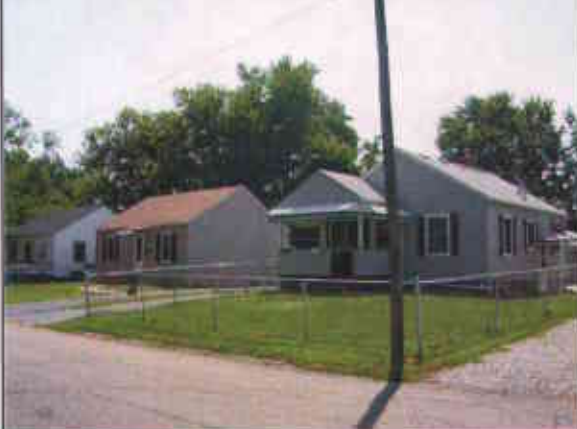
33	SE	<p>2929 E. 13th Avenue 1-story front-gabled house, built 1944 vinyl siding and asphalt shingle roof</p> <p>2935 E. 13th Avenue 1-story side-gabled house, built 1946 vinyl siding and asphalt shingle roof</p> <p>2941 E. 13th Avenue 1-story side-gabled house, built 1946 vinyl siding and asphalt shingle roof</p> <p>Lack significance</p>
