## **APPENDIX J HISTORIC RESOURCES**

This appendix provides documentation of consultation with the Ohio State Historic Preservation Office. Attachments 1 - 7 are surveys and consultation in support of the impact assessment for Historic, Architectural, Archaeological, and Cultural Resources.

***Federal Aviation Administration***  
**ENVIRONMENTAL IMPACT STATEMENT**  
**FOR**  
**REPLACEMENT RUNWAY AND TERMINAL PROJECT**  
**AT**  
**PORT COLUMBUS INTERNATIONAL AIRPORT**  
**AGENCY MEETING – OHIO HISTORIC PRESERVATION OFFICE**  
**MEETING MINUTES**  
**NOVEMBER 21, 2006**

**Cultural Resources Existing Conditions and Survey  
Methodology Report for the  
Port Columbus International Airport  
Environmental Impact Statement,  
Cities of Columbus and Gahanna, Franklin County, Ohio**

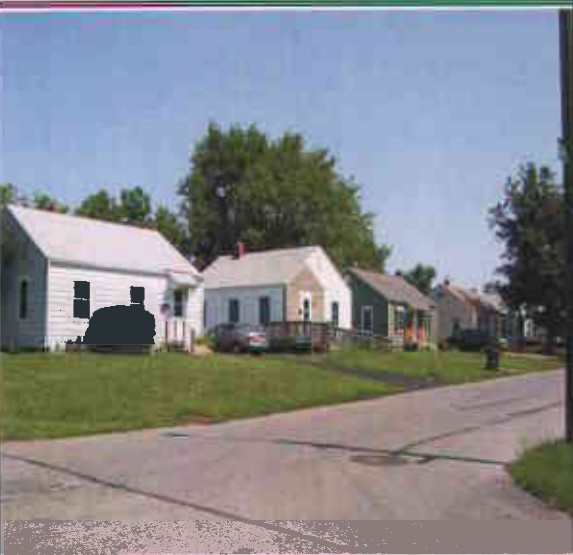
Photo No.	Direction	Description <sup>3</sup>	Photo
34	NE	2954 E. 13th Avenue 1-story side-gabled house, built 1946 aluminum siding and asphalt shingle roof

2960 E. 13th Avenue 1-story front-gabled house, built 1947 vinyl siding and Permastone and asphalt shingle roof	
		2968 E. 13th Avenue 1-story side-gabled house, built 1947 aluminum siding with brick veneer at front doorway, asphalt shingle roof	
		2974 E. 13th Avenue 1-story side-gabled house, built 1947 vinyl siding and Permastone and asphalt shingle roof	
		Lack significance	
35	SE	2953 E. 13th Avenue 1-story side-gabled house, built 1946 vinyl siding and asphalt shingle roof

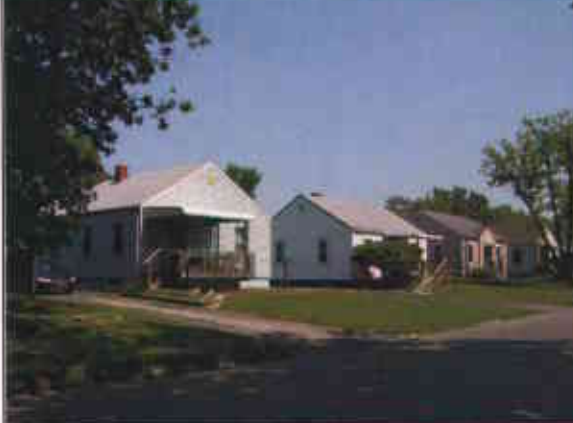
Lack significance	
36	NE	2980 E. 13th Avenue 1-story front-gabled house, built 1947 vinyl siding and asphalt shingle roof

2986 E. 13th Avenue 1-story side-gabled house, built 1947 aluminum siding and asphalt shingle roof	
		2992 E. 13th Avenue 1-story side-gabled house, built 1947 asbestos cement shingle siding and asphalt shingle roof	
		Lack significance

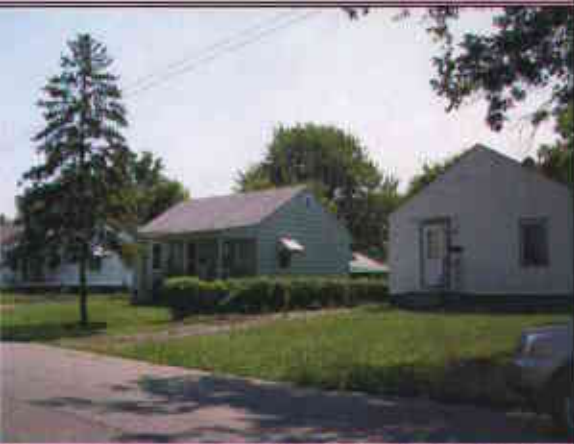
Photo No.	Direction	Description <sup>3</sup>	Photo
37	SE	<p>2979 E. 13th Avenue 1-story front-gabled house, built 1950 aluminum siding and asphalt shingle roof</p> <p>2985 E. 13th Avenue 1-story side-gabled house, built 1948 asbestos cement shingle siding and asphalt shingle roof</p> <p>2991 E. 13th Avenue 1-story side-gabled house, built 1948 aluminum siding and asphalt shingle roof</p> <p>Lack significance</p>

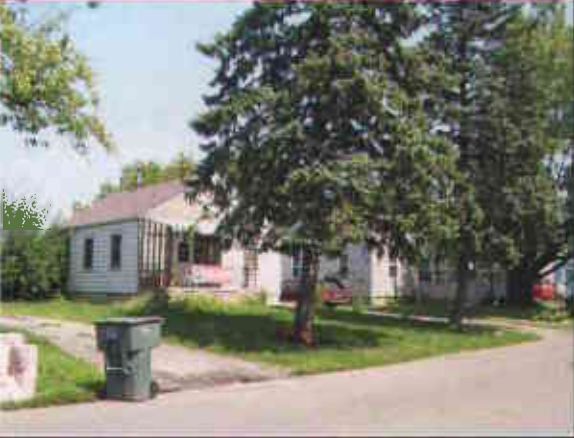
38	NE	<p>2998 E. 13th Avenue 1-story front-gabled house, built 1950 aluminum siding, Permastone at front entrance, stucco in front gable end, asphalt shingle roof</p> <p>3004 E. 13th Avenue Minimal Traditional, built 1947 vinyl siding and asphalt shingle roof, large front porch addition</p> <p>Lack significance</p>

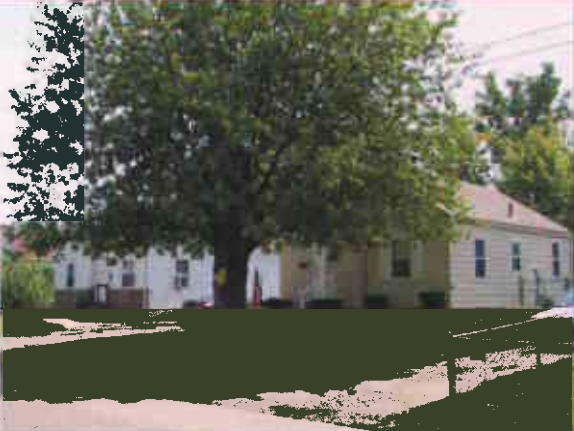
39	SE	<p>2997 E. 13th Avenue 1-story front-gabled house, built 1949 aluminum siding and asphalt shingle roof</p> <p>3003 E. 13th Avenue Minimal Traditional, built 1946 aluminum siding and Permastone and asphalt shingle roof</p> <p>Lack significance</p>

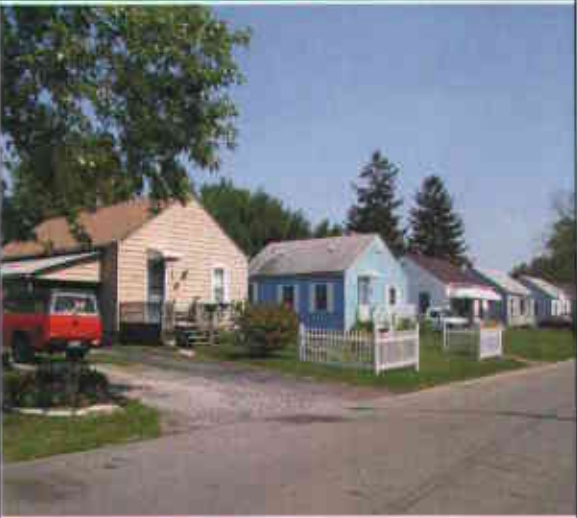
Photo No.	Direction	Description <sup>3</sup>	Photo
40	NE	3010 E. 13th Avenue 1-story front-gabled house, built 1947 aluminum siding and asphalt shingle roof

3016 E. 13th Avenue 1-story front-gabled house, built 1947 aluminum siding and asphalt shingle roof	
		3024 E. 13th Avenue 1-story side-gabled house, built 1946 vinyl siding and asphalt shingle roof	
		3030 E. 13th Avenue 1-story side-gabled house, built 1947 vinyl siding and asphalt shingle roof	
		Lack significance	
41	SE	3009 E. 13th Avenue 1-story front-gabled house, built 1947 vinyl siding and asphalt shingle roof

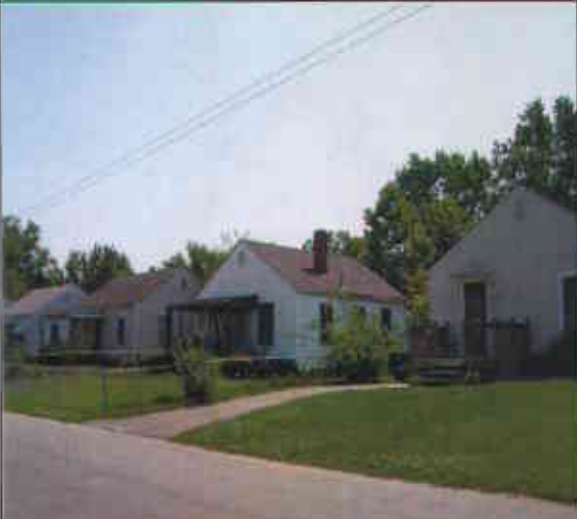
3015 E. 13th Avenue 1-story front-gabled house, built 1947 vinyl siding and asphalt shingle roof	
		3023 E. 13th Avenue 1-story side-gabled house, built 1946 vinyl siding and asphalt shingle roof	
		3029 E. 13th Avenue 1-story side-gabled house, built 1946 aluminum siding and asphalt shingle roof	
		Lack significance

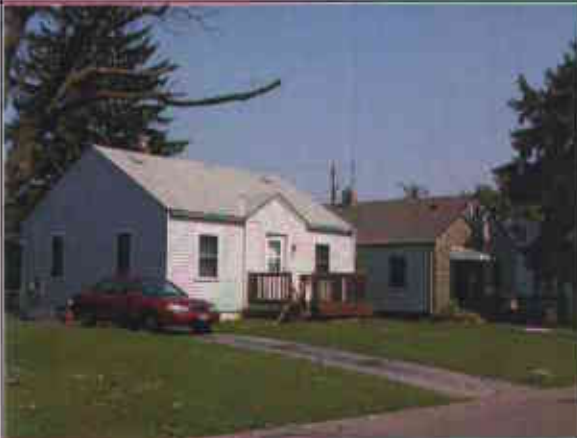
42	NE	3036 E. 13th Avenue 1-story side-gabled house, built 1948 vinyl siding and asphalt shingle roof

3042 E. 13th Avenue 1-story front-gabled house, built 1942 vinyl siding and Permastone and asphalt shingle roof	
		Lack significance

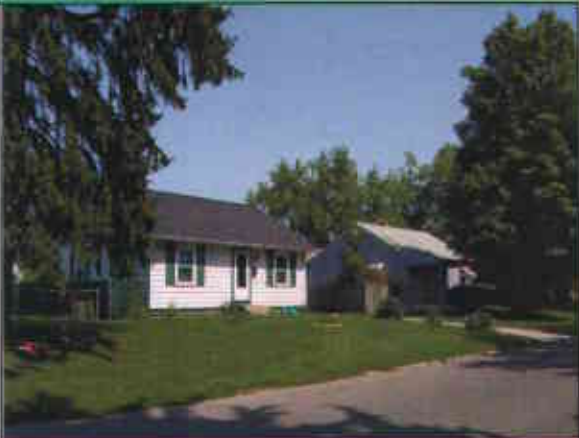
Photo No.	Direction	Description <sup>3</sup>	Photo
43	NE	<p>3048 E. 13th Avenue 1.5-story side-gabled house, built 1946 aluminum siding and asphalt shingle roof</p> <p>3056 E. 13th Avenue 1-story side-gabled house, built 1946 asbestos cement shingle siding and asphalt shingle roof</p> <p>Lack significance</p>

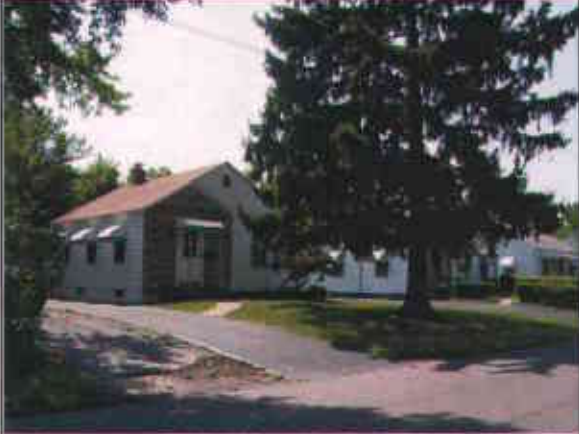
44	SW	<p>3035 E. 13th Avenue Minimal Traditional, built 1946 aluminum siding and asphalt shingle roof</p> <p>3041 E. 13th Avenue 1-story front-gabled house, built 1949 aluminum siding and Permastone and asphalt shingle roof</p> <p>Lack significance</p>

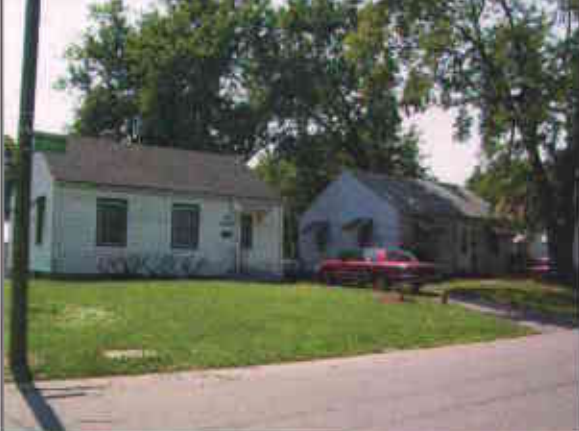
45	SW	<p>3047 E. 13th Avenue 1-story side-gabled house, built 1949 vinyl siding and asphalt shingle roof</p> <p>3055 E. 13th Avenue 1-story side-gabled house, built 1948 vinyl siding and asphalt shingle roof</p> <p>Lack significance</p>

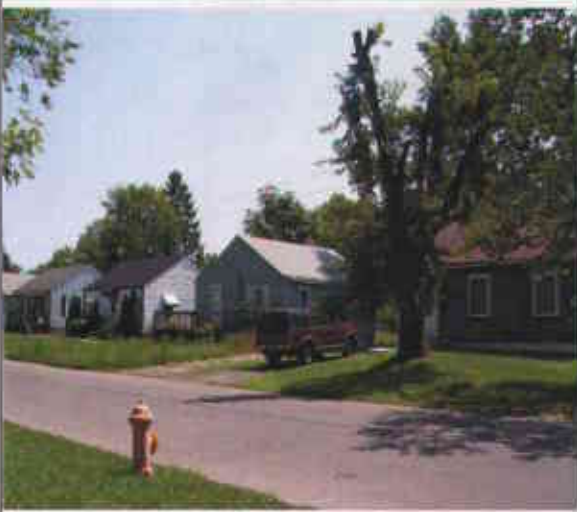
Photo No.	Direction	Description <sup>3</sup>	Photo
46	SE	<p>3067 E. 13th Avenue 1-story side-gabled house, built 1946 asbestos cement shingle siding and asphalt shingle roof</p> <p>3073 E. 13th Avenue 1-story front-gabled house, built 1947 vinyl siding and asphalt shingle roof</p> <p>3079 E. 13th Avenue 1-story side-gabled house, built 1947 vinyl siding and asphalt shingle roof</p> <p>3085 E. 13th Avenue 1-story side-gabled house, built 1947 vinyl siding and asphalt shingle roof</p> <p>Lack significance</p>

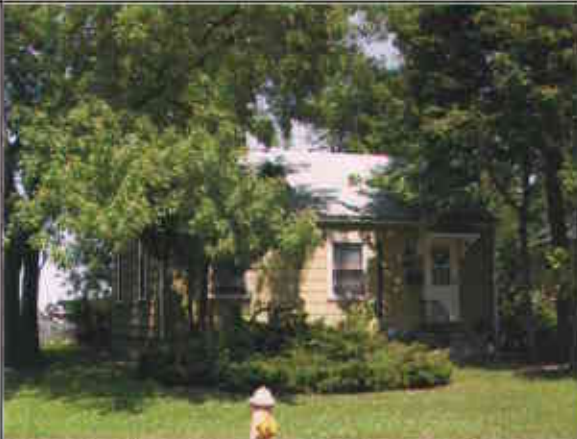
47	NE	<p>3068 E. 13th Avenue 1-story side-gabled house, built 1946 wood shingle siding and asphalt shingle roof</p> <p>Lacks significance</p>

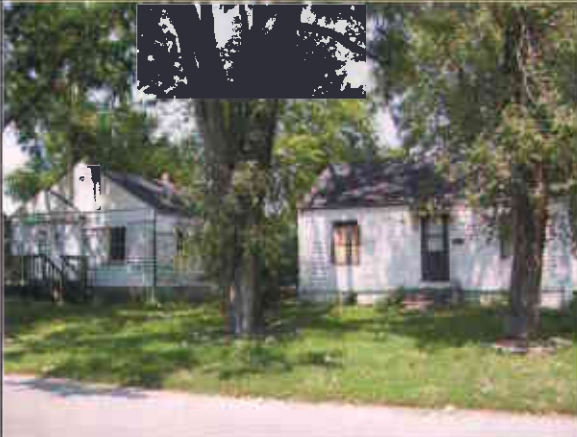
48	NW	<p>3074 E. 13th Avenue 1-story front-gabled house, built 1947 wood clapboard and aluminum siding and asphalt shingle roof</p> <p>3080 E. 13th Avenue 1-story side-gabled house, built 1946 vinyl siding and asphalt shingle roof</p> <p>Lack significance</p>

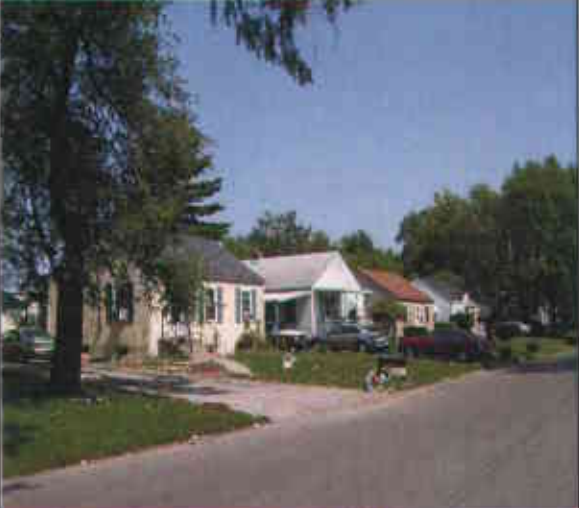
Photo No.	Direction	Description <sup>3</sup>	Photo
49	NE	3086 E. 13th Avenue 1-story side-gabled house, built 1950 stucco and asphalt shingle roof

3092 E. 13th Avenue 1-story front-gabled house, built 1949 aluminum siding and asphalt shingle roof	
		3098 E. 13th Avenue 1-story side-gabled house, built 1950 vinyl siding and asphalt shingle roof	
		3106 E. 13th Avenue Minimal Traditional, built 1951 vinyl siding and asphalt shingle roof  Lack significance	
50	SE	3091 E. 13th Avenue 1-story front-gabled house, built 1950 asbestos cement shingle siding and asphalt shingle roof

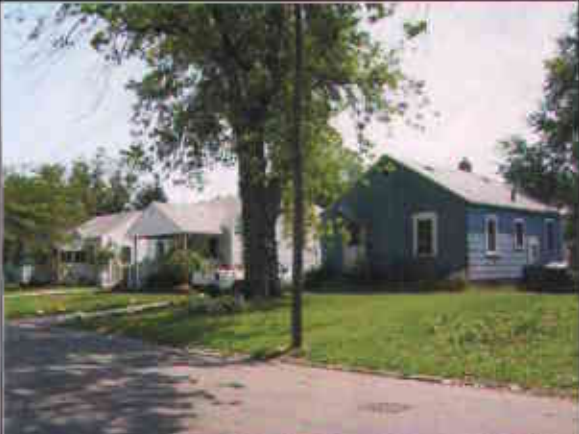
3097 E. 13th Avenue 1-story side-gabled house, built 1942 vinyl siding and asphalt shingle roof, porch added	
		3105 E. 13th Avenue 1-story side-gabled house, built 1947 vinyl siding and asphalt shingle roof, porch added  Lack significance	
51	NE	3112 E. 13th Avenue 1-story front-gabled house, built 1946 vinyl siding and asphalt shingle roof, front porch enclosed  Lacks significance

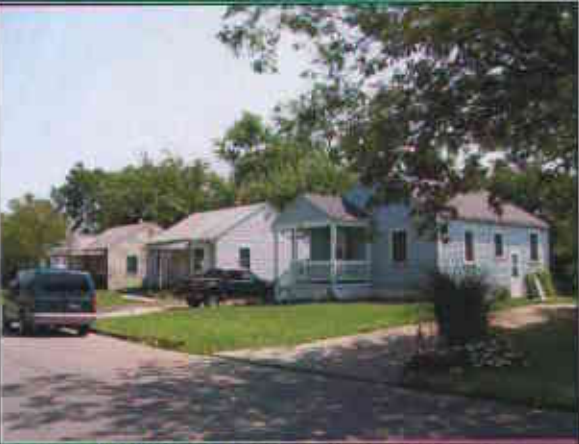
Photo No.	Direction	Description <sup>3</sup>	Photo
52	SE	<p>3111 E. 13th Avenue 1-story front-gabled house, built 1948 vinyl siding and asphalt shingle roof</p> <p>3117 E. 13th Avenue 1-story side-gabled house, built 1948 asbestos cement shingle siding and asphalt shingle roof</p> <p>3123 E. 13th Avenue Minimal Traditional, built 1950 vinyl siding and asphalt shingle roof</p> <p>Lack significance</p>

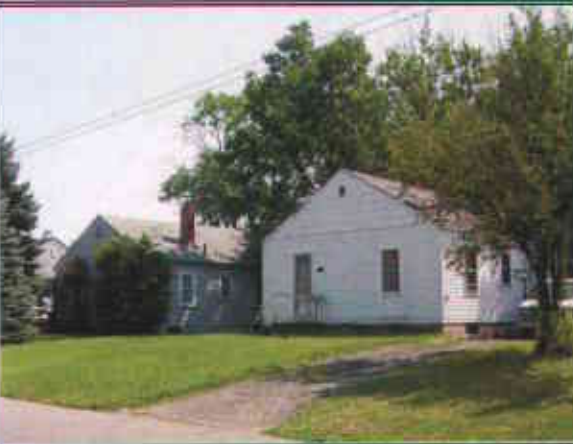
Photo No.	Direction	Description <sup>3</sup>	Photo
55	SE	<p>3129 E. 13th Avenue 1-story front-gabled house, built 1942 wood siding and asbestos cement shingles in the gable end, asphalt shingle roof</p> <p>3135 E. 13th Avenue 1-story front-gabled house, built 1947 asbestos cement shingle siding and asphalt shingle roof</p> <p>Lack significance</p>

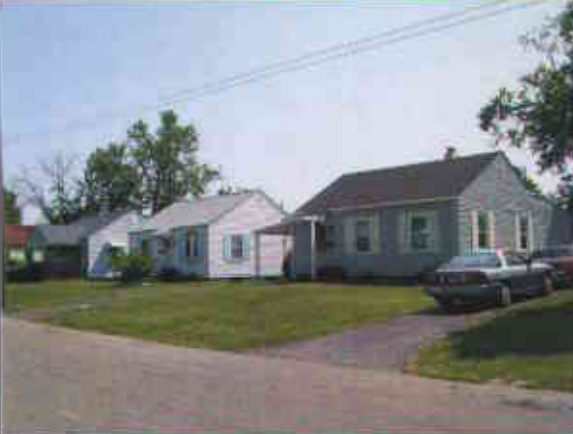
56	SE	<p>3141 E. 13th Avenue 1-story side-gabled house, built 1948 vinyl siding and asphalt shingle roof, addition on rear</p> <p>3147 E. 13th Avenue 1-story side-gabled house, built 1947 vinyl siding and asphalt shingle roof</p> <p>3153 E. 13th Avenue 1-story side-gabled house, built 1947 vinyl siding and asphalt shingle roof, porch added</p> <p>Lack significance</p>

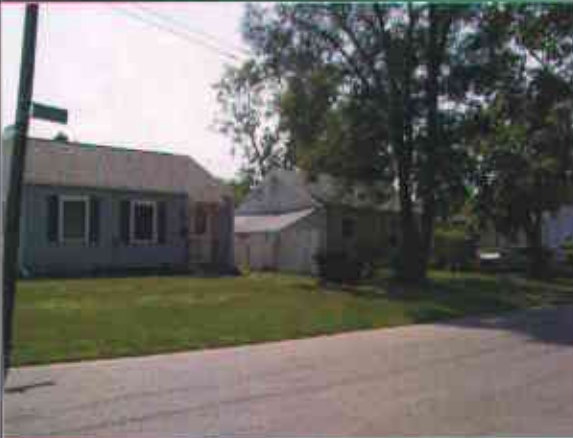
57	SW	<p>3161 E. 13th Avenue 1-story front-gabled house, built 1947 aluminum siding and asphalt shingle roof</p> <p>3167 E. 13th Avenue 1-story side-gabled house, built 1948 vinyl siding and asphalt shingle roof</p> <p>3173 E. 13th Avenue 1-story side-gabled house, built 1946 vinyl siding and asphalt shingle roof</p> <p>Lack significance</p>

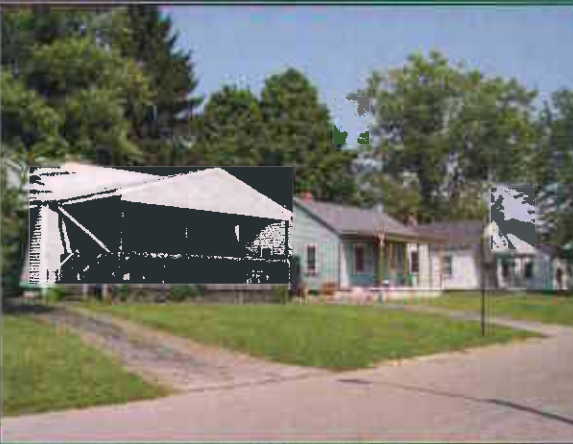
Photo No.	Direction	Description <sup>3</sup>	Photo
58	NE	3148 E. 13th Avenue 1-story side-gabled house, built 1950 vinyl siding and asphalt shingle roof, porch added

3154 E. 13th Avenue 1-story side-gabled house, built 1950 wood siding and asphalt shingle roof, porch added	
		3162 E. 13th Avenue 1-story front-gabled house, built 1947 aluminum siding and asphalt shingle roof  Lack significance	
59	NE	3168 E. 13th Avenue 1-story side-gabled house, built 1947 aluminum siding and asphalt shingle roof

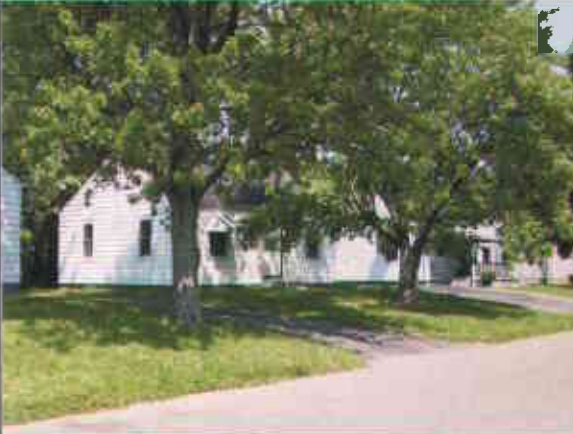
3174 E. 13th Avenue 1-story side-gabled house, built 1952 vinyl siding and asphalt shingle roof  Lack significance	
60	NE	2822 E. 12th Avenue 1.5-story side-gabled house, built 1947 vinyl siding and asphalt shingle roof  2830 E. 12th Avenue 2-story gambrel roof house, built 1927 vinyl siding and asphalt shingle roof  Lack significance

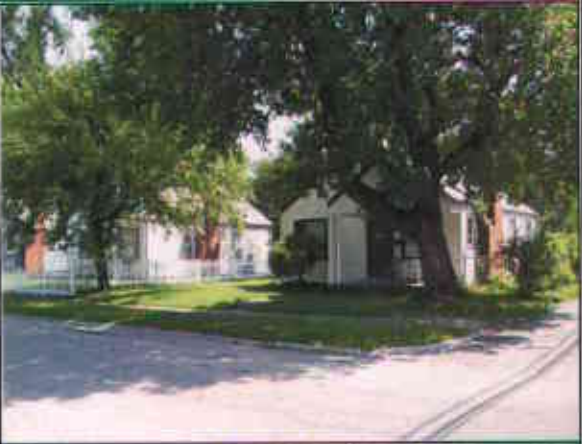
Photo No.	Direction	Description <sup>3</sup>	Photo
61	SE	<p>2819 E. 12th Avenue 1-story front-gabled house, built 1949 aluminum siding on façade and stucco on other walls, original Tudor-arch front door</p> <p>2825 E. 12th Avenue 1.5-story front-gabled house, built 1946 aluminum siding and asphalt shingle roof</p> <p>Lack significance</p>

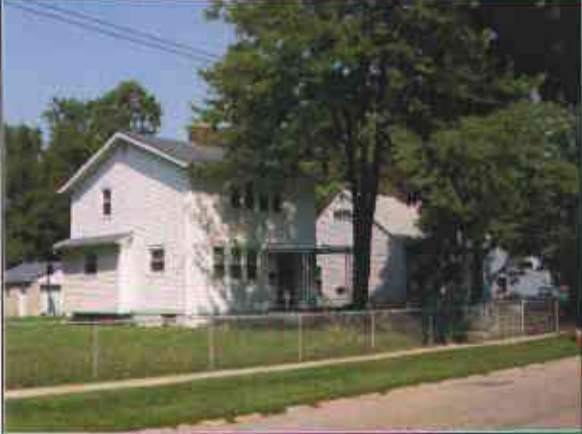
62	NE	<p>2842 E. 12th Avenue 2-story side-gabled house, built 1936 vinyl siding and asphalt shingle roof</p> <p>2848 E. 12th Avenue 1.5-story side-gabled house, built 1950 vinyl siding and asphalt shingle roof</p> <p>Lack significance</p>

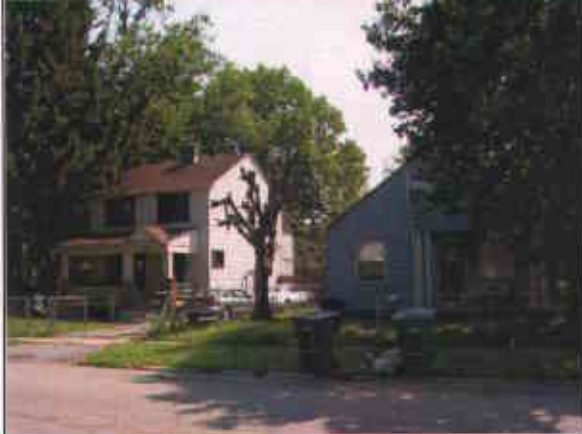
63	SE	<p>2833 E. 12th Avenue 1.5-story front-gabled house, built 1949 aluminum siding and asphalt shingle roof, original Tudor-arch front door</p> <p>2837 E. 12th Avenue 2-story side-gabled house, built 1935 asbestos cement shingle siding and asphalt shingle roof</p> <p>Lack significance</p>

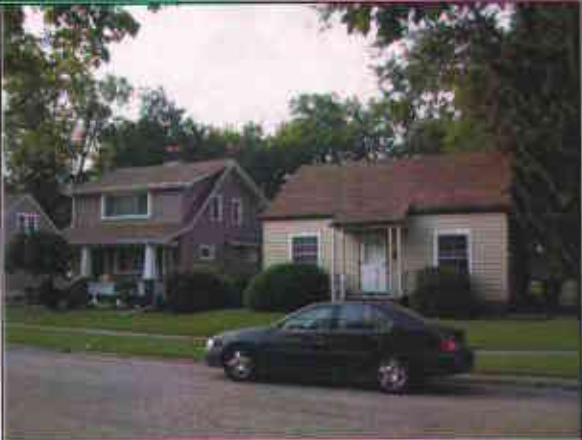
Photo No.	Direction	Description <sup>3</sup>	Photo
64	SE	<p>2845 E. 12th Avenue 1-story side-gabled house, built 1949 wood siding and asphalt shingle roof</p> <p>2851 E. 12th Avenue 2-story side-gabled house, built 1928 vinyl siding and asphalt shingle roof</p> <p>Lack significance</p>

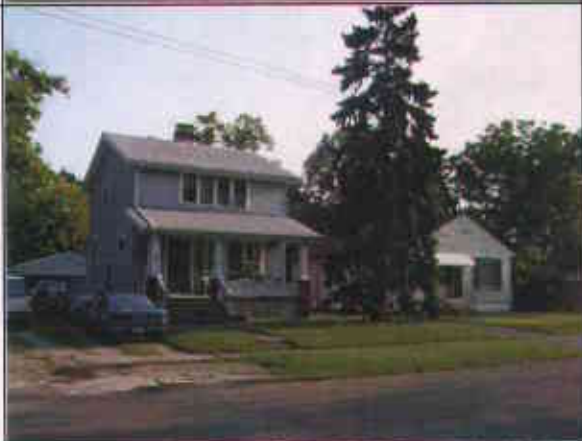
65	NE	<p>2852 E. 12th Avenue 2-story side-gabled house, built 1927 vinyl siding and asphalt shingle roof</p> <p>2860 E. 12th Avenue 1-story front-gabled house, built 1940 vinyl siding and asphalt shingle roof</p> <p>Lack significance</p>

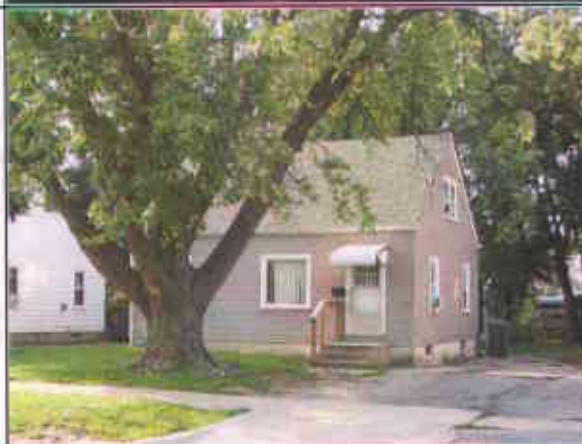
66	SE	<p>2857 E. 12th Avenue 1.5-story side-gabled house, built 1950 vinyl siding and asphalt shingle roof</p> <p>Lacks significance</p>

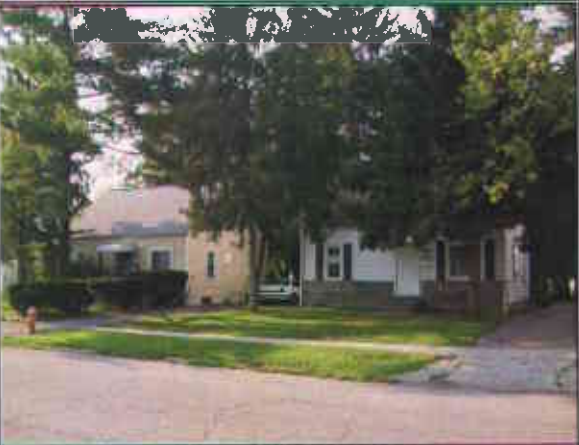
Photo No.	Direction	Description <sup>3</sup>	Photo
67	SE	<p>2863 E. 12th Avenue 1.5-story side-gabled house, built 1950 aluminum siding and Permastone and asphalt shingle roof</p> <p>2869 E. 12th Avenue 1.5-story side-gabled house, built 1950 aluminum siding and asphalt shingle roof</p> <p>Lack significance</p>

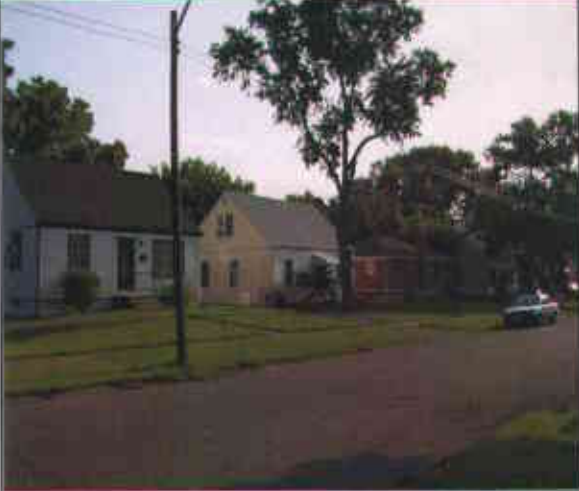
68	NE	<p>2872 E. 12th Avenue 1.5-story side-gabled house, built 1947 vinyl siding and asphalt shingle roof</p> <p>2876 E. 12th Avenue 1.5-story side-gabled house, built 1950 vinyl siding and asphalt shingle roof, addition on rear</p> <p>2886 E. 12th Avenue ranch house, built 1956 brick veneer and asphalt shingle roof</p> <p>2892 E. 12th Avenue 1.5-story side-gabled house, built 1950 vinyl siding and asphalt shingle roof</p> <p>Lack significance</p>

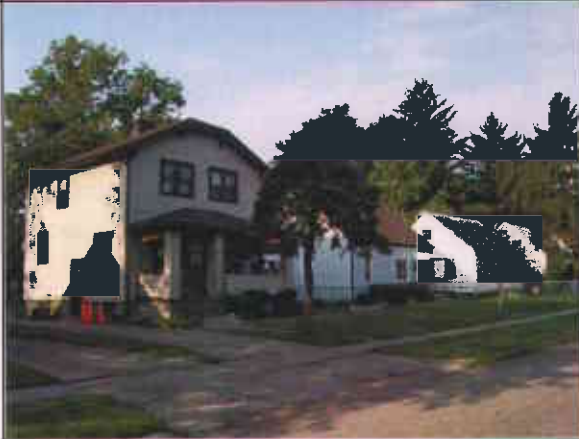
69	SW	<p>2875 E. 12th Avenue 1.5-story side-gabled house, built 1947 vinyl siding and asphalt shingle roof</p> <p>2881 E. 12th Avenue 1.5-story side-gabled house, built 1950 vinyl siding and asphalt shingle roof</p> <p>2889 E. 12th Avenue 2-story front-clipped-gable house, built 1936 vinyl siding and asphalt shingle roof</p> <p>Lack significance</p>

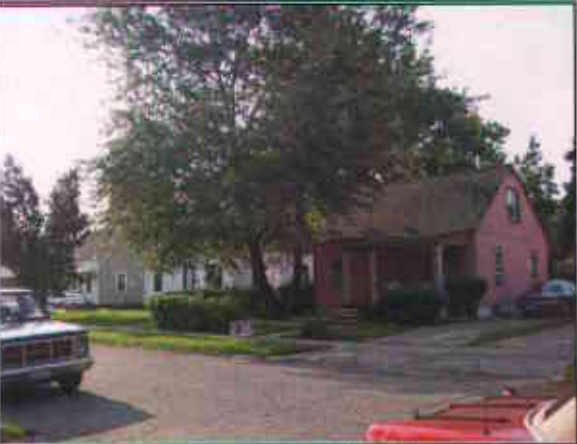
Photo No.	Direction	Description <sup>3</sup>	Photo
70	SE	<p>2895 E. 12th Avenue 1.5-story side-gabled house, built 1950 aluminum siding and asphalt shingle roof</p> <p>2901 E. 12th Avenue 1.5-story side-gabled house, built 1950 aluminum siding and asphalt shingle roof</p> <p>2907 E. 12th Avenue 1.5-story side-gabled house, built 1950 vinyl siding and asphalt shingle roof</p> <p>Lack significance</p>

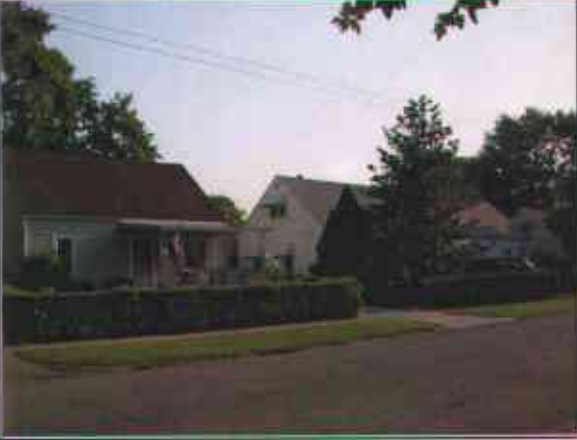
71	NE	<p>2904 E. 12th Avenue 1.5-story side-gabled house, built 1950 vinyl siding and asphalt shingle roof</p> <p>2912 E. 12th Avenue 1.5-story side-gabled house, built 1950 vinyl siding and asphalt shingle roof</p> <p>2918 E. 12th Avenue 1.5-story side-gabled house, built 1950 vinyl siding and asphalt shingle roof</p> <p>Lack significance</p>

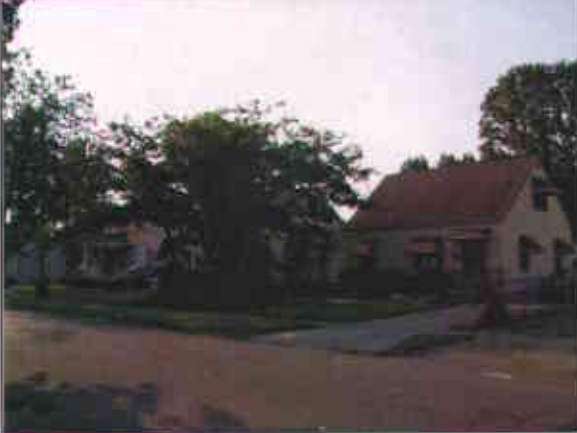
72	SE	<p>2919 E. 12th Avenue 1.5-story side-gabled house, built 1950 vinyl siding and Permastone and asphalt shingle roof</p> <p>2927 E. 12th Avenue 1.5-story side-gabled house, built 1948 aluminum siding and asphalt shingle roof</p> <p>2933 E. 12th Avenue 1.5-story side-gabled house, built 1948 aluminum siding and asphalt shingle roof</p> <p>Lack significance</p>

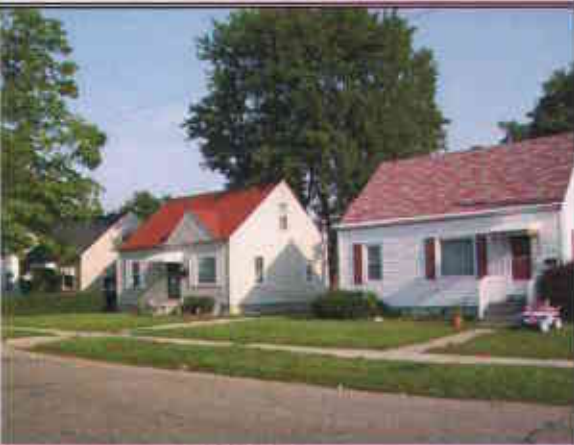
Photo No.	Direction	Description <sup>3</sup>	Photo
73	NW	<p>2924 E. 12th Avenue 1.5-story side-gabled house, built 1950 vinyl siding and asphalt shingle roof</p> <p>2930 E. 12th Avenue 1.5-story side-gabled house, built 1950 vinyl siding and asphalt shingle roof</p> <p>2936 E. 12th Avenue 1.5-story side-gabled house, built 1950 vinyl siding and asphalt shingle roof</p> <p>Lack significance</p>

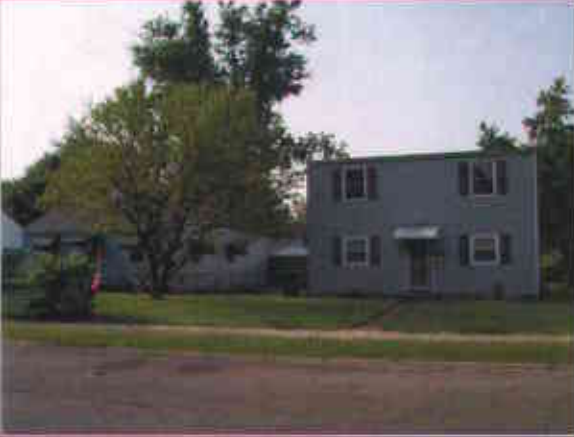
74	SE	<p>2945 E. 12th Avenue 2-story side-gabled house, built 1950 vinyl siding and asphalt shingle roof, second floor is addition</p> <p>2951 E. 12th Avenue 1-story side-gabled house, built 1950 vinyl siding and asphalt shingle roof, addition on rear</p> <p>Lack significance</p>

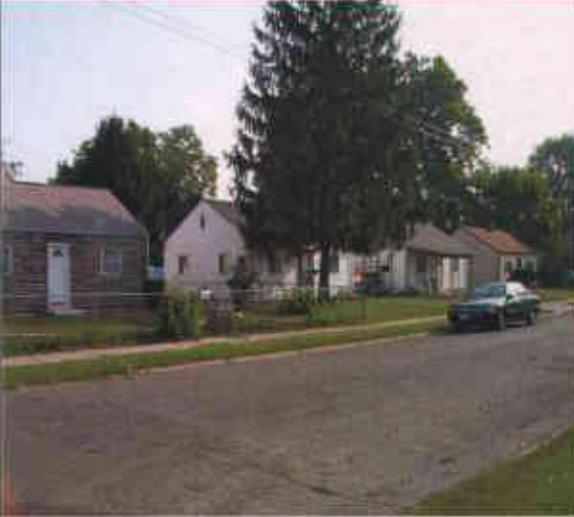
75	NE	<p>2948 E. 12th Avenue 1-story side-gabled house, built 1950 stone veneer and vinyl siding, asphalt shingle roof</p> <p>2954 E. 12th Avenue 1-story side-gabled house, built 1950 vinyl siding and asphalt shingle roof</p> <p>2960 E. 12th Avenue 1-story side-gabled house, built 1950 plywood siding and asphalt shingle roof, porch added</p> <p>2966 E. 12th Avenue 1-story side-gabled house, built 1950 vinyl siding and asphalt shingle roof</p> <p>Lack significance</p>

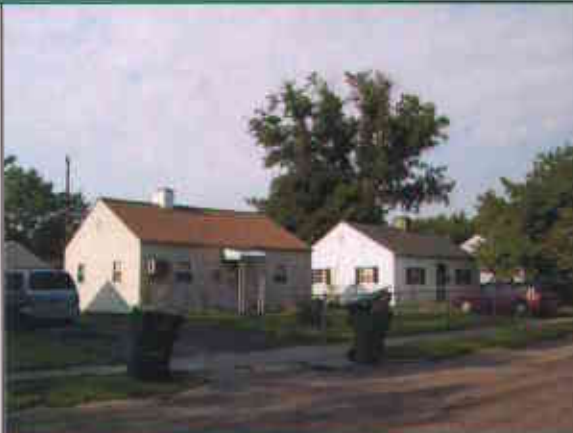
Photo No.	Direction	Description <sup>3</sup>	Photo
76	SW	<p>2957 E. 12th Avenue 1-story side-gabled house, built 1950 vinyl siding and asphalt shingle roof</p> <p>2963 E. 12th Avenue 1-story side-gabled house, built 1950 vinyl siding and asphalt shingle roof</p> <p>Lack significance</p>

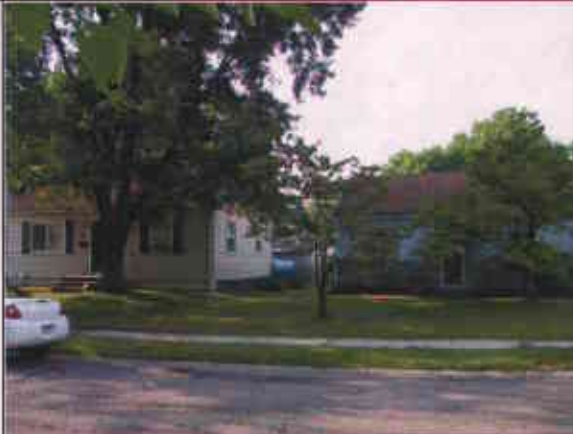
77	SE	<p>2969 E. 12th Avenue 1-story side-gabled house, built 1950 stucco and Permastone, asphalt shingle roof</p> <p>2975 E. 12th Avenue 1.5-story side-gabled house, built 1950 vinyl siding and asphalt shingle roof</p> <p>Lack significance</p>

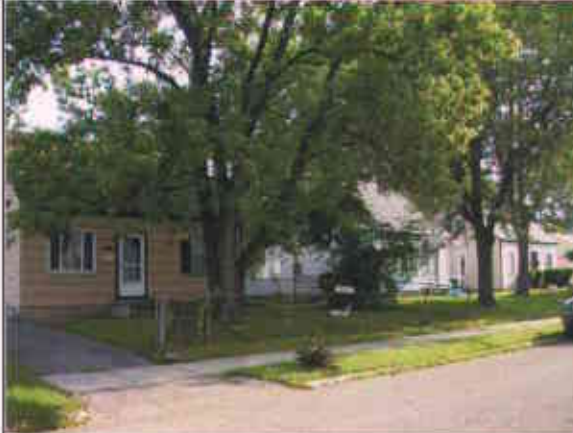
78	NE	<p>2978 E. 12th Avenue 1.5-story side-gabled house, built 1952 asbestos cement shingle siding and asphalt shingle roof</p> <p>2984 E. 12th Avenue 1.5-story side-gabled house, built 1951 vinyl siding and asphalt shingle roof</p> <p>2992 E. 12th Avenue 1.5-story side-gabled house, built 1950 vinyl siding and asphalt shingle roof</p> <p>Lack significance</p>

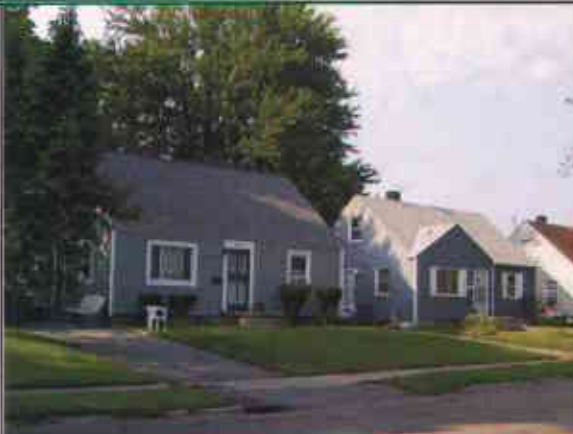
Photo No.	Direction	Description <sup>3</sup>	Photo
79	SW	<p>2981 E. 12th Avenue 1.5-story Minimal Traditional, built 1956 vinyl siding and asphalt shingle roof</p> <p>2987 E. 12th Avenue 1.5-story side-gabled house, built 1956 vinyl siding and asphalt shingle roof</p> <p>Lack significance</p>

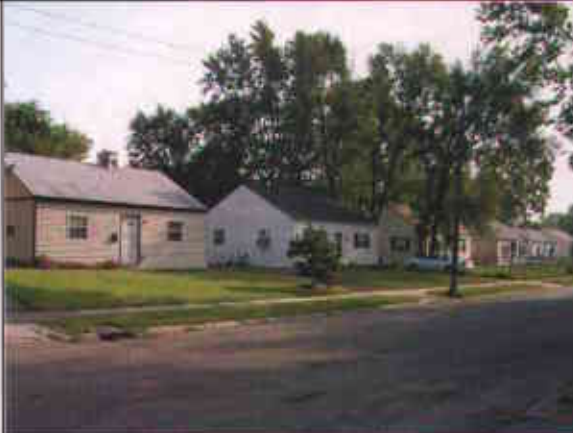
80	SE	<p>2995 E. 12th Avenue 1.5-story Minimal Traditional, built 1956 vinyl siding and asphalt shingle roof</p> <p>3001 E. 12th Avenue 1-story side-gabled house, built 1950 aluminum siding and asphalt shingle roof</p> <p>3007 E. 12th Avenue 1-story side-gabled house, built 1950 aluminum siding and asphalt shingle roof</p> <p>Lack significance</p>

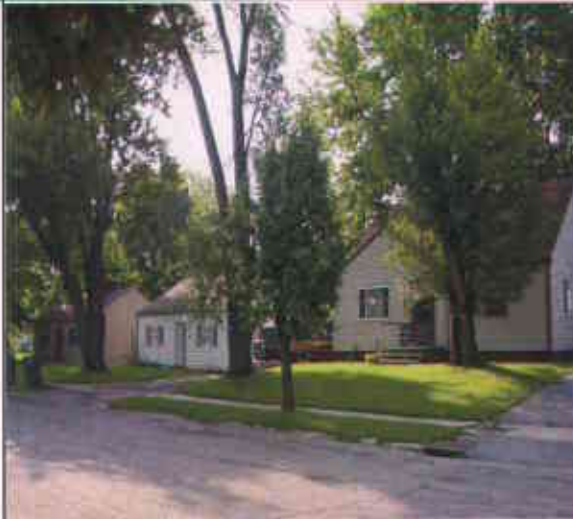
81	NE	<p>2998 E. 12th Avenue 1-story side-gabled house, built 1950 vinyl siding and asphalt shingle roof</p> <p>3004 E. 12th Avenue 1-story side-gabled house, built 1950 vinyl siding and asphalt shingle roof</p> <p>3010 E. 12th Avenue 1-story side-gabled house, built 1950 aluminum siding and asphalt shingle roof</p> <p>3016 E. 12th Avenue 1-story side-gabled house, built 1950 vinyl siding and asphalt shingle roof</p> <p>Lack significance</p>

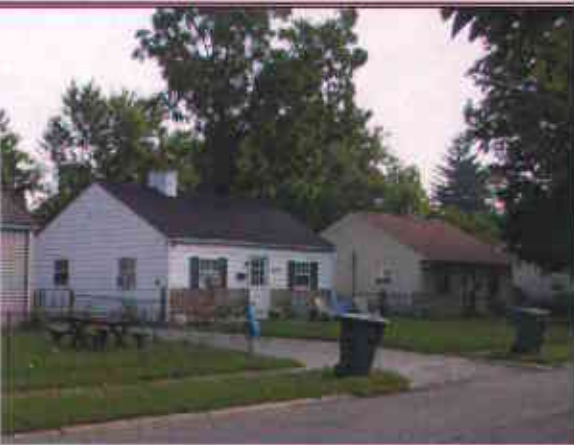
Photo No.	Direction	Description <sup>3</sup>	Photo
82	NE	<p>3022 E. 12th Avenue 1-story side-gabled house, built 1950 aluminum siding and Permastone and asphalt shingle roof</p> <p>3028 E. 12th Avenue 1-story side-gabled house, built 1950 vinyl siding and asphalt shingle roof</p> <p>Lack significance</p>

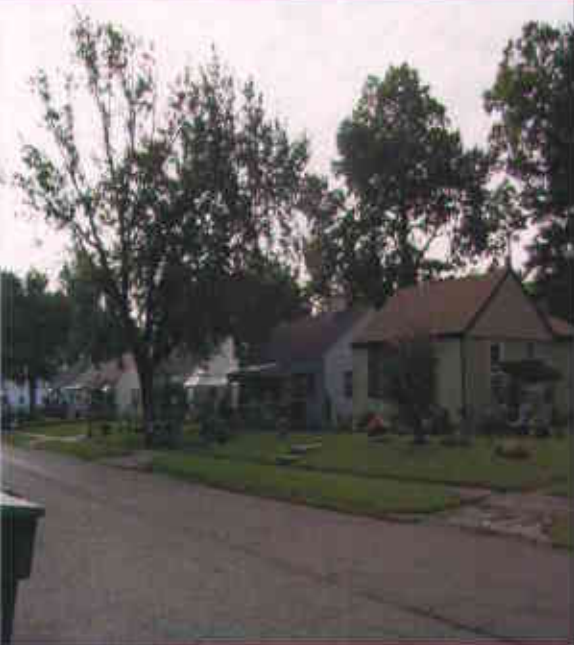
83	SE	<p>3019 E. 12th Avenue 1-story side-gabled house, built 1942 stucco and asphalt shingle roof</p> <p>3025 E. 12th Avenue 1-story side-gabled house, built 1952 vinyl siding and asphalt shingle roof</p> <p>3031 E. 12th Avenue 1-story side-gabled house, built 1950 vinyl siding and asphalt shingle roof</p> <p>3037 E. 12th Avenue 1-story side-gabled house, built 1950 vinyl siding and Permastone and asphalt shingle roof</p> <p>3045 E. 12th Avenue 1-story side-gabled house, built 1950 vinyl siding and asphalt shingle roof</p> <p>Lack significance</p>

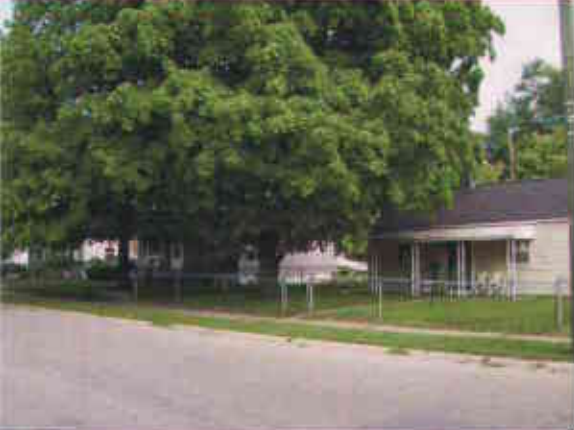
84	NW	<p>3034 E. 12th Avenue 1-story side-gabled house, built 1950 vinyl siding and asphalt shingle roof</p> <p>3042 E. 12th Avenue 1.5-story side-gabled house, built 1950 asbestos cement shingle siding and asphalt shingle roof</p> <p>3048 E. 12th Avenue 1-story side-gabled house, built 1950 vinyl siding and asphalt shingle roof</p> <p>Lack significance</p>

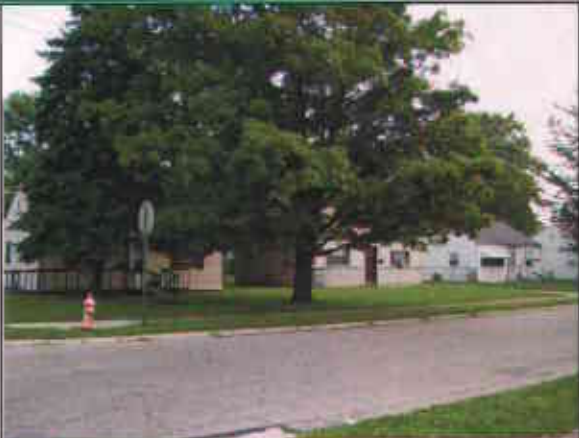
Photo No.	Direction	Description <sup>3</sup>	Photo
85	NE	<p>3062 E. 12th Avenue 1-story side-gabled house, built 1950 vinyl siding and asphalt shingle roof</p> <p>3068 E. 12th Avenue 1-story side-gabled house, built 1950 vinyl siding and PermaStone and asphalt shingle roof</p> <p>3074 E. 12th Avenue 1-story side-gabled house, built 1950 vinyl siding and asphalt shingle roof</p> <p>Lack significance</p>

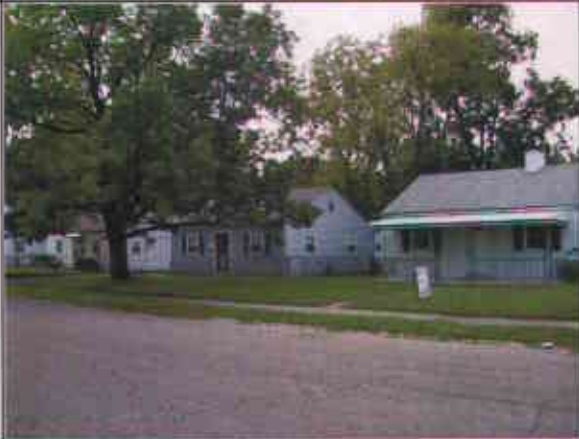
86	SE	<p>3059 E. 12th Avenue 1-story side-gabled house, built 1950 vinyl siding and asphalt shingle roof, porch added</p> <p>3065 E. 12th Avenue 1-story side-gabled house, built 1950 vinyl siding and asphalt shingle roof</p> <p>3071 E. 12th Avenue 1-story side-gabled house, built 1950 aluminum siding and asphalt shingle roof</p> <p>Lack significance</p>

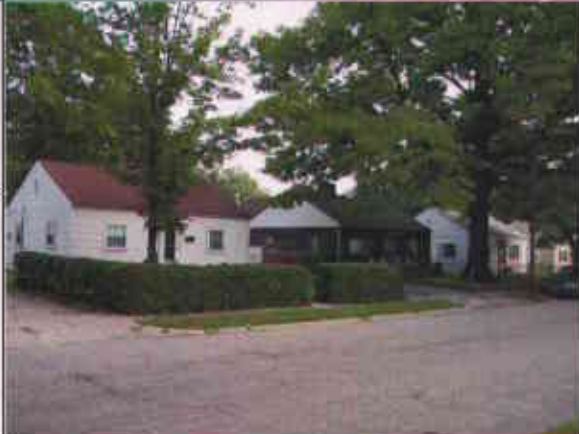
87	NE	<p>3080 E. 12th Avenue 1-story side-gabled house, built 1950 asbestos cement shingle siding and asphalt shingle roof</p> <p>3086 E. 12th Avenue 1-story side-gabled house, built 1950 stucco and asphalt shingle roof</p> <p>3092 E. 12th Avenue 1-story side-gabled house, built 1950 plywood siding and asphalt shingle roof</p> <p>Lack significance</p>

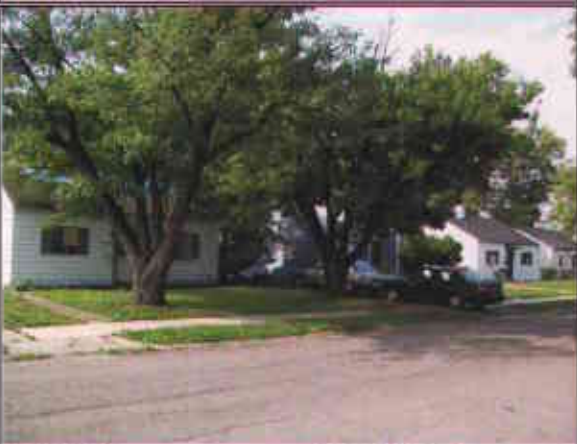
Photo No.	Direction	Description <sup>3</sup>	Photo
88	SW	3077 E. 12th Avenue 1-story side-gabled house, built 1947 plywood siding and asphalt shingle roof

3083 E. 12th Avenue 1-story side-gabled house, built 1950 plywood siding and asphalt shingle roof	
		3089 E. 12th Avenue 1-story side-gabled house, built 1950 aluminum siding and asphalt shingle roof	
		Lack significance	
89	NE	3098 E. 12th Avenue 1-story side-gabled house, built 1950 aluminum siding and asphalt shingle roof

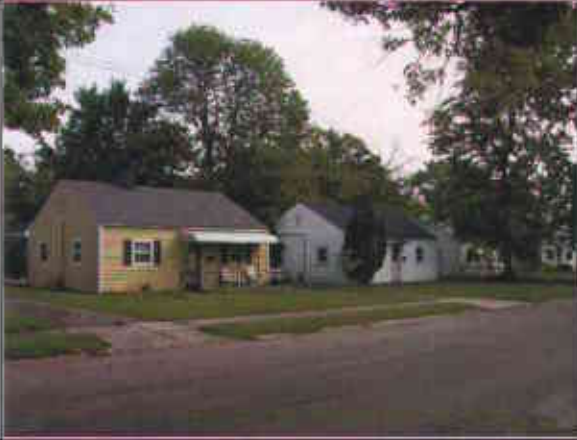
3104 E. 12th Avenue 1-story side-gabled house, built 1950 vinyl and aluminum siding and asphalt shingle roof	
		3110 E. 12th Avenue 1-story side-gabled house, built 1950 aluminum siding and asphalt shingle roof	
		Lack significance	
90	SW	3095 E. 12th Avenue 1-story side-gabled house, built 1950 aluminum siding and asphalt shingle roof

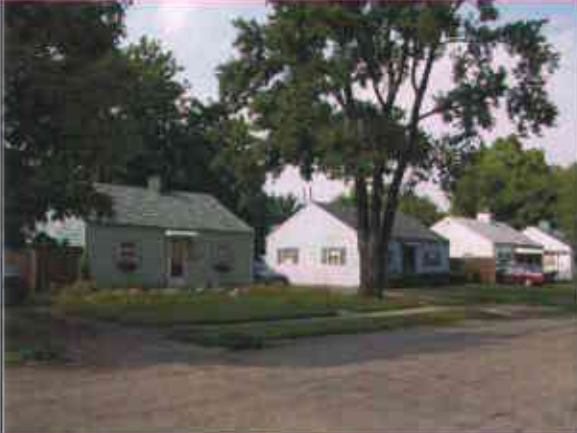
3101 E. 12th Avenue 1-story side-gabled house, built 1950 aluminum siding and asphalt shingle roof

3107 E. 12th Avenue 1-story side-gabled house, built 1950 aluminum siding and asphalt shingle roof	
		Lack significance

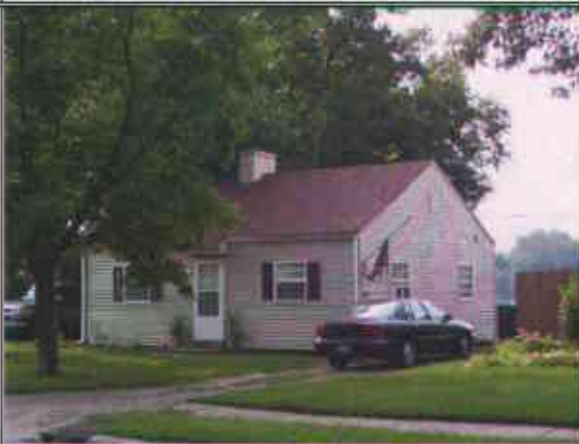
Photo No.	Direction	Description <sup>3</sup>	Photo
91	SE	<p>3113 E. 12th Avenue 1-story side-gabled house, built 1950 vinyl siding and asphalt shingle roof</p> <p>Lacks significance</p>

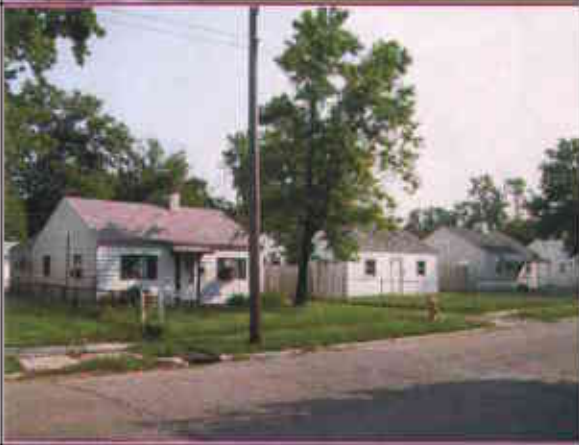
92	NE	<p>3116 E. 12th Avenue 1-story side-gabled house, built 1950 aluminum siding and asphalt shingle roof, addition on rear</p> <p>3124 E. 12th Avenue 1-story side-gabled house, built 1950 vinyl siding and asphalt shingle roof, additions on rear</p> <p>3130 E. 12th Avenue 1-story side-gabled house, built 1950 aluminum siding and asphalt shingle roof</p> <p>Lack significance</p>

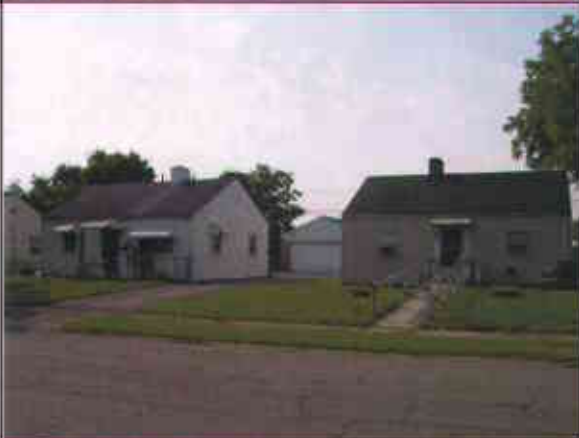
93	SE	<p>3125 E. 12th Avenue 1-story side-gabled house, built 1950 vinyl siding and asphalt shingle roof</p> <p>3133 E. 12th Avenue 1-story side-gabled house, built 1950 aluminum siding and asphalt shingle roof</p> <p>Lack significance</p>

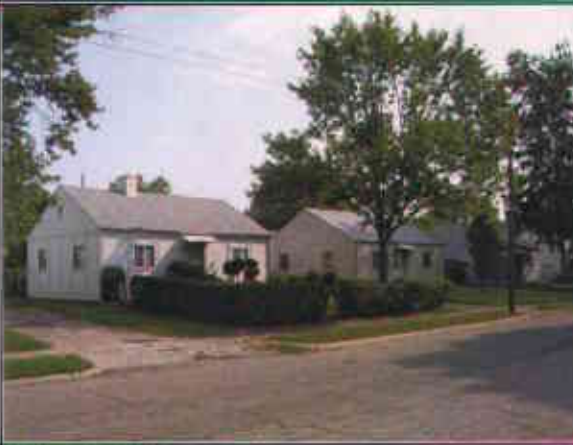
Photo No.	Direction	Description <sup>3</sup>	Photo
94	NE	<p>3136 E. 12th Avenue 1-story side-gabled house, built 1950 plywood siding and asphalt shingle roof</p> <p>3142 E. 12th Avenue 1-story side-gabled house, built 1950 vinyl siding and asphalt shingle roof</p> <p>3148 E. 12th Avenue 1-story side-gabled house, built 1950 vinyl siding and asphalt shingle roof</p> <p>Lack significance</p>

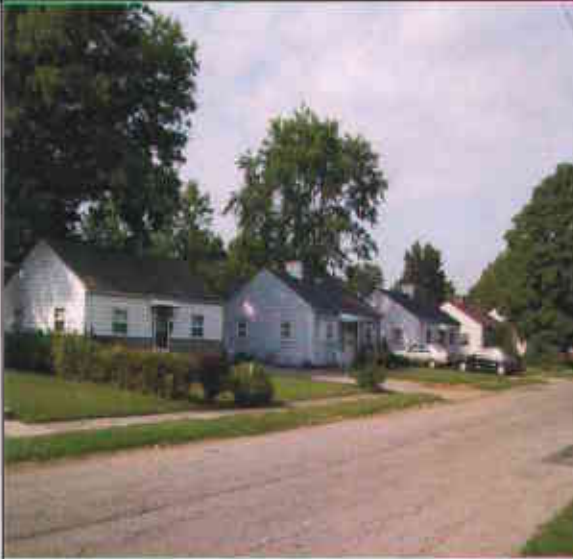
95	SW	<p>3139 E. 12th Avenue 1-story side-gabled house, built 1950 aluminum siding and Permastone and asphalt shingle roof, addition on rear</p> <p>3145 E. 12th Avenue 1-story side-gabled house, built 1950 aluminum siding and asphalt shingle roof</p> <p>3151 E. 12th Avenue 1-story side-gabled house, built 1950 aluminum siding and asphalt shingle roof</p> <p>3157 E. 12th Avenue 1-story side-gabled house, built 1950 aluminum siding and Permastone and asphalt shingle roof</p> <p>Lack significance</p>

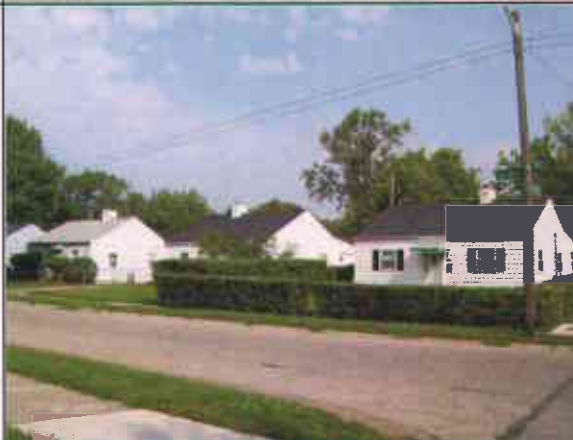
96	NW	<p>3154 E. 12th Avenue 1-story side-gabled house, built 1950 vinyl siding and asphalt shingle roof</p> <p>3160 E. 12th Avenue 1-story side-gabled house, built 1950 aluminum siding and asphalt shingle roof</p> <p>3166 E. 12th Avenue 1-story side-gabled house, built 1950 aluminum siding and asphalt shingle roof</p> <p>Lack significance</p>

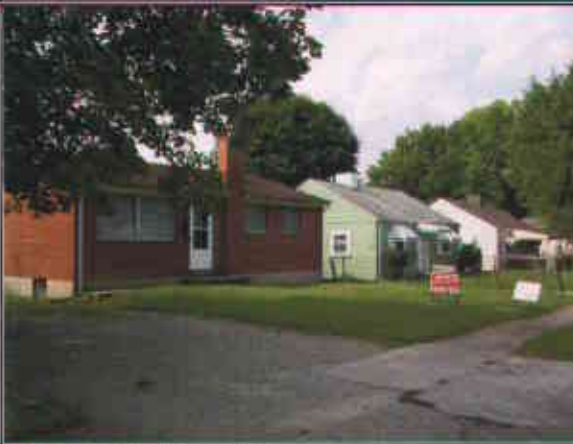
Photo No.	Direction	Description <sup>3</sup>	Photo
97	SW	<p>3177 E. 12th Avenue 1-story side-gabled house, built 1951 vinyl siding and asphalt shingle roof</p> <p>3183 E. 12th Avenue 1-story side-gabled house, built 1950 asbestos cement shingle siding and asphalt shingle roof</p> <p>3189 E. 12th Avenue ranch house, built 1956 brick veneer and asphalt shingle roof</p> <p>Lack significance</p>

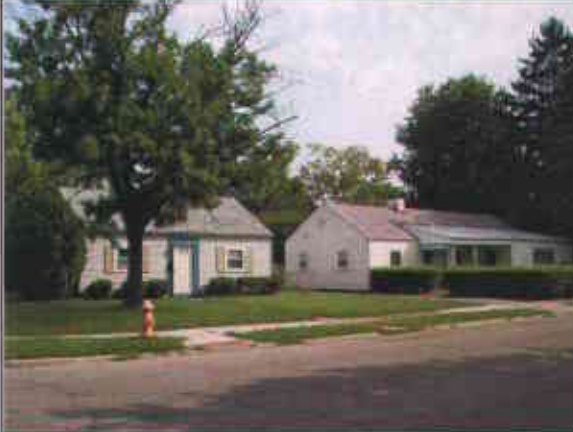
98	NE	<p>3180 E. 12th Avenue 1-story side-gabled house, built 1950 vinyl siding and asphalt shingle roof</p> <p>3186 E. 12th Avenue 1-story side-gabled house, built 1950 vinyl siding and asphalt shingle roof, additions</p> <p>Lack significance</p>

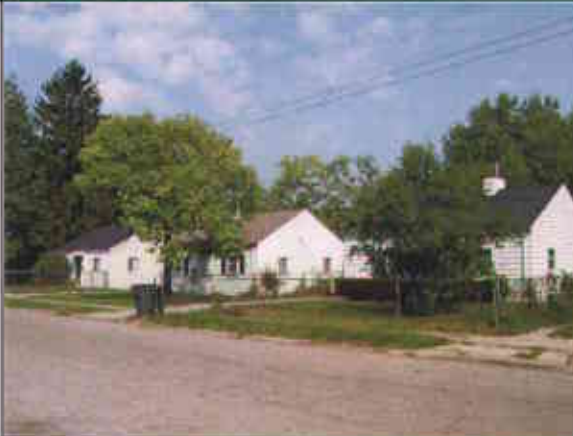
99	NW	<p>3198 E. 12th Avenue 1-story side-gabled house, built 1950 aluminum siding and asphalt shingle roof</p> <p>3204 E. 12th Avenue 1-story side-gabled house, built 1950 aluminum siding and asphalt shingle roof</p> <p>3210 E. 12th Avenue 1-story side-gabled house, built 1950 aluminum siding and asphalt shingle roof</p> <p>Lack significance</p>

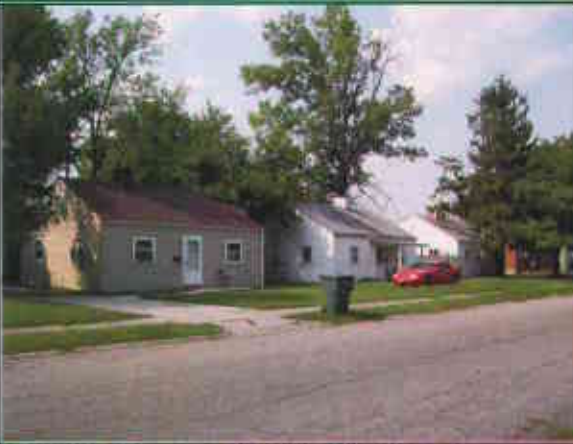
Photo No.	Direction	Description <sup>3</sup>	Photo
100	SW	<p>3195 E. 12th Avenue 1-story side-gabled house, built 1950 plywood siding and asphalt shingle roof</p> <p>3201 E. 12th Avenue 1-story side-gabled house, built 1950 vinyl siding and asphalt shingle roof</p> <p>3207 E. 12th Avenue 1-story side-gabled house, built 1950 vinyl siding and asphalt shingle roof</p> <p>Lack significance</p>
