## **APPENDIX J HISTORIC RESOURCES**

This appendix provides documentation of consultation with the Ohio State Historic Preservation Office. Attachments 1 - 7 are surveys and consultation in support of the impact assessment for Historic, Architectural, Archaeological, and Cultural Resources.

***Federal Aviation Administration***  
**ENVIRONMENTAL IMPACT STATEMENT**  
**FOR**  
**REPLACEMENT RUNWAY AND TERMINAL PROJECT**  
**AT**  
**PORT COLUMBUS INTERNATIONAL AIRPORT**  
**AGENCY MEETING – OHIO HISTORIC PRESERVATION OFFICE**  
**MEETING MINUTES**  
**NOVEMBER 21, 2006**

**Cultural Resources Existing Conditions and Survey  
Methodology Report for the  
Port Columbus International Airport  
Environmental Impact Statement,  
Cities of Columbus and Gahanna, Franklin County, Ohio**

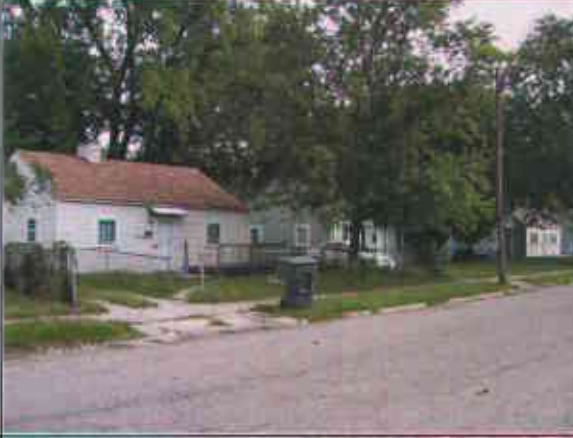
101	NE	<p>3216 E. 12th Avenue 1-story side-gabled house, built 1950 vinyl siding and asphalt shingle roof</p> <p>3222 E. 12th Avenue 1-story side-gabled house, built 1950 vinyl siding and asphalt shingle roof</p> <p>3228 E. 12th Avenue 1-story side-gabled house, built 1950 aluminum siding and asphalt shingle roof</p> <p>Lack significance</p>

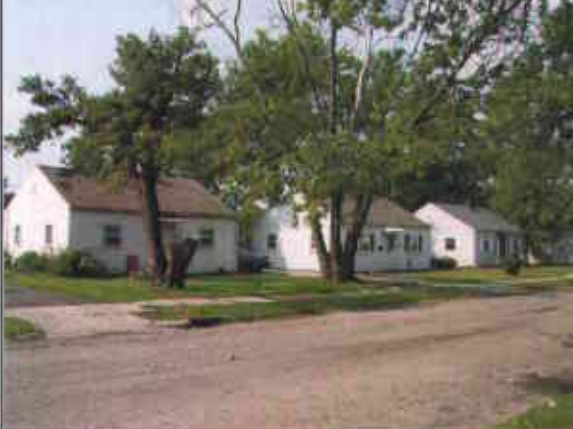
102	SW	<p>3215 E. 12th Avenue 1-story side-gabled house, built 1950 vinyl siding and asphalt shingle roof</p> <p>3219 E. 12th Avenue 1-story side-gabled house, built 1950 plywood siding and asphalt shingle roof</p> <p>3225 E. 12th Avenue 1-story side-gabled house, built 1950 vinyl siding and asphalt shingle roof</p> <p>Lack significance</p>

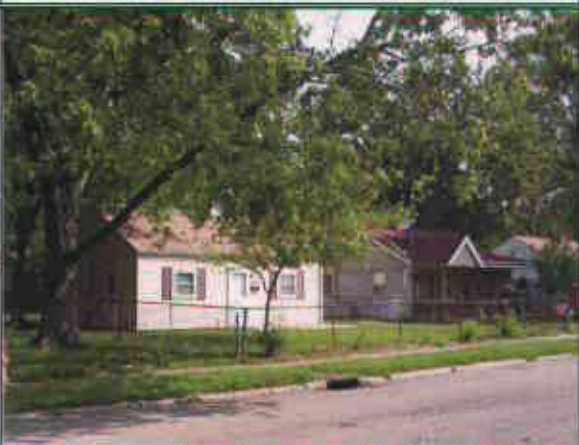
Photo No.	Direction	Description <sup>3</sup>	Photo
103	NE	<p>3234 E. 12th Avenue 1-story side-gabled house, built 1950 vinyl siding and asphalt shingle roof</p> <p>3240 E. 12th Avenue 1-story side-gabled house, built 1950 stucco and asphalt shingle roof, porch added</p> <p>Lack significance</p>

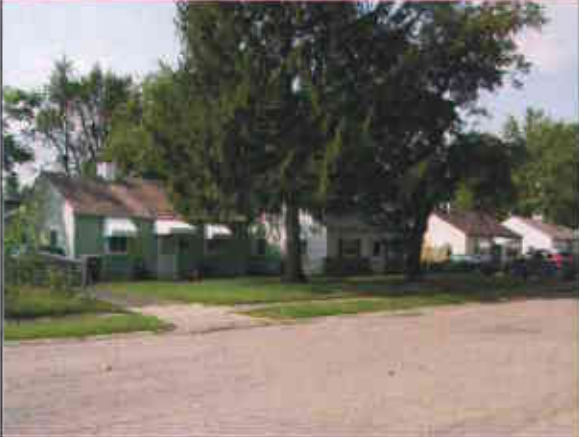
104	SW	<p>3231 E. 12th Avenue 1-story side-gabled house, built 1950 vinyl siding and asphalt shingle roof</p> <p>3237 E. 12th Avenue 1-story side-gabled house, built 1950 vinyl siding and PermaStone and asphalt shingle roof</p> <p>3245 E. 12th Avenue 1-story side-gabled house, built 1950 aluminum siding and asphalt shingle roof</p> <p>Lack significance</p>

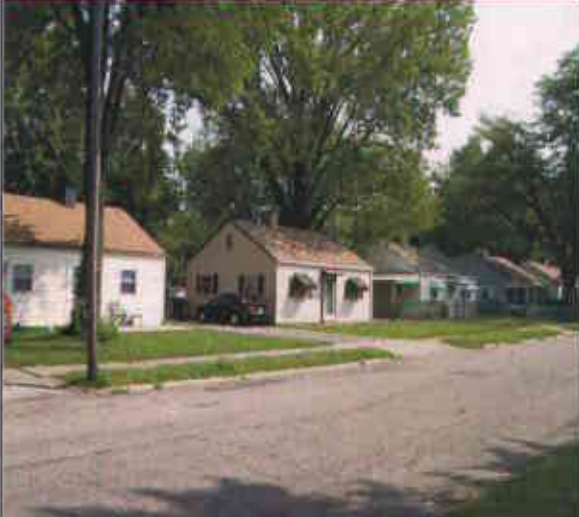
105	NE	<p>3248 E. 12th Avenue 1-story side-gabled house, built 1950 vinyl siding and asphalt shingle roof</p> <p>3254 E. 12th Avenue 1-story side-gabled house, built 1950 vinyl siding and asphalt shingle roof</p> <p>3260 E. 12th Avenue 1-story side-gabled house, built 1950 aluminum siding and PermaStone and asphalt shingle roof</p> <p>3266 E. 12th Avenue 1-story side-gabled house, built 1950 aluminum siding and asphalt shingle roof, porch added</p> <p>Lack significance</p>

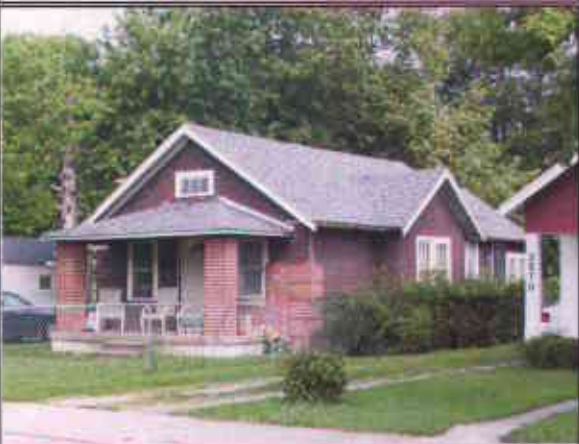
110	NE	<p>2870 E. 11th Avenue 1-story side-gabled house, built 1920 rock-faced concrete block foundation, asbestos cement shingle siding, asphalt shingle roof</p> <p>Lacks significance</p>

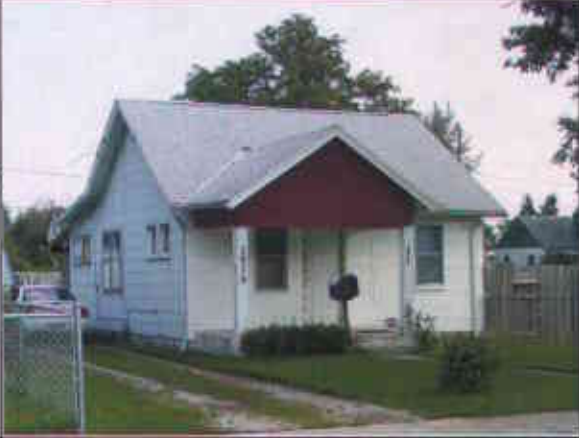
111	NE	<p>2880 E. 11th Avenue 1-story side-gabled house, built 1920 rock-faced concrete block foundation, asbestos cement shingle siding, asphalt shingle roof</p> <p>Lacks significance</p>

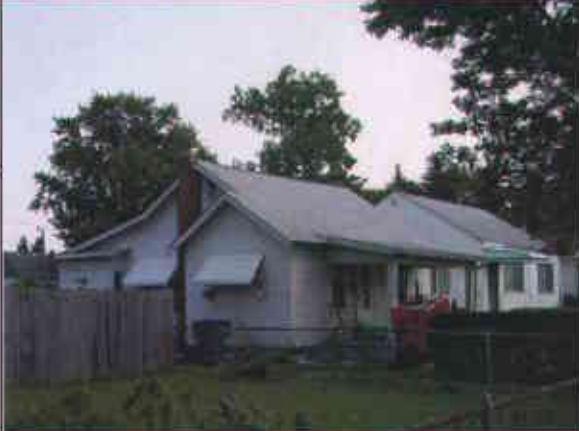
Photo No.	Direction	Description <sup>3</sup>	Photo
112	NE	<p>2886 E. 11th Avenue 1-story side-gabled house, built 1952 asbestos cement shingle siding, asphalt shingle roof</p> <p>Lacks significance</p>

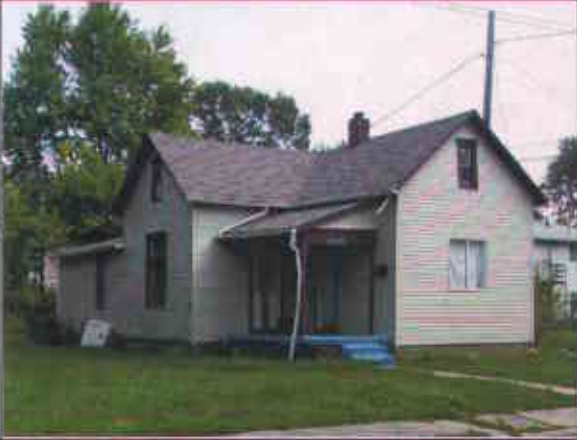
114	NW	<p>961 Alton Avenue 1.5-story front-gabled house, built 1951 aluminum siding and asphalt shingle roof, garage addition</p> <p>Lacks significance</p>

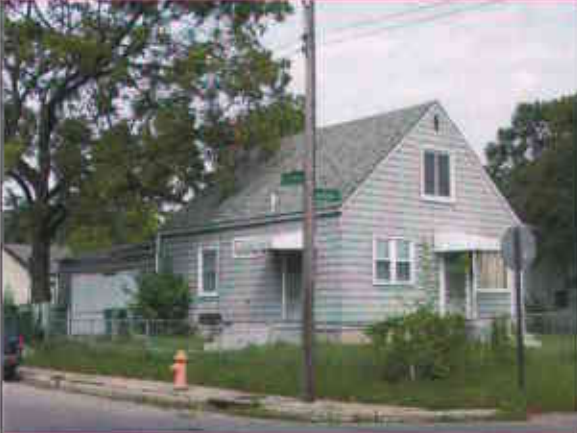
Photo No.	Direction	Description <sup>3</sup>	Photo
115	NE	<p>2958 E. 11th Avenue 1-story hip roof house, built 1954 vinyl siding and asphalt shingle roof, several additions</p> <p>Lacks significance and integrity</p>

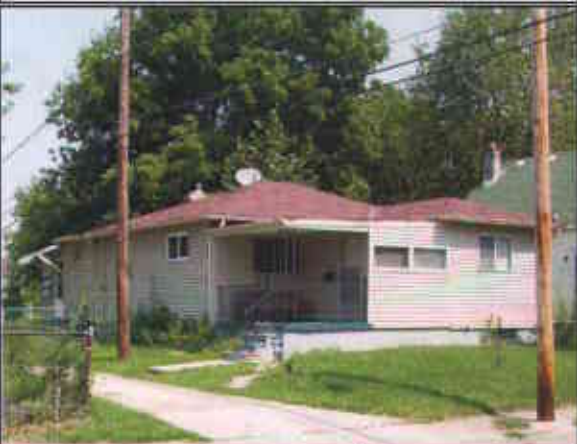
116	NW	<p>2960 E. 11th Avenue 1.5-story front-gabled house, built 1952 vinyl siding and asphalt shingle roof</p> <p>2966 E. 11th Avenue 1.5-story front-gabled house, built 1952 aluminum siding and PermaStone and asphalt shingle roof</p> <p>2970 E. 11th Avenue 1.5-story front-gabled house, built 1952 aluminum siding and asphalt shingle roof</p> <p>Lack significance</p>

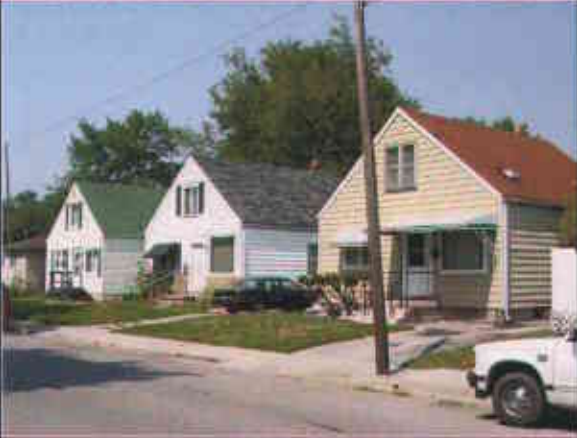
117	S	<p>2961 E. 11th Avenue 1-story side-gabled house, built 1920 rock-faced concrete block foundation, vinyl siding, and asphalt shingle roof</p> <p>Lacks significance</p>

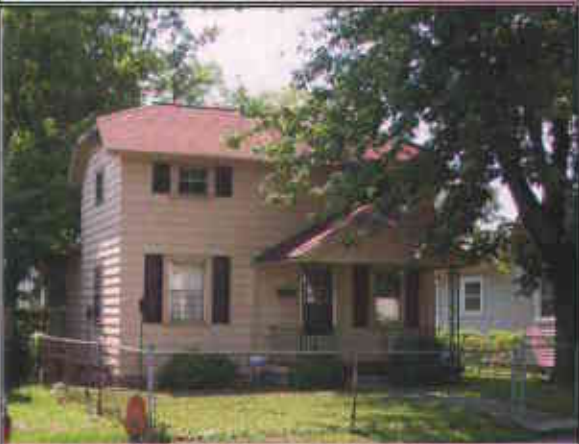
119	SE	<p>2969 E. 11th Avenue 2-story clipped side-gabled house, built 1925 rock-faced concrete block foundation, vinyl siding, asphalt shingle roof, replacement windows</p> <p>Lacks significance</p>

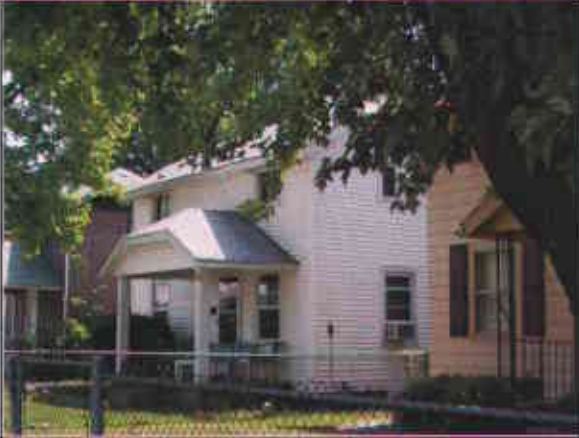
120	SE	<p>2975 E. 11th Avenue 2-story clipped side-gabled house, built 1925 rock-faced concrete block foundation, wood siding, asphalt shingle roof</p> <p>Lacks significance</p>

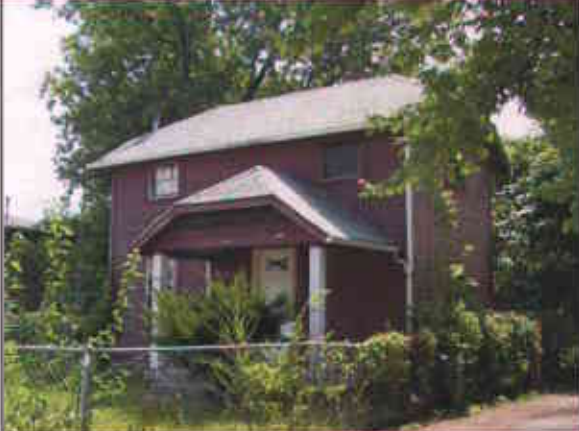
Photo No.	Direction	Description <sup>3</sup>	Photo
121	NW	<p>2976 E. 11th Avenue 2-story front-gabled hip roof house, built 1920 vinyl siding, asphalt shingle roof, front porch altered, additions</p> <p>Lacks significance and integrity</p>

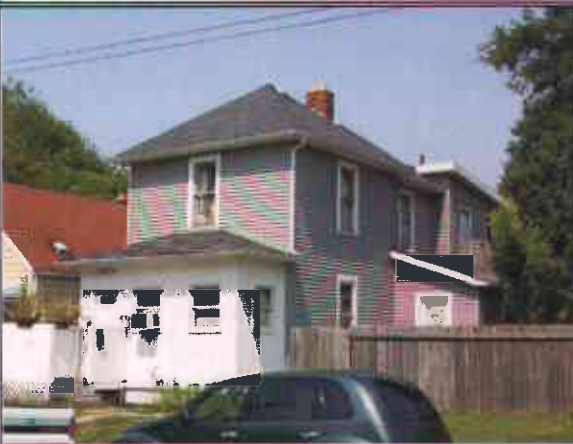
122	NW	<p>2990 E. 11th Avenue 2-story front-gabled hip roof house, built 1917 aluminum siding, asphalt shingle roof, front porch altered</p> <p>Lacks significance</p>

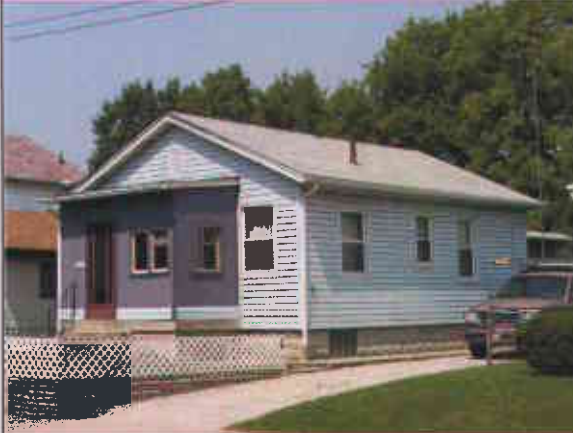
Photo No.	Direction	Description <sup>1</sup>	Photo
124	NW	<p>3008 E. 11th Avenue 1.5-story front-gabled house, built 1952 vinyl siding and Permastone, asphalt shingle roof, porch added</p> <p>3012 E. 11th Avenue 1.5-story front-gabled house, built 1952 aluminum siding, asphalt shingle roof, porch added</p> <p>Lack significance</p>

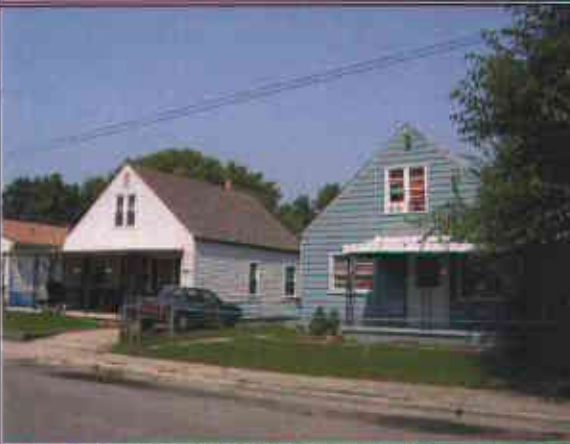
125	SW	<p>3005 E. 11th Avenue ranch house, built 1954 vinyl siding, asphalt shingle roof, porch added</p> <p>Lacks significance</p>

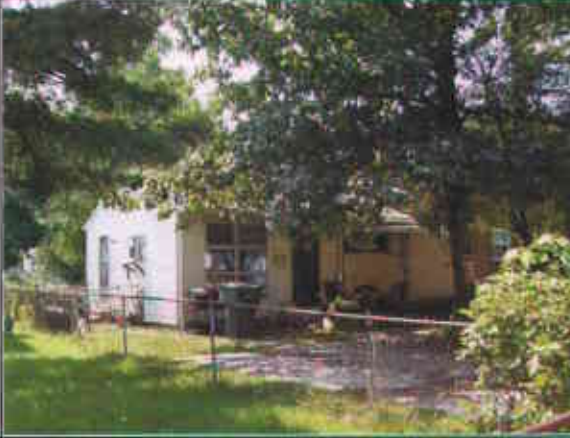
126	SW	<p>3011 E. 11th Avenue ranch house, built 1954 vinyl siding and asphalt shingle roof</p> <p>3015 E. 11th Avenue ranch house, built 1952 vinyl siding and asphalt shingle roof</p> <p>Lack significance</p>

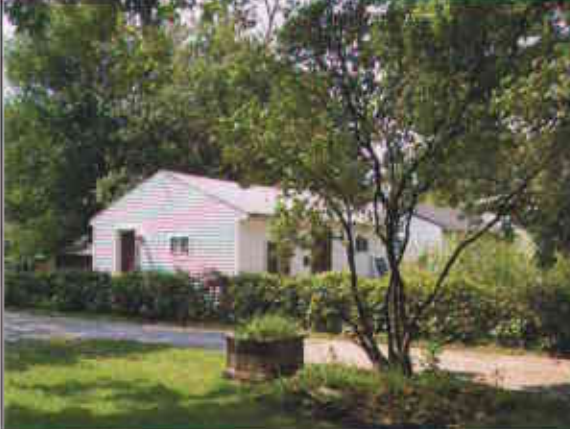
Photo No.	Direction	Description <sup>3</sup>	Photo
127	SE	952 Rarig Avenue ranch house, built 1947 aluminum siding and asphalt shingle roof  Lacks significance

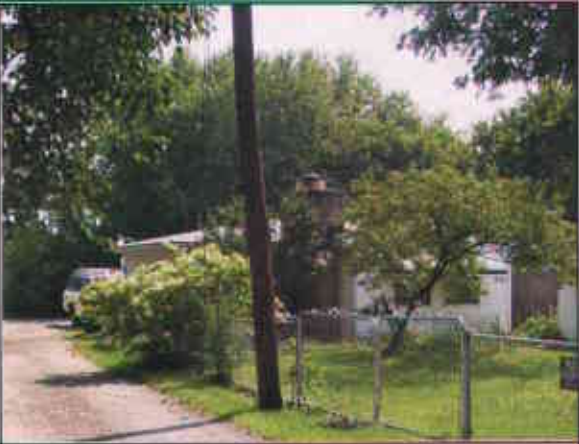
128	SE	946 Rarig Avenue ranch house, built 1952 vinyl siding and PermaStone and asphalt shingle roof  Lacks significance

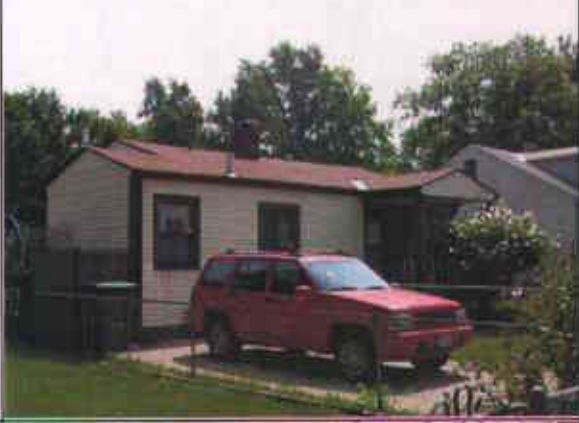
129	NE	938 Rarig Avenue Cape Cod, built 1951 Aluminum siding and asphalt shingle roof, original windows  Lacks significance

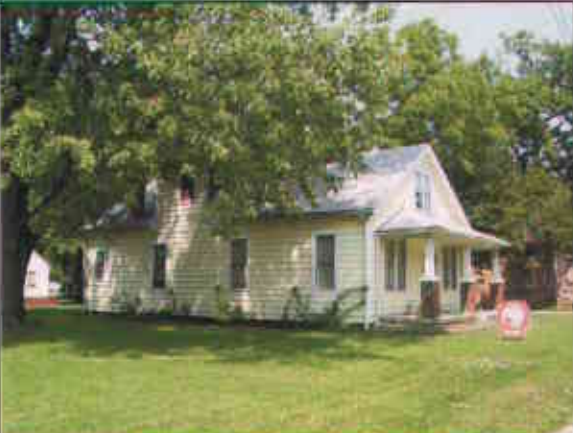
131	NE	<p>914 Rarig Avenue 1.5-story front-gabled house, built 1920 vinyl siding, asphalt shingle roof, front porch enclosed</p> <p>Lacks significance</p>

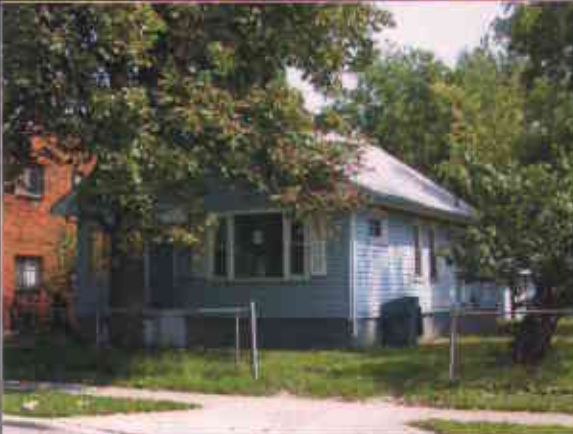
132	SW	<p>3069 E. 11th Avenue 1-story side-gabled house, built 1918 rock-faced concrete block foundation, vinyl siding on façade and asbestos cement shingle siding on other walls, asphalt shingle roof, addition on rear</p> <p>Lacks significance</p>

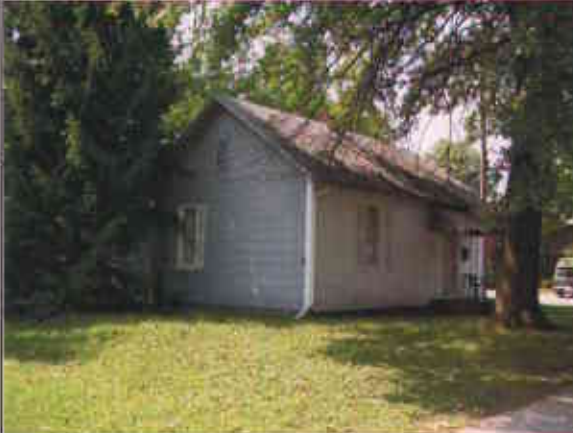
Photo No.	Direction	Description <sup>3</sup>	Photo
133	NE	<p>3070 E. 11th Avenue 2.5-story front-gabled house, built 1930 rock-faced concrete block foundation, vinyl siding, asphalt shingle roof, garage addition, front porch enclosed</p> <p>Lacks significance and integrity</p>

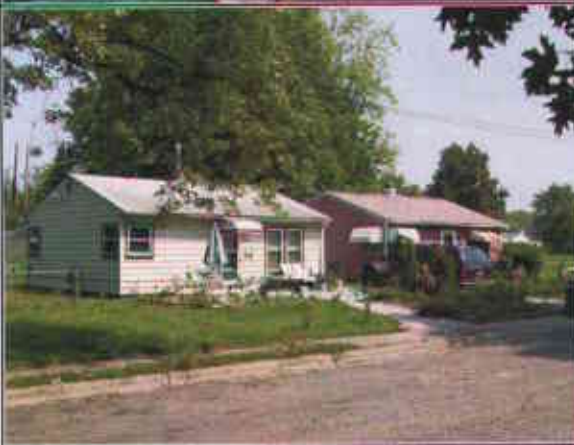
135	NE	<p>921 Stelzer Avenue built 1950 concrete block walls and asphalt shingle roof</p> <p>Lacks significance</p>

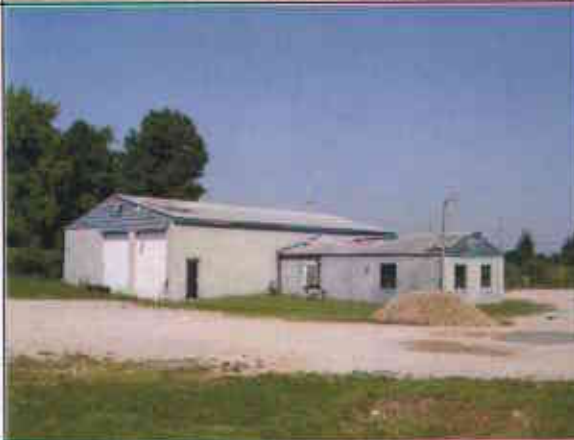
Photo No.	Direction	Description <sup>3</sup>	Photo
136	NW	<p>1229 Sunbury Road Neighborhood Center, Ohio Dominican University Built 1915 Vinyl siding, asphalt shingle roof, numerous additions</p> <p>Lacks integrity</p>

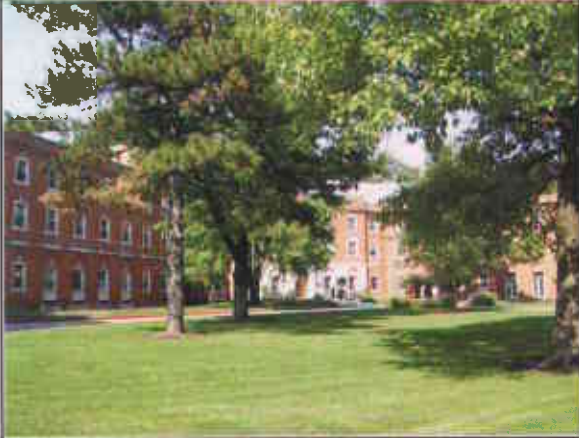
138	NW	<p>4920 E. 5th Avenue Old Port Columbus Airport Control Tower Built 1929 (NRHP form) Brick walls with flat roof</p> <p>NRHP listed</p>

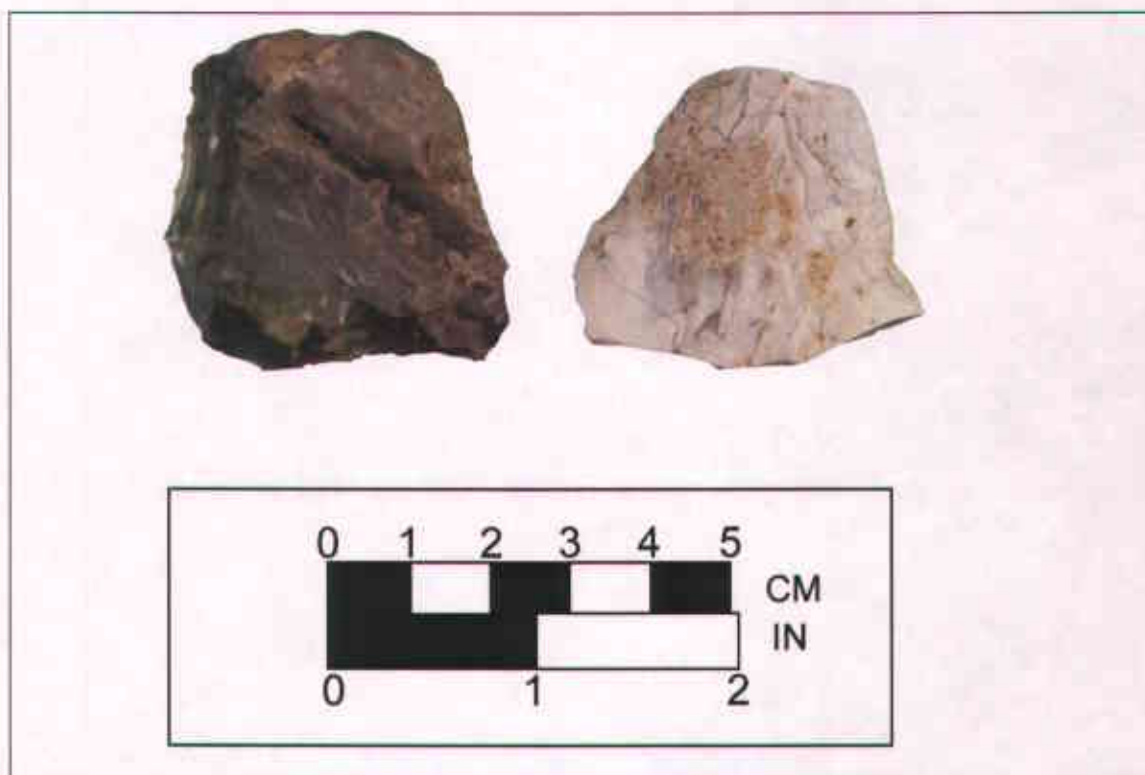
Plate 6. Prehistoric artifacts recovered during the Phase I survey. A) unidentified chert core recovered from 33FR2703; B) Vanport Stage 3 biface recovered from 33FR2704.

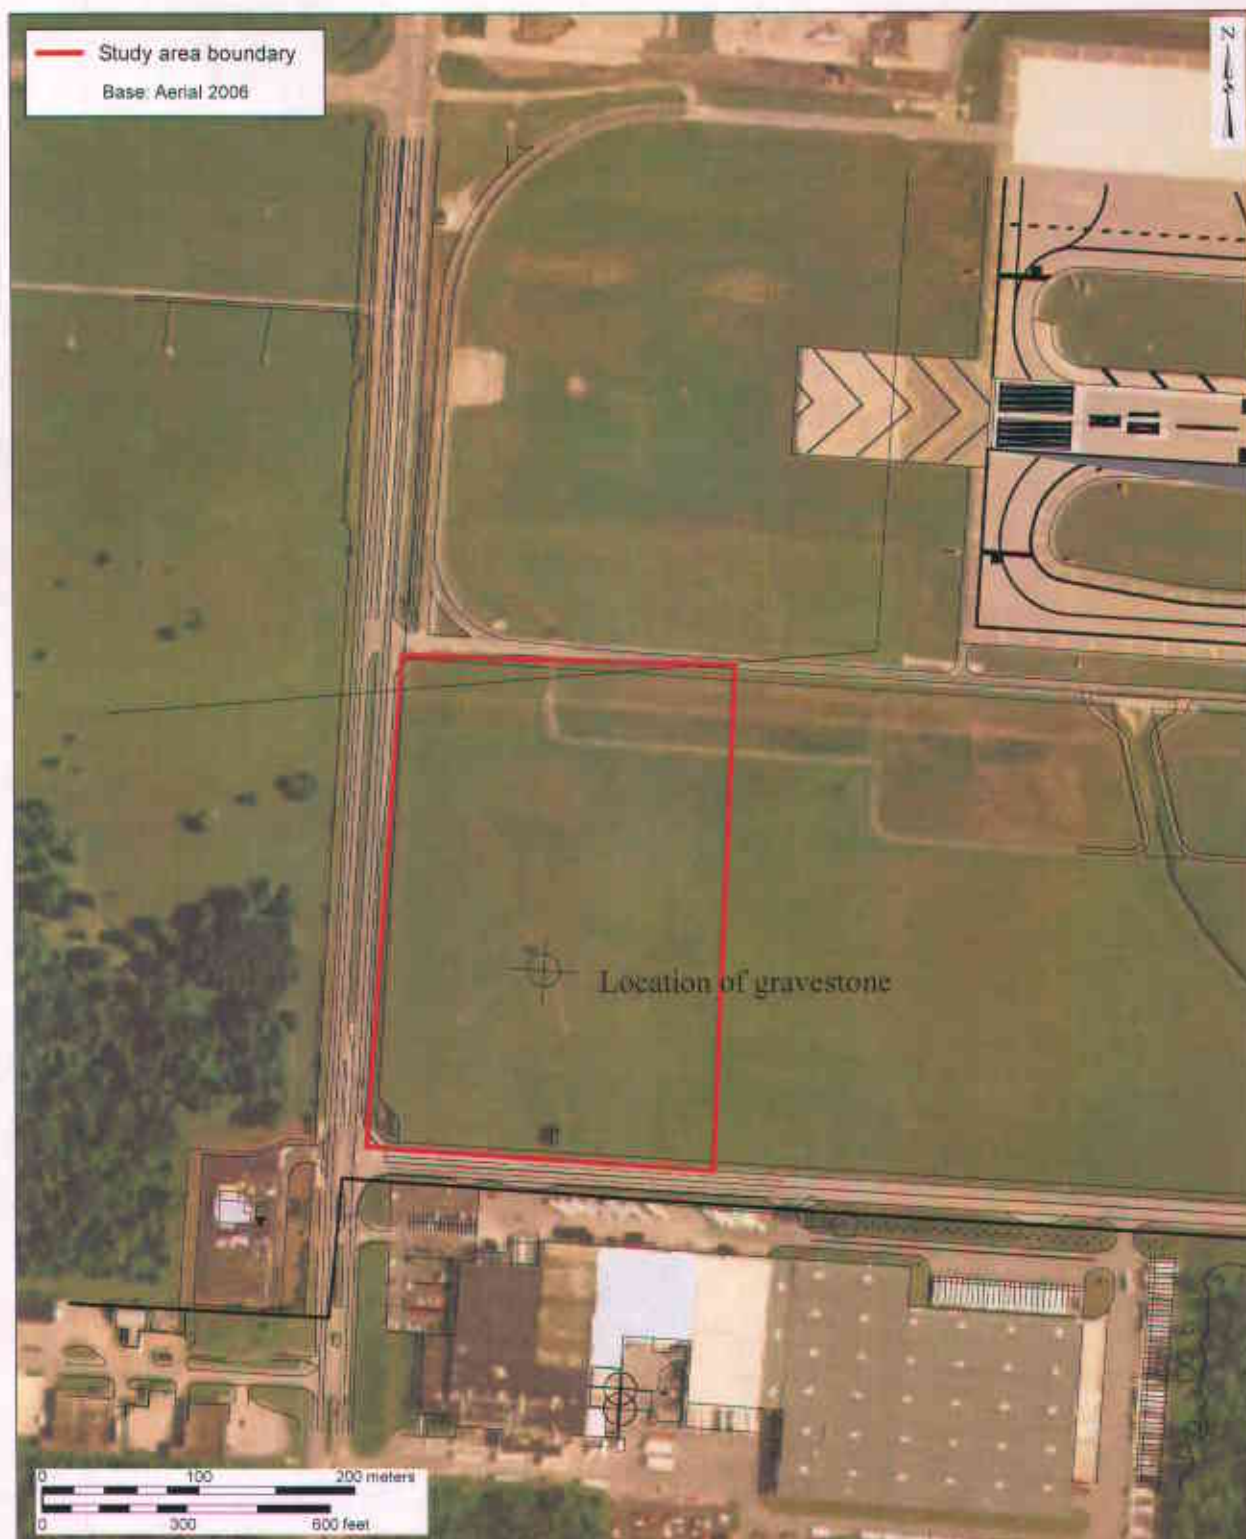
Figure 10. Map of the location where Anna Mary Stelzer's gravestone was removed by Columbus Regional Airport Authority employees. Note: no human remains were found there.

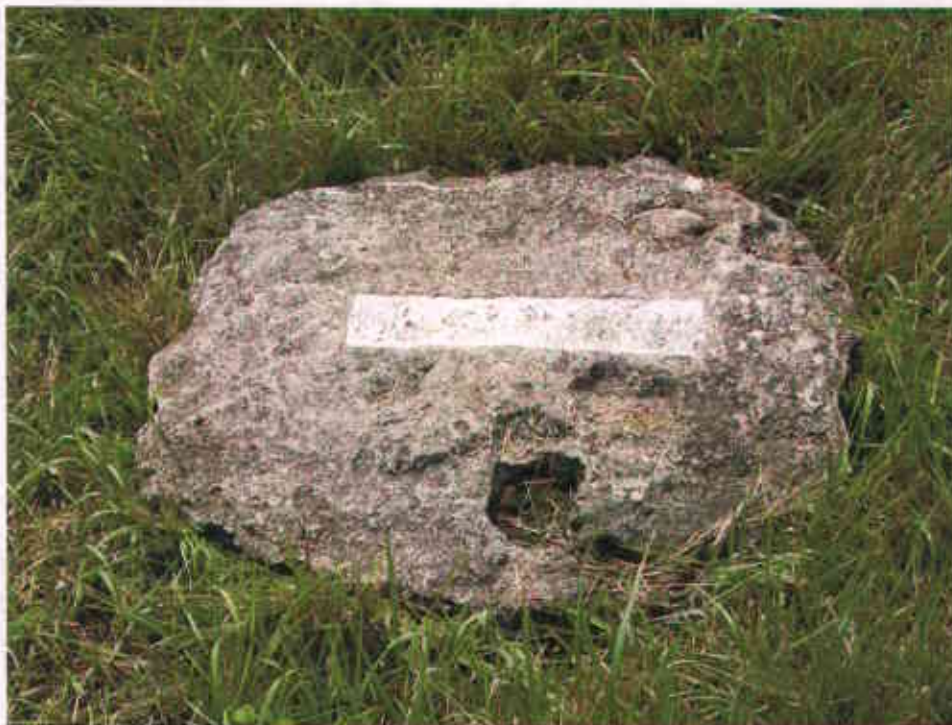
Plate 6. Gravestone base found near the silo. The base was not in situ.

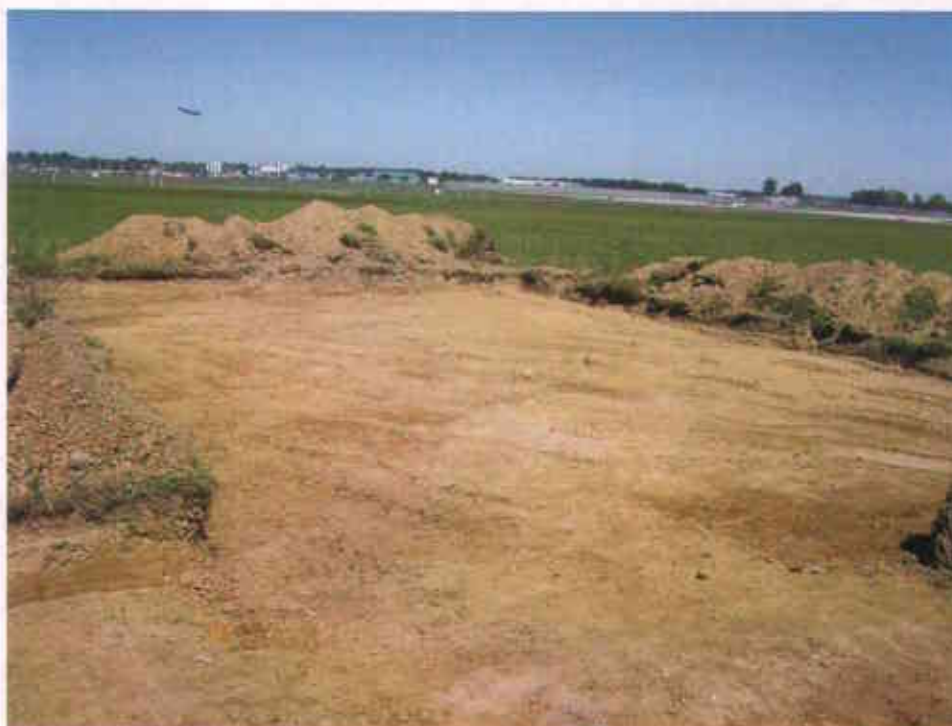
Plate 7. Trench 1, north end after excavation.

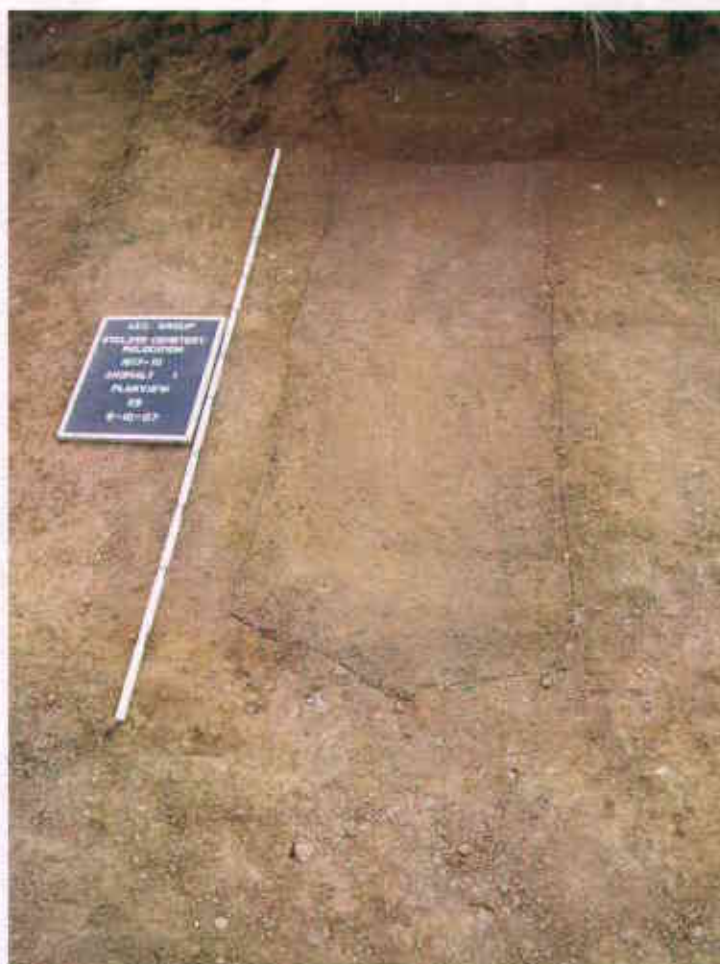
Plate 8. Plan view of Feature 1, before excavation.

The shape of Feature 1 is subrectangular and the western end is rounded. It is about 70 in (178 cm) in length, although 4 in–6 in (10 cm–15 cm) are estimated to be under the west trench wall (this area was not excavated) [Figure 16; Plate 8]. The grave width was variable: between 23 in (58 cm) and 25 in (64 cm). A 20-in (50-cm) wide slit trench was placed so as to cover the approximate mid-section of the grave. The trench was extended 3-in (10-cm) beyond the graveshaft edge on each side so that the contrast with the subsoil would be obvious in profile. The excavation was carried out with a trowel and later a hand pick. There was some variation in the grave fill, but consisted of mostly of loose brownish yellow (10YR 6/6) sandy loam with less than 1 percent angular gravel (Stratum IV) [Figure 17]. Certain areas, particularly along the margins of the grave, were darker, consisting of loose, fine yellowish brown to dark yellowish brown (10YR 5/8–10YR 4/4) clay loam with decomposing sandstone and iron oxide inclusions (Stratum IVa). Not until the excavations had penetrated about 8 in (20 cm) into the grave fill was Stratum V uncovered: a loose very fine very pale brown (10YR 7/4) silty loam with less than 1 percent angular gravels. It never covered the entire floor of the trench. The demarcation between the grave trench and natural subsoil was very obvious and easy to re-establish with a trowel. The fill soil was loose and easier to remove while the natural subsoil had more rock and

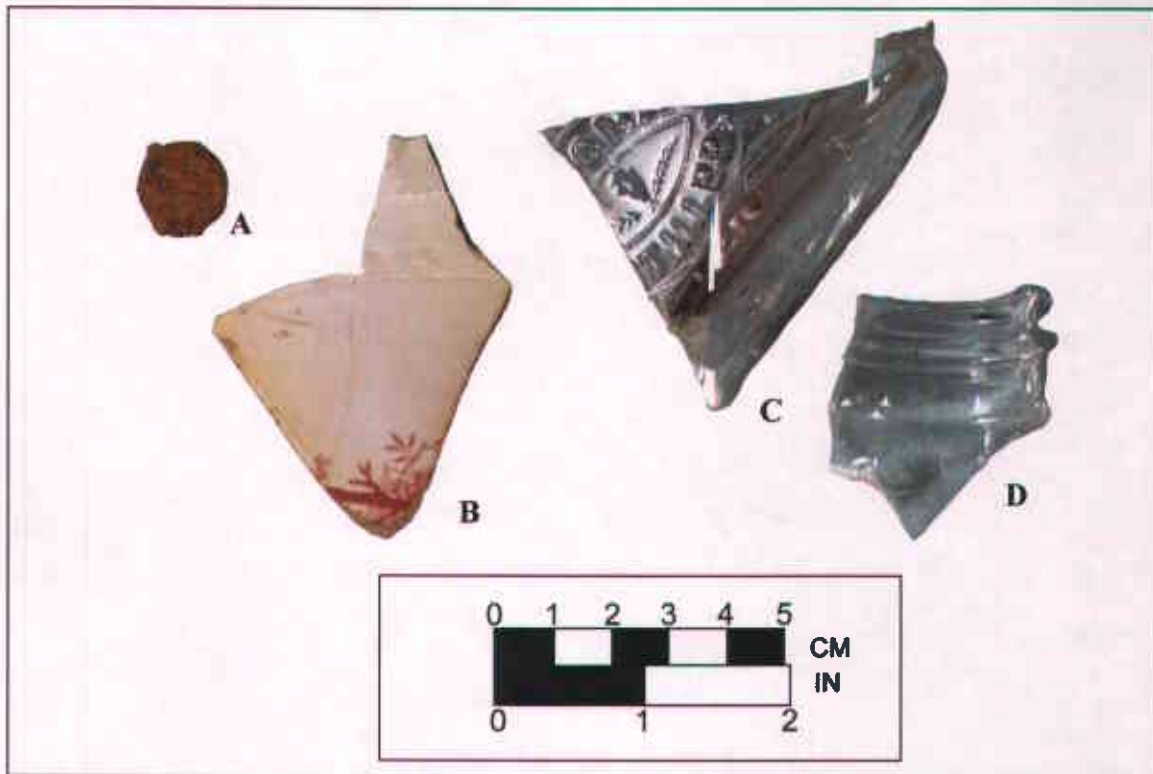
Plate 9. Examples of Historic artifacts recovered from 33FR2711 (Trench 1): A) Ferrous metal disk found in grave fill (likely a button), Feature 1, Stratum IV; B) whiteware sherd with red transfer print and molded decoration, Stratum II; C) colorless bottle base sherd, with embossed letters and numbers and Owen's scar, Stratum II; D) colorless bottle sherd with machine-made finish and lug-thread closure, Stratum II.

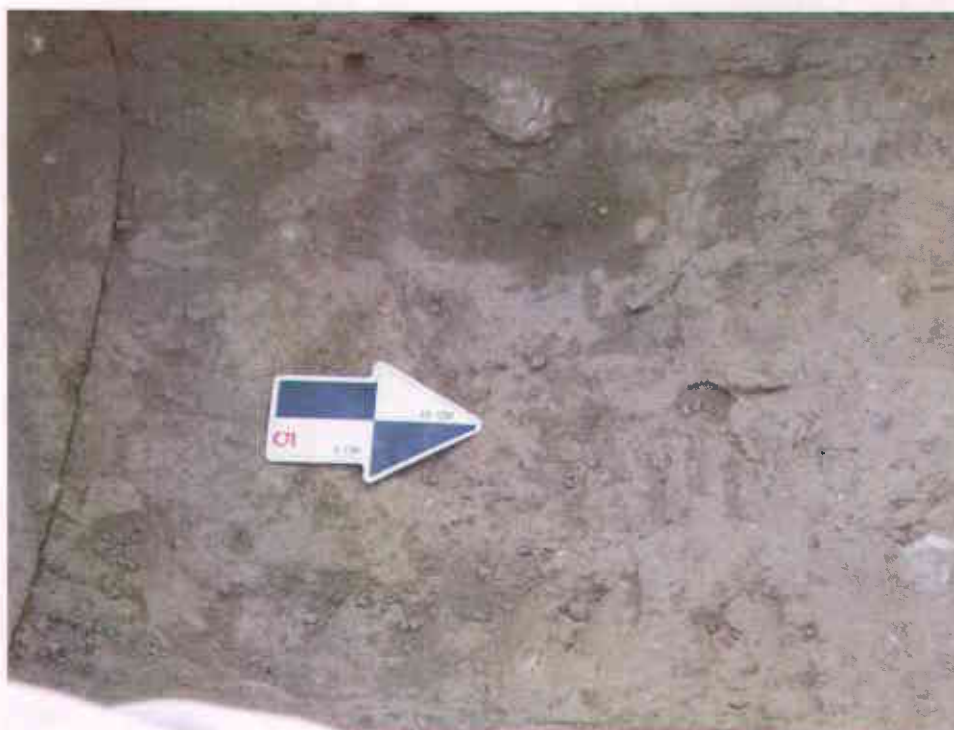
Plate 10. Close-up of human rib bone fragment uncovered in situ in Feature 1.

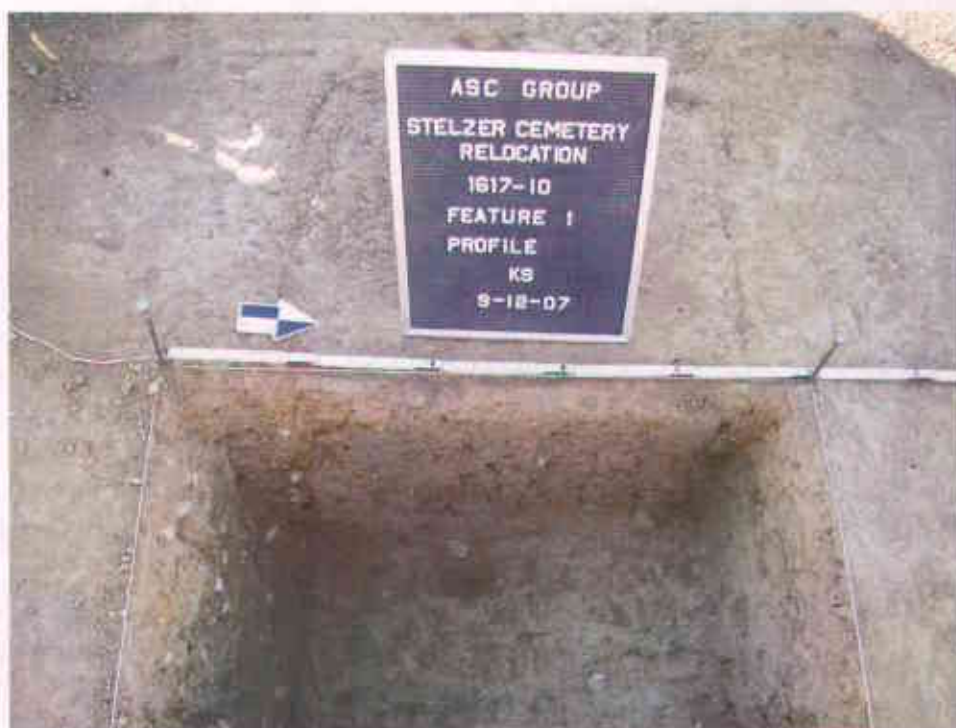
Plate 12. West profile of slit trench for Feature 1.

At 15 in (38 cm) below the trench floor (about 31 in/80 cmbs) a fragment of human rib bone was uncovered. The bone was in good condition although it was fragmentary. It is about 2 in (5 cm) in length. The rib's costal groove was visible, suggesting that this was part of a costal rib. It was photographed in place (Plate 10) and then photographed against a light-colored background (Plate 11). After the second photograph it was replaced in the grave where it was found. No other bones/bone fragments were uncovered. Although the floor was cleaned, mapped, and photographed (Figure 18; Plate 12), no further excavations were undertaken.

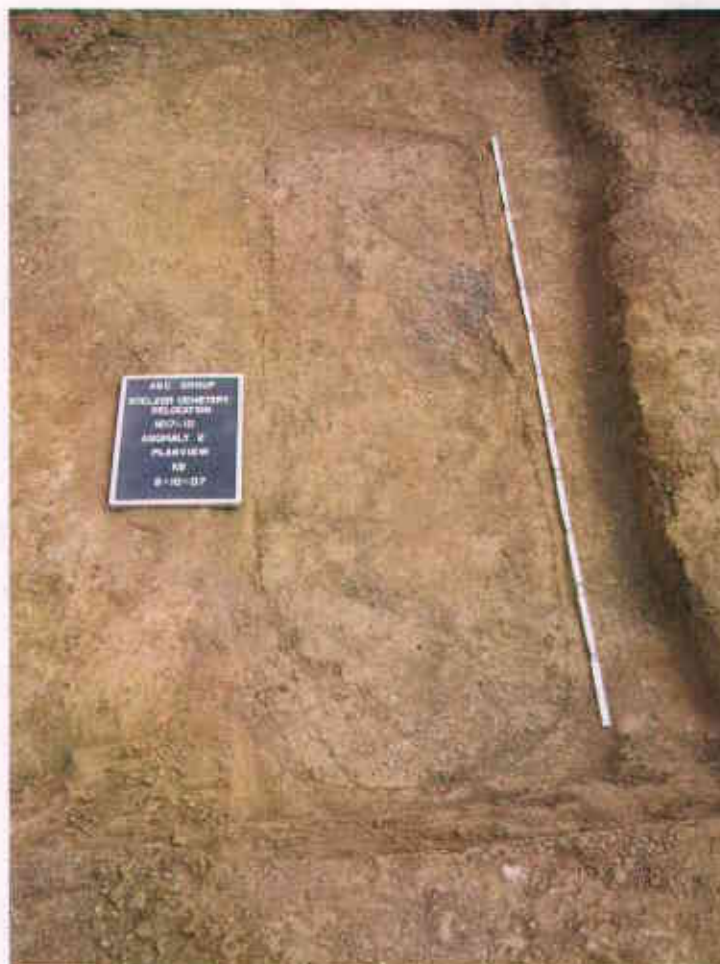
Plate 13. Plan view of Feature 2, before excavation.

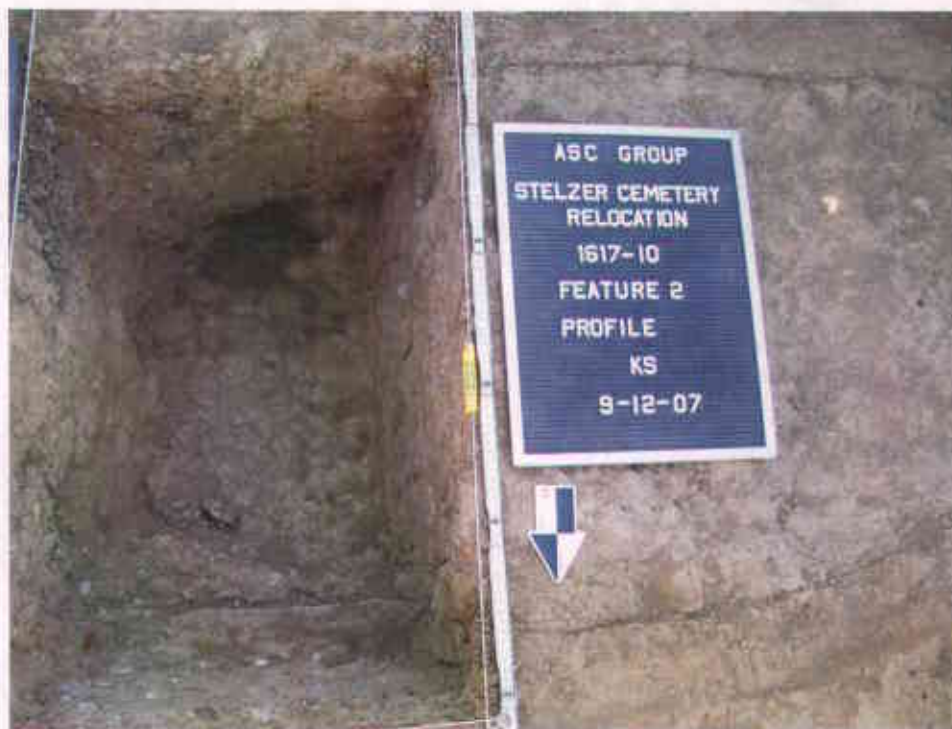
Plate 14. Plan view of Feature 2, after excavation.

A coffin fragment was exposed at 36 in (91 cm) below surface, which corresponds to 14 inbs (35 cm) below the Trench 1 floor (Figure 21; Plates 14 and 15). The coffin fragment is about 3.1 in (8 cm) in length and an escutcheon or other hardware is attached. It is flush with the wood and has the form of a “bullseye.” Likely, the metal helped preserve the wood of this part of the coffin because only a few other wooden fragments were found under and around it, and they were much smaller. The two largest coffin fragments were taken out of the grave to photograph against a light-colored background (Plate 16) and then were replaced. After the coffin fragments were replaced, the grave was cleaned and photographed (Plate 17) but no more excavations were undertaken.

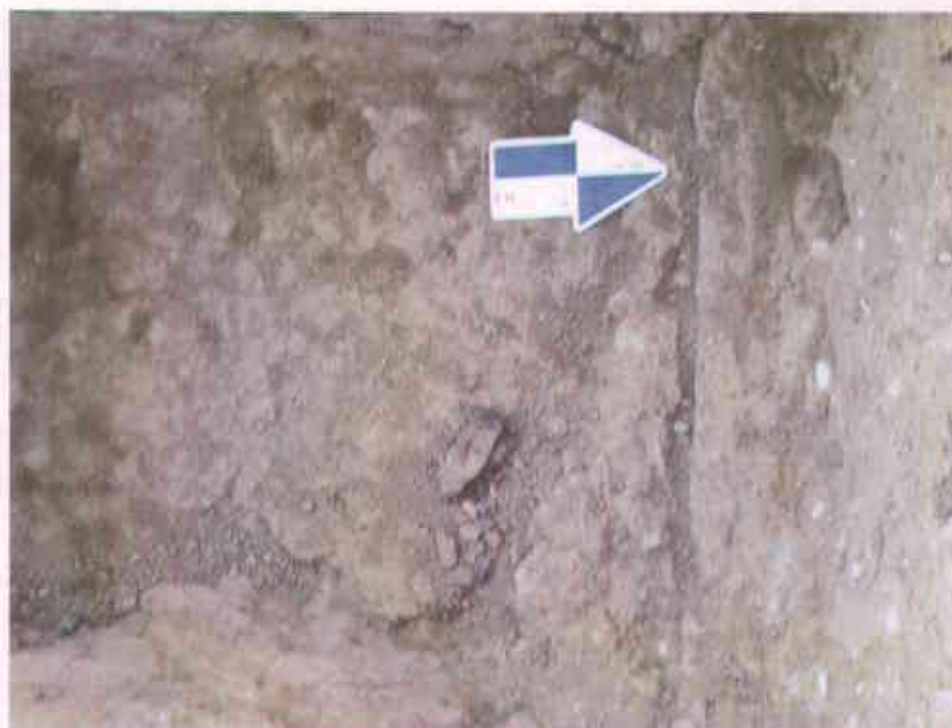
Plate 15. Close-up of coffin fragment, in situ.

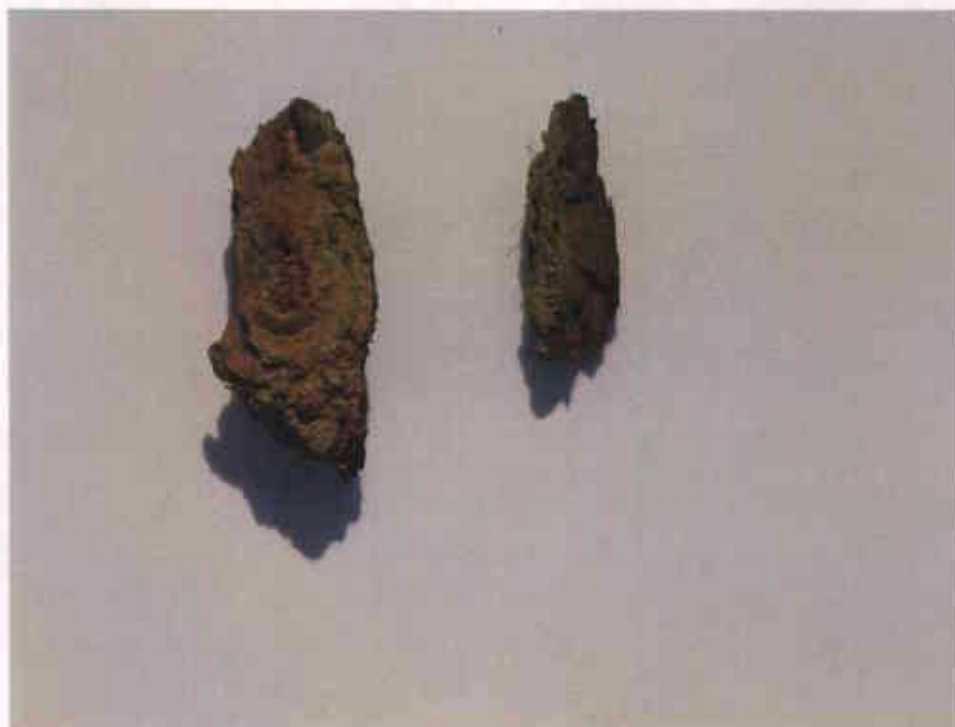
Plate 16. Photograph made on-site of coffin fragments at Feature 2.

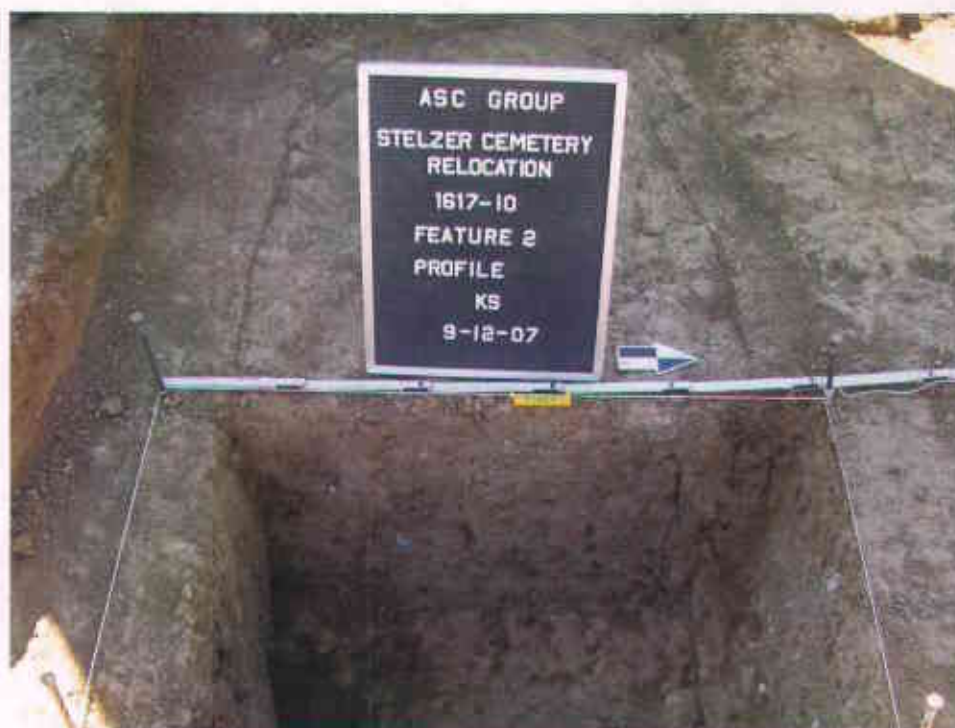
Plate 17. West wall profile of slit trench for Feature 2.

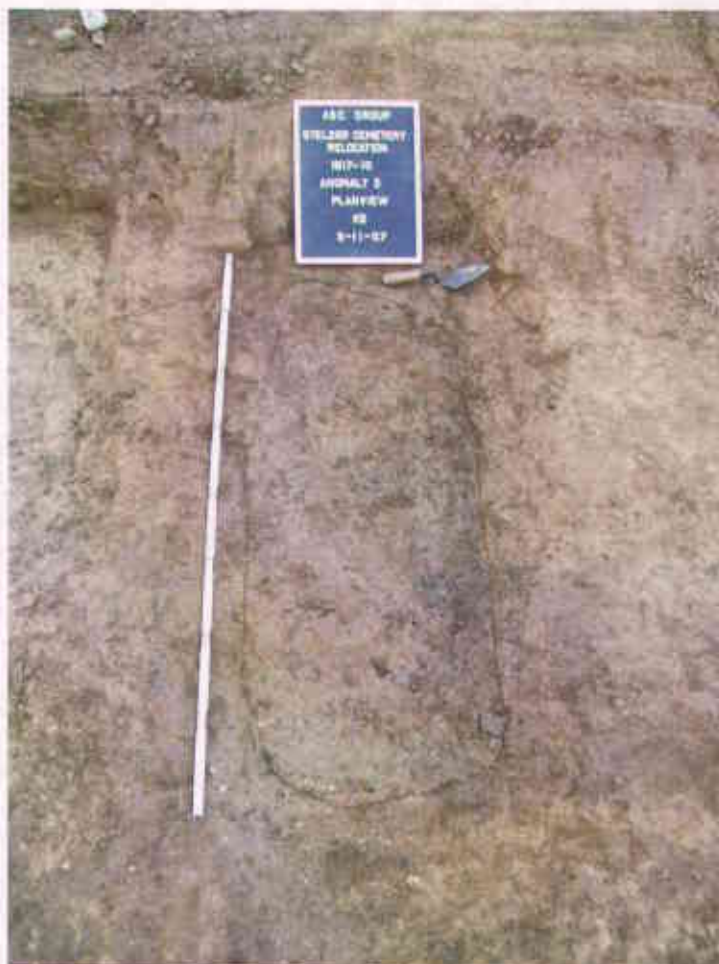
Plate 18. Plan view of Feature 3, unexcavated.

Feature 3 is smaller than the other two features and hence is thought to be the foster infant burial mentioned above (OGS, FCC 1980:ii). It is 51 in (128 cm) long and averages about 18 in (46 cm) in width, though the width is variable (Figure 22). In plan view, Feature 2 is a little less recognizable against the subsoil background than the other two features (Plate 18). Its boundaries were less distinct. It may be that, as an infant burial, it was less formally prepared than an adult burial would have been. Stratum IV, which is likely grave fill, consisted of a friable yellowish brown (10YR 5/4) sandy loam with a few pebbles. It was mottled with a yellowish brown (10YR 5/6) sandy loam. In the northern part of the feature, the mottling was not present (Stratum V), although the boundary between the two areas was indistinct. In one area along the northern edge of the graveshaft a topsoil ped (about 2 in/6 cm thick) was found. It is a dark grayish brown (10YR 4/2) silt loam. It is evidence of the grave refilling.

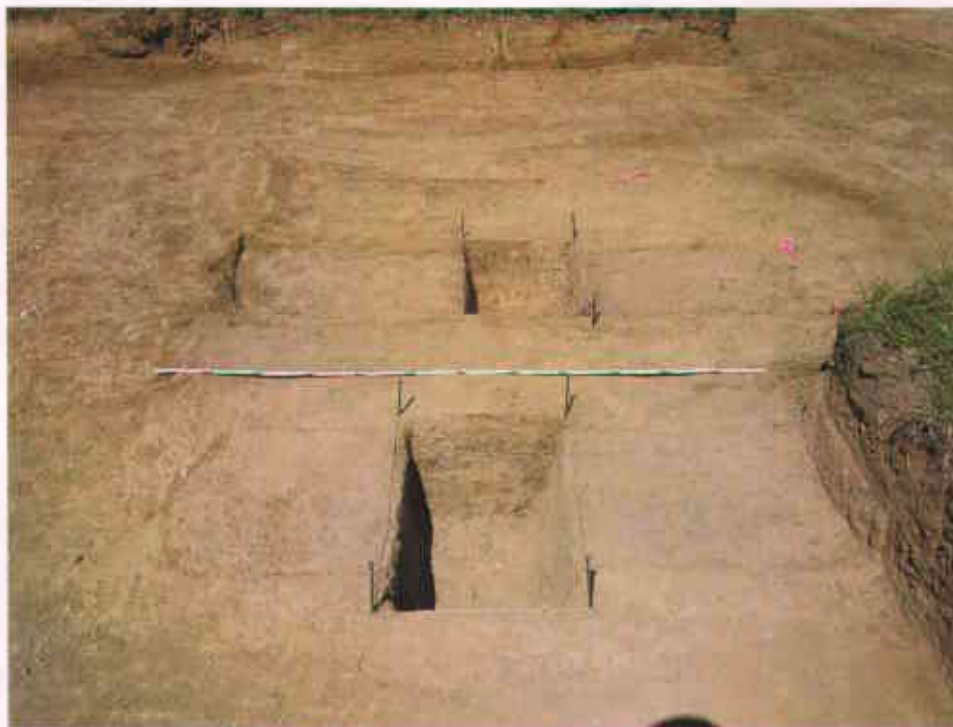
Plate 19. Overview of graves after excavations.

The site boundaries were drawn to include the three graves, a 6.6 ft (2-m) buffer, and the northern end of the original trench, where the historic artifacts were found (Figure 15; Plates 19 and 20). The site size is 23 ft (7 m) by 23 ft (7 m). The site is named the Stelzer Cemetery Site and was assigned 33FR2711 in the Ohio Archaeological Inventory. Based on documentary and archaeological evidence, the cemetery does not extend beyond the current boundaries of 33FR2711 (Figure 23). The site type is a historic cemetery, with limited dispersed refuse in overlying strata. No prehistoric site type can be defined. GPS coordinates are provided for the centerpoint of each grave (Table 1):
