## **APPENDIX J HISTORIC RESOURCES**

This appendix provides documentation of consultation with the Ohio State Historic Preservation Office. Attachments 1 - 7 are surveys and consultation in support of the impact assessment for Historic, Architectural, Archaeological, and Cultural Resources.

***Federal Aviation Administration***  
**ENVIRONMENTAL IMPACT STATEMENT**  
**FOR**  
**REPLACEMENT RUNWAY AND TERMINAL PROJECT**  
**AT**  
**PORT COLUMBUS INTERNATIONAL AIRPORT**  
**AGENCY MEETING – OHIO HISTORIC PRESERVATION OFFICE**  
**MEETING MINUTES**  
**NOVEMBER 21, 2006**

**Cultural Resources Existing Conditions and Survey  
Methodology Report for the  
Port Columbus International Airport  
Environmental Impact Statement,  
Cities of Columbus and Gahanna, Franklin County, Ohio**

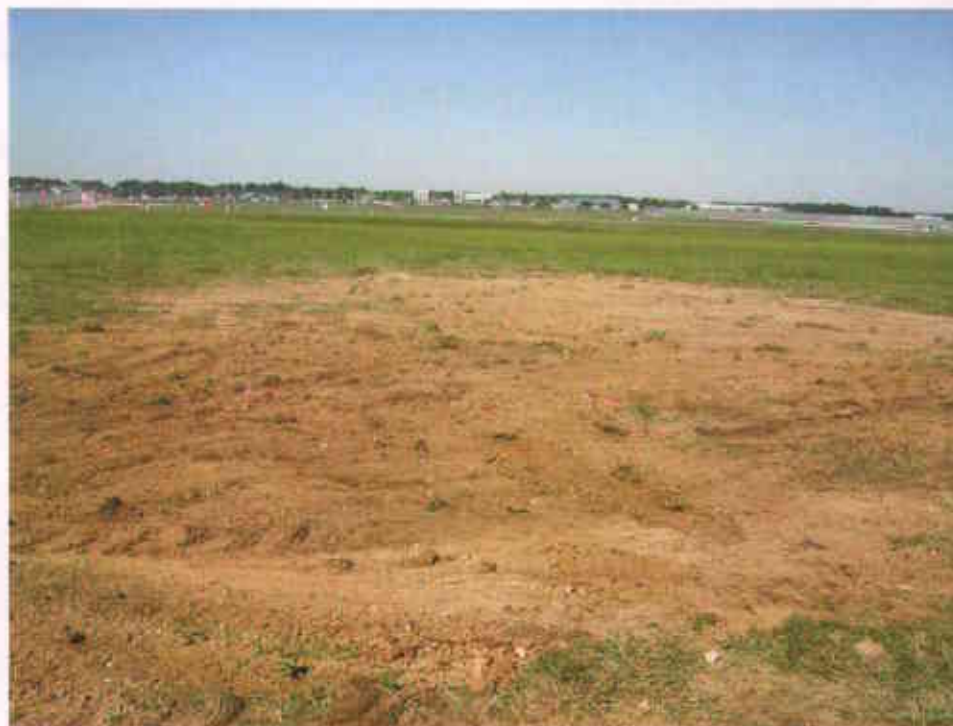
Plate 20. Overview of the Stelzer Cemetery site (33FR2711) after refilling Trench 1.

The site boundaries were drawn to include the three graves, a 6.6 ft (2-m) buffer, and the northern end of the original trench, where the historic artifacts were found (Figure 15; Plates 19 and 20). The site size is 23 ft (7 m) by 23 ft (7 m). The site is named the Stelzer Cemetery Site and was assigned 33FR2711 in the Ohio Archaeological Inventory. Based on documentary and archaeological evidence, the cemetery does not extend beyond the current boundaries of 33FR2711 (Figure 23). The site type is a historic cemetery, with limited dispersed refuse in overlying strata. No prehistoric site type can be defined. GPS coordinates are provided for the centerpoint of each grave (Table 1):

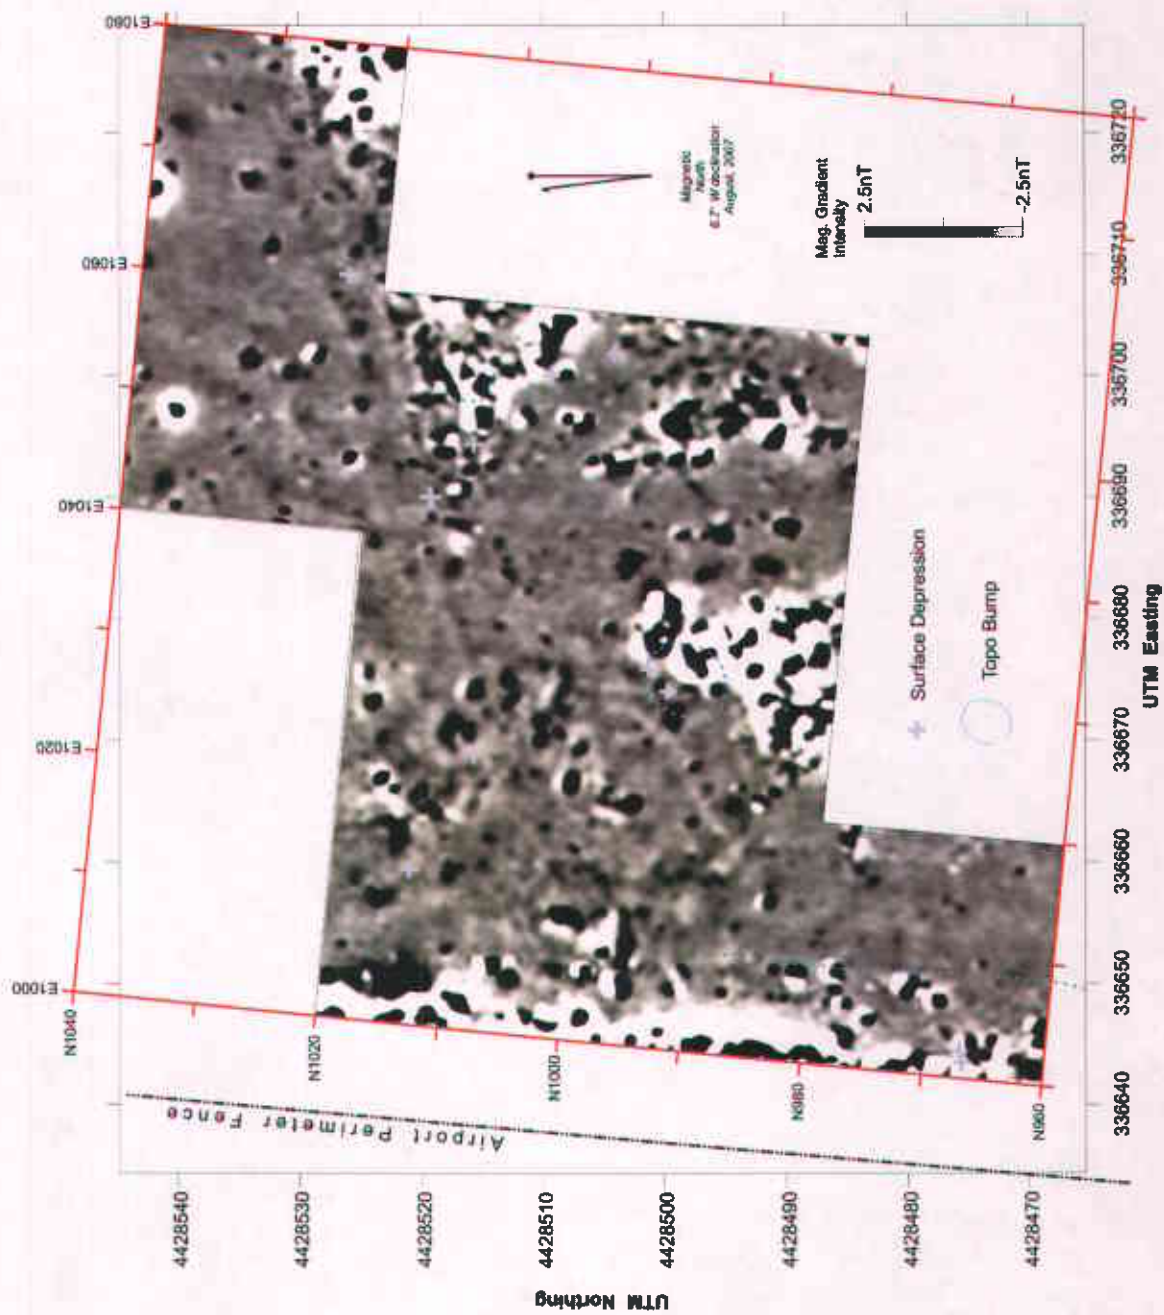
Figure A-3. Map of the magnetic gradient survey results.

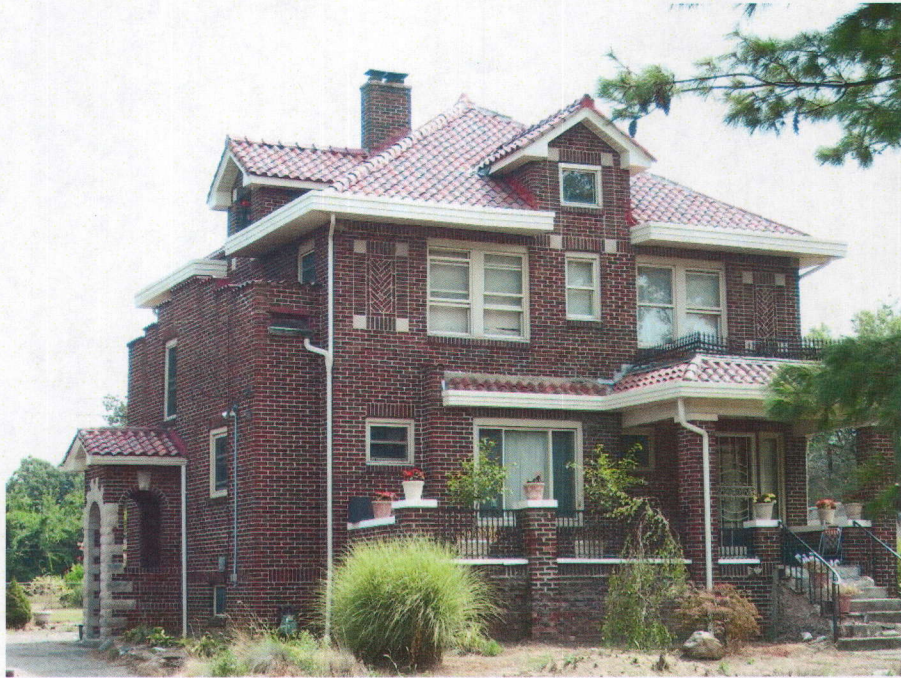
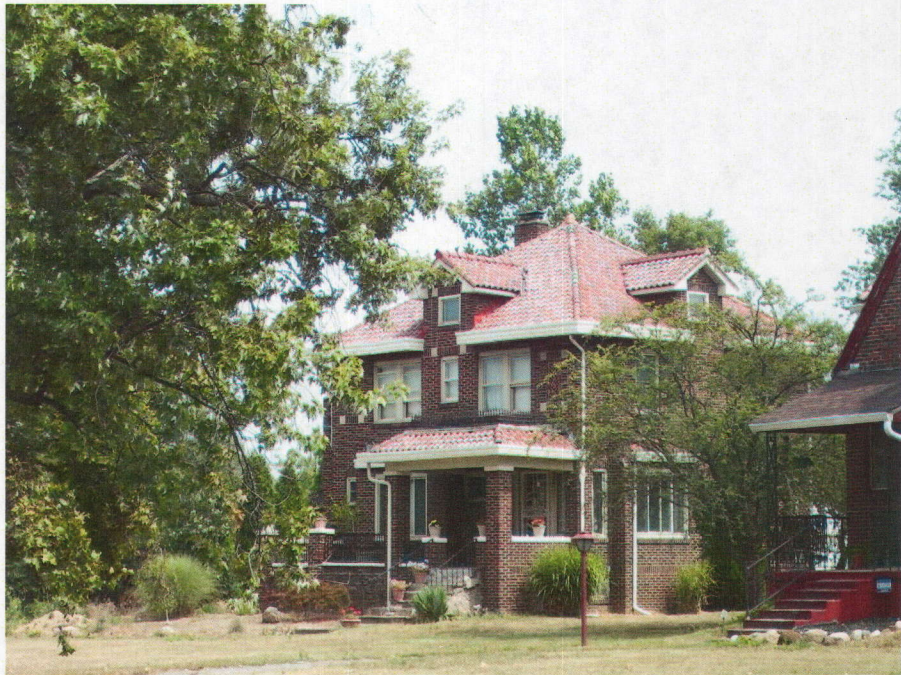
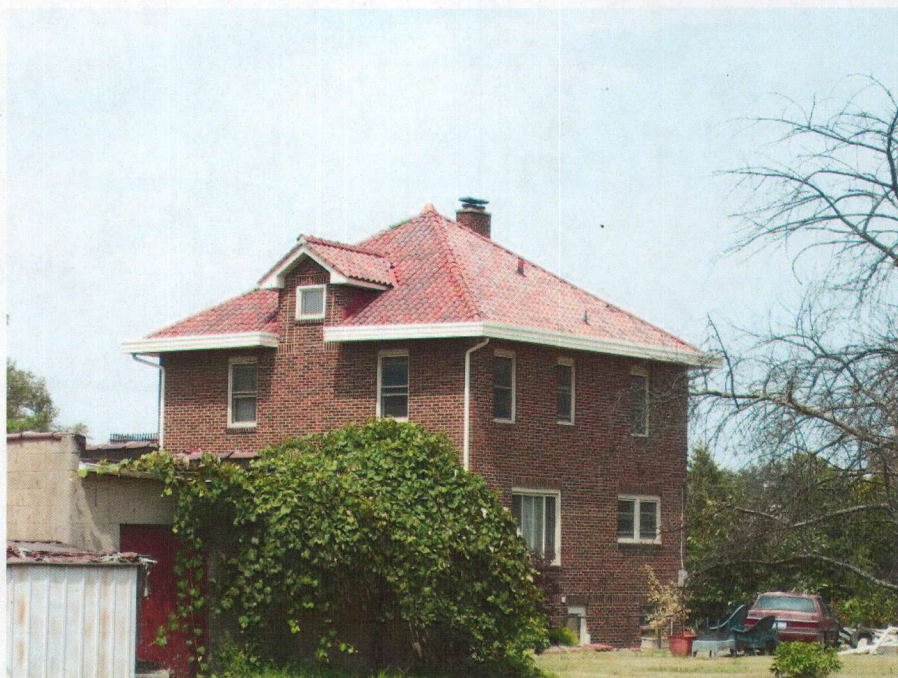
Plate 7. FRA-9788-12, view southeast.

FRA-9788-12 is a two-and-one-half-story house located at 2541 Johnstown Road (Plates 7 and 8). The house's basic form is an American Foursquare. The walls and foundation are covered in stretcher bond brick, and the pyramidal main roof is covered with rounded clay tiles. The front porch and side stoop also have clay tile roofs. A covered porch shelters the front entrance at the south end of the façade and continues north across most of the rest of the façade as an open, raised patio. The covered porch has concrete steps and brick posts. The front door is original. A gabled roof, partially enclosed stoop shelters a side entrance in the north wall. The stoop has stone quoins and keystones. The windows are modern replacements; picture windows have been inserted in several locations on the first floor. A basement entrance is located in the east (rear) wall (Plate 9). An original flat-roof brick garage is located at the northeast corner of the house (Plate 10). A second garage, constructed of concrete block, is located directly behind the original garage.

The house is not known to be associated with historic events or trends under Criterion A. The house appears to have been intended to be part of a planned subdivision (Kensington Subdivision) that failed due to the Great Depression. Only this house and its neighbor to the south (FRA-9787-12) appear to have been built. Most of the rest of the subdivision was replatted and developed in the 1960s and 1970s with ranch and split level houses. The house is not known to be associated with a person or people important in history under Criterion B. No information was found identifying any member of the Guzzo family as historically significant. The house is not a significant example of a type, period, or method of construction under Criterion C. Although derived from a catalog house design, the owner and/or builder took great liberties with the model design, and FRA-9788-12 does not have any of the stylistic features that provide visual associations with the model's Spanish name and is not good example of this model of Sears catalog house. On its own merits, the house is not a strong example of an architectural style or house type. FRA-9788-12 retains integrity of location, design, materials, workmanship, and feeling. The integrity of setting and association has been lost to the later residential subdivision to the east and south. The house lacks significance and is recommended as not eligible for inclusion in the NRHP.

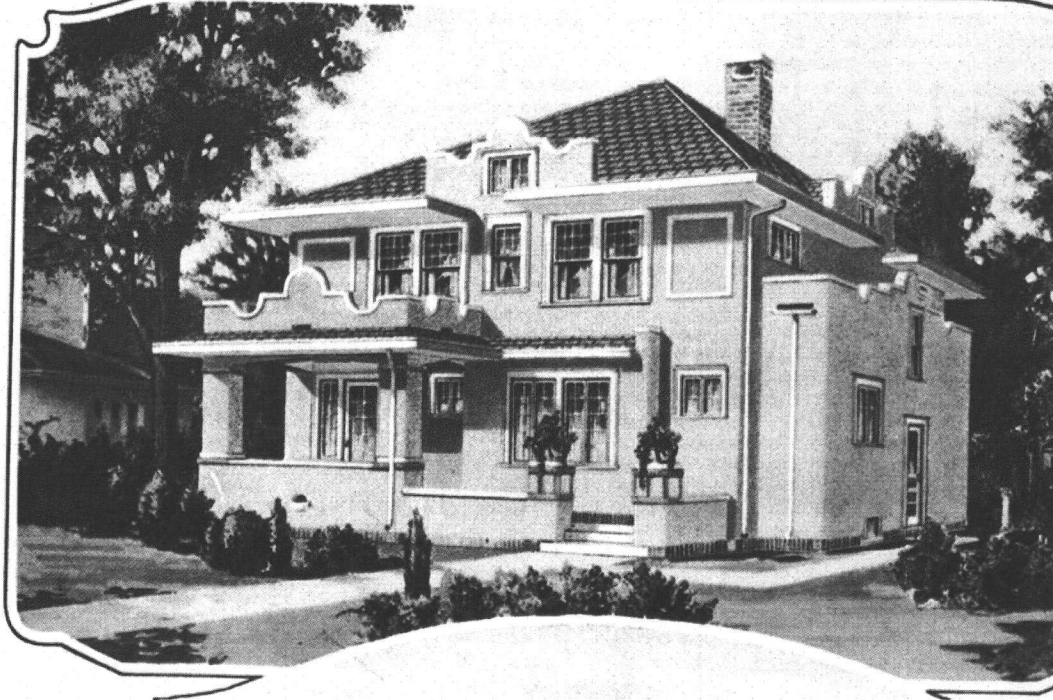
Plate 11. Alhambra model from Sears, Roebuck & Co., "Honor Bilt" Modern Homes, 1926.

According to information obtained from the Franklin County Auditor's website, the house was built in 1929, and the property was owned by members of the Guzzo family from 1928 to 1950. The house's design has been adapted from the Alhambra model found in Sears, Roebuck house catalogs off and on between 1918 and 1929, although the owner or builder deviated greatly from the model as shown in the catalog (Plate 11). The Alhambra model is a

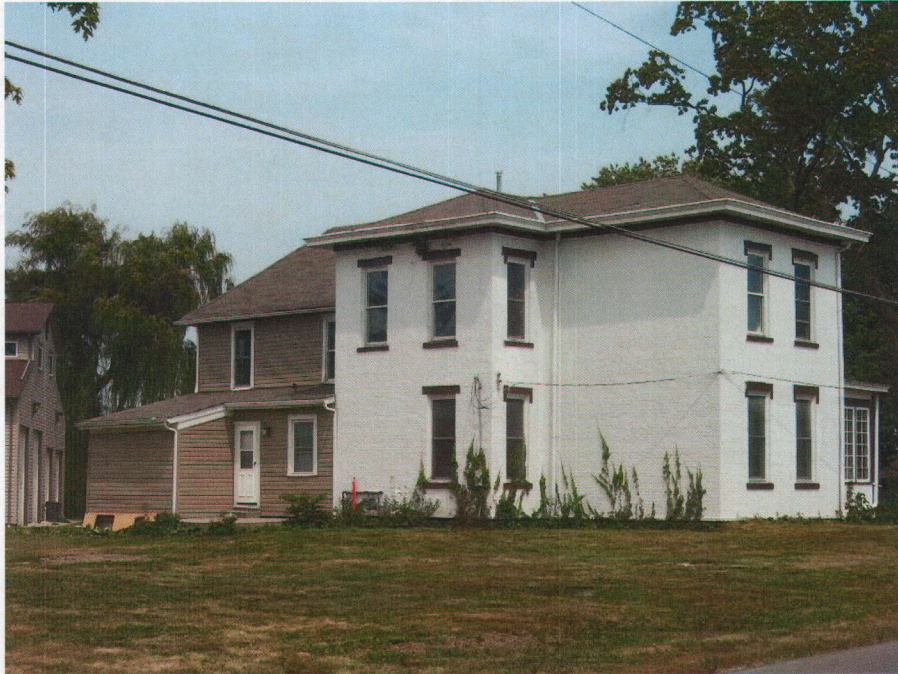
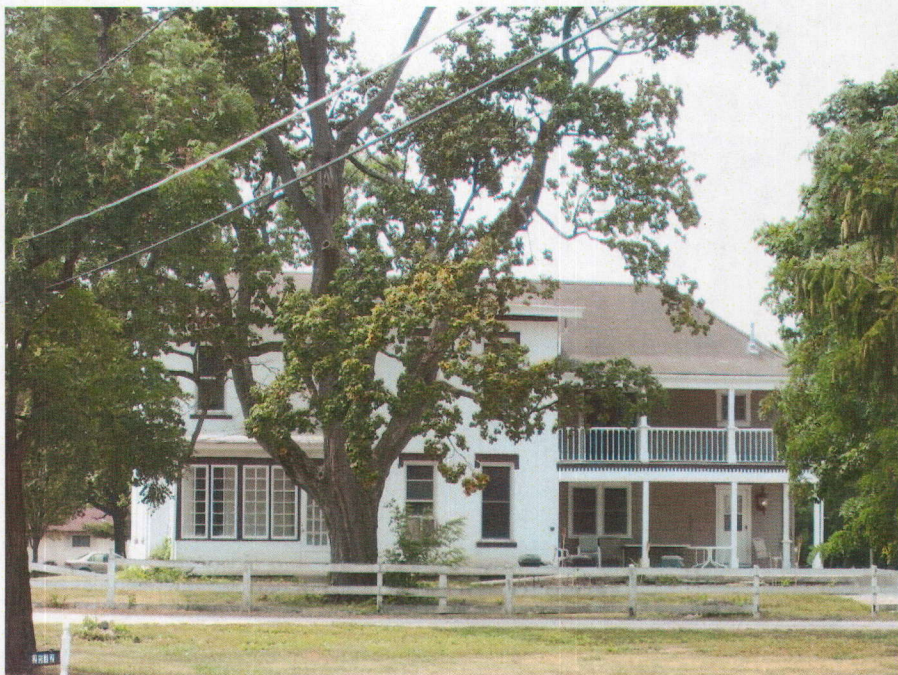
Plate 12. FRA-9789-12, view north.

FRA-9789-12 is a T-plan Italianate-style house located at 2568 Johnstown Road (Plates 12 and 13). The house is not a high-style example of the Italianate; the shallow hipped roof and the window lintels are the primary features of the style present on this house. The walls are brick, mostly in 7/1 American bond. The roof is covered in asphalt shingles. The windows are mostly modern replacements. The house has a two-story, hipped roof rear addition. This addition is wood-framed and clad in vinyl siding. A two-story porch lines the north side of this addition. A concrete ramp leads to a concrete pad deck at the ground level of this porch. The porch posts have been clad in aluminum. There is a door on the first floor within the porch and double French doors on the second floor of the porch. Small one-story additions line the south side of the addition. A side door with a concrete patio also is located on the south side of the addition. An older enclosed porch is located in the northeast corner of the house's ell. A large modern garage/warehouse building is located behind the house (Plate 14). I-670 runs along the west edge of this property, but is out of sight due to a tree line at the edge of the property. The houses to either side of FRA-9789-12 are modern ranch houses, and the buildings to the north,

The house has no significant associations with historic events or trends under Criterion A. Although likely once a farmhouse, the property retains no agricultural land or old outbuildings. The house has no associations with a person or people important in history under Criterion B. No information was found identifying any member of the Dorsey family as historically significant. The house is not a significant example of a type, period, or method of construction under Criterion C. The house has the barest minimum of design elements to give the appearance of the Italianate style and is not a significant example of the style. The house's original appearance also has been altered with a large wood-framed addition. The house retains integrity of location, materials, and feeling. The large addition and the enclosed front porch have removed the integrity of design. The loss of farmland and outbuildings and the introduction of modern houses and I-670 have removed the integrity of setting. The additions and window replacements have removed the integrity of workmanship. The loss of farmland and outbuildings has removed any associations with agricultural history. FRA-9789-12 lacks significance and integrity and is recommended as not eligible for inclusion in the NRHP.

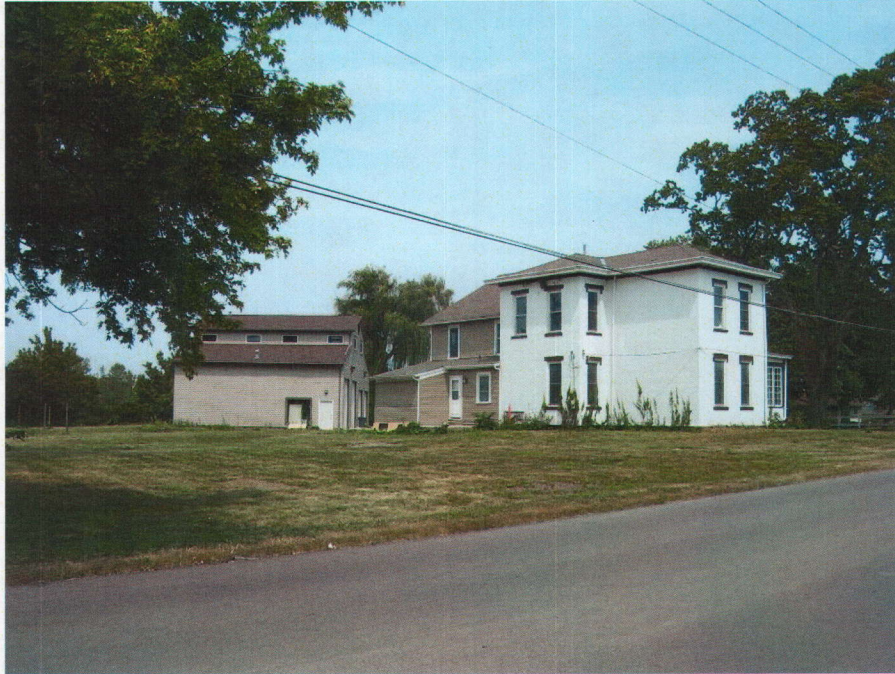
Plate 14. FRA-9789-12, house and modern garage, view north.

The construction date of 1860 was obtained from the Franklin County Auditor's website. Elizabeth Dorsey is labeled as the property owner on Marble's 1883 county map and Modie & Kilmer's 1910 county atlas. The house is depicted on the 1900 East Columbus quadrangle (USGS 15' topographic map). The 1872 county atlas does not depict a building or label a property owner on this piece of land. The Dorsey family continued to own the property into the 1960s. Elizabeth Dorsey owned 38 acres of land at this location on the historic atlas maps, so the property likely was once a small farm, although no old outbuildings survive with the property today.

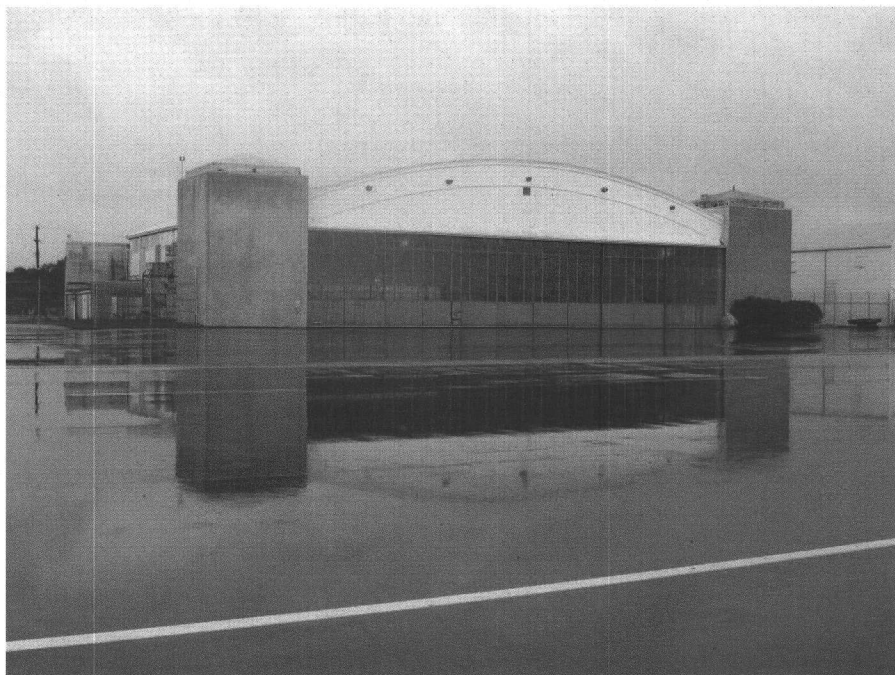
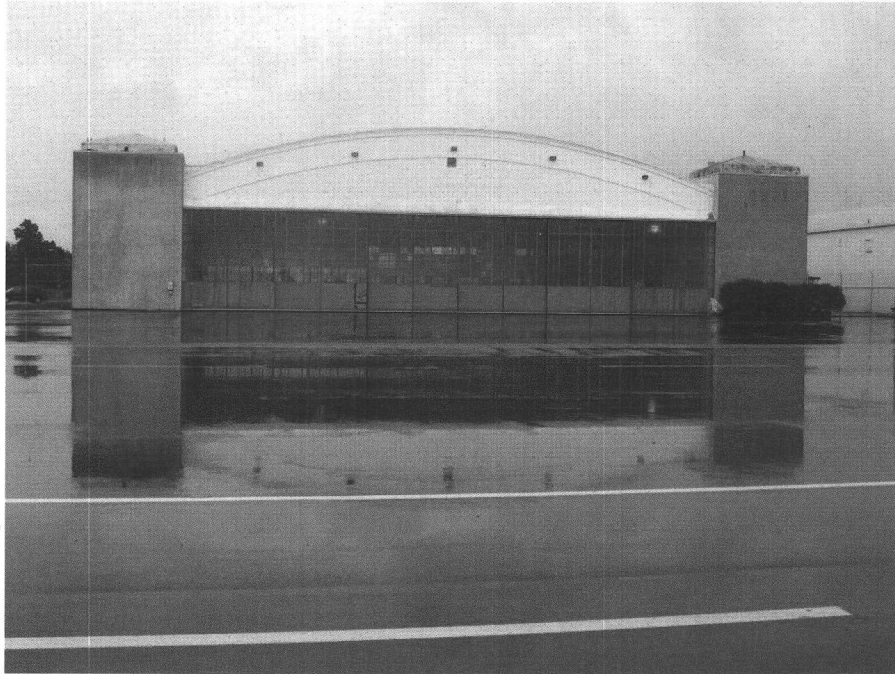
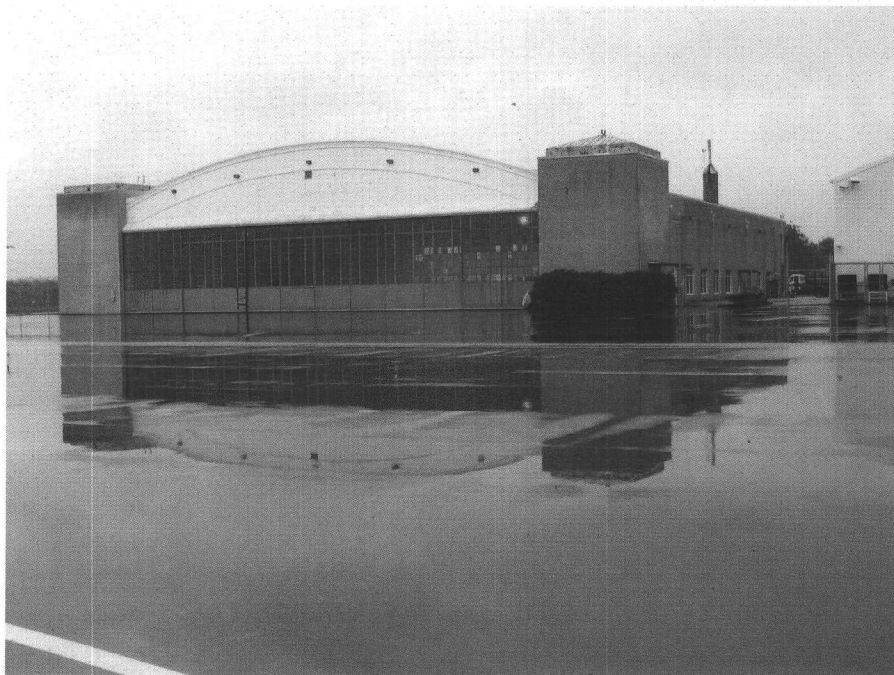
Plate 5. Nationwide Hangar, view southeast.

The Nationwide Hangar (FRA-9676-12), in contrast to the TAT Hangar (FRA-9675-12), has been recommended as not eligible for inclusion in the NRHP for two reasons: 1) the Nationwide Hangar does not share the same level of historic significance as the TAT Hangar and 2) the Nationwide Hangar has a lower level of integrity than the TAT Hangar. Even before the site for Port Columbus had been chosen, the city of Columbus had been chosen as the eastern terminus for the air travel portion of Transcontinental Air Transport's (TAT) combined rail-air transcontinental travel service. Unlike most of the early airlines, which focused mostly on airmail transport, TAT intended to develop passenger air travel in competition with railroad service. When opened, Port Columbus had the only combined air and rail passenger station in the world. TAT later became Trans World Airlines (TWA) with transcontinental flight-only service from Columbus. The dedication of Port Columbus Airport on July 8, 1929, featured the inaugural flight of TAT service from the airport. The Nationwide Hangar had not yet been constructed at this time. When constructed, the Nationwide Hangar was leased by the Curtiss Flying Service, which operated a flight school, charter service for short flights or sightseeing, and sales agency for airplane sales. The TAT Hangar is significant for its associations with the establishment of Port Columbus Airport and for the introduction of passenger air travel in the U.S. The Nationwide Hangar, while an early hangar at Port Columbus, does not have the same significant historic associations as the TAT Hangar.

Map No. 37: The Nationwide Hangar will be required to be demolished to meet airport design standards for the proposed runway. The FAA is making a recommendation that the Nationwide Hangar is not eligible for the NRHP.

to the TAT Hangar, has led to the recommendation that the Nationwide Hangar (FRA-9676-12) is not eligible for the NRHP.
